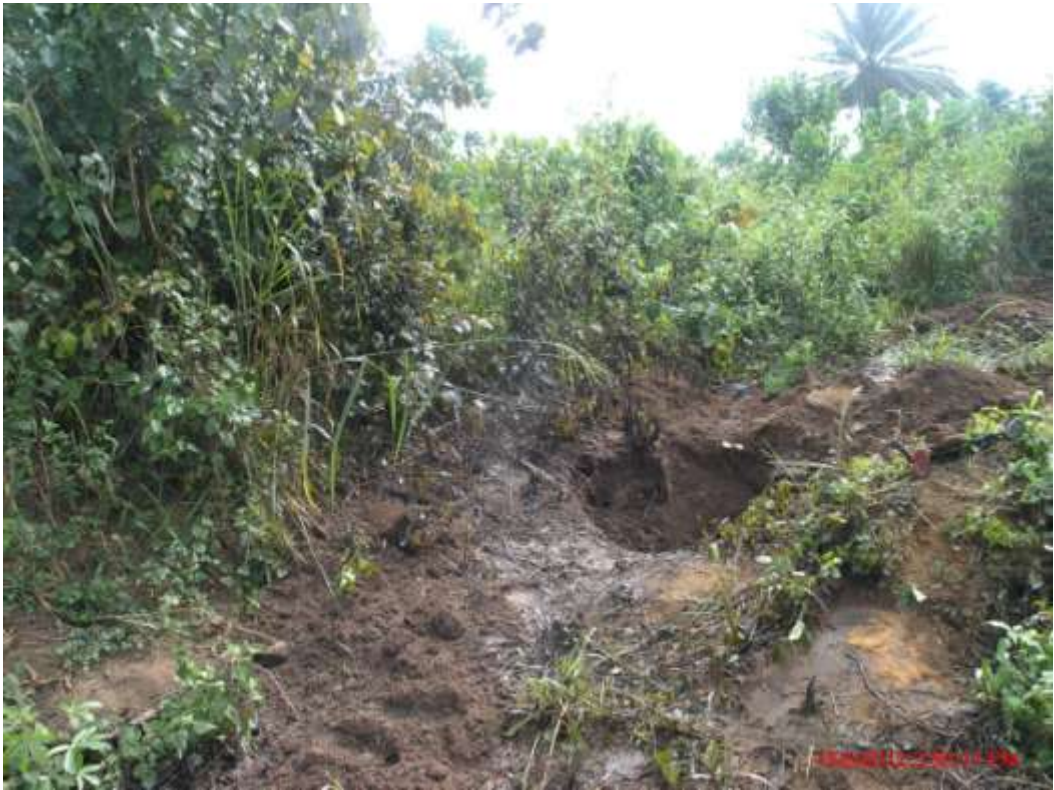
Overview: Part of spill impact on 24" Nembe Creek Trunkline right of way behind Sego Manifold. Picture was taken during Joint Investigation of 27th May 2012.

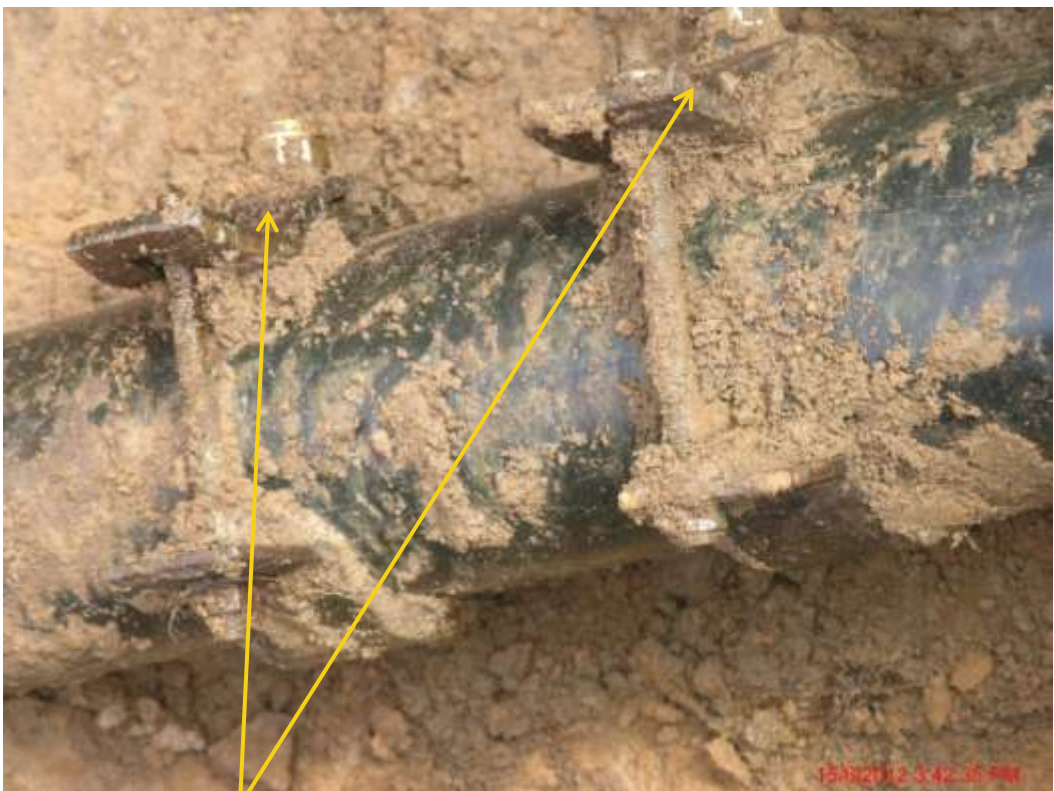
Close up: Illegal fittings on 24" Nembe Creek Trunkline behind Sego Manifold. Picture was taken during Joint Investigation of 27th May 2012.

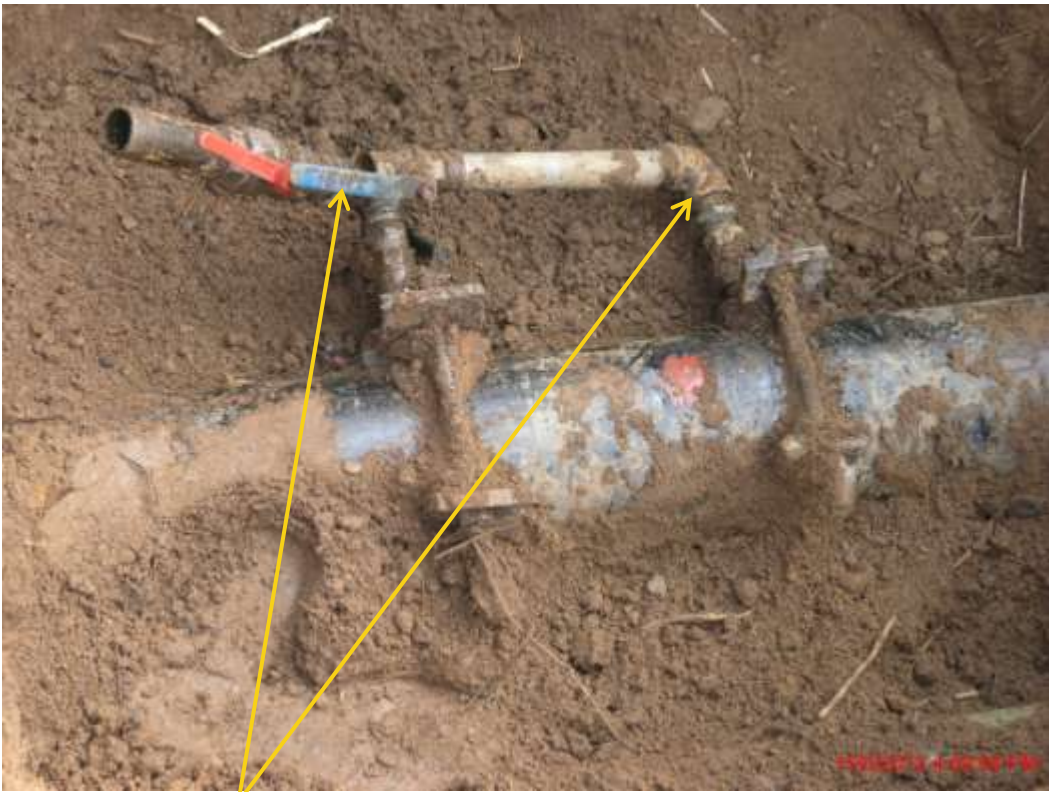
Close up: Illegal fittings on 24" Nembe Creek Trunkline behind Sego Manifold. Picture was taken during Joint Investigation of 27th May 2012.
