Overview: View of part of the spill incident on the 18in Assa-Rumekpe pipeline at Egbeda. Picture was taken during JIV of 8th May, 2011

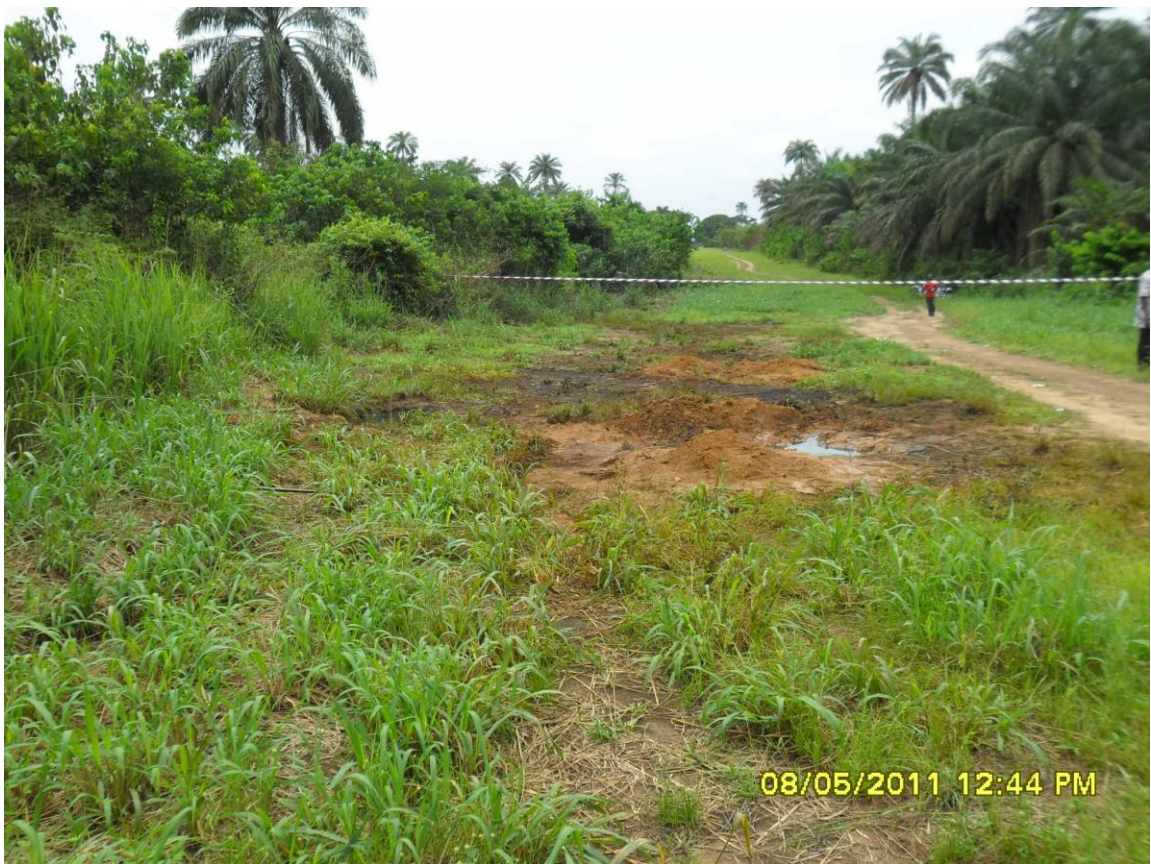
Overview: Extent of the spill incident impact over the Assa-Rumekpe pipeline Right of Way in Egbeda. Picture was taken during JIV of 8th May, 2011

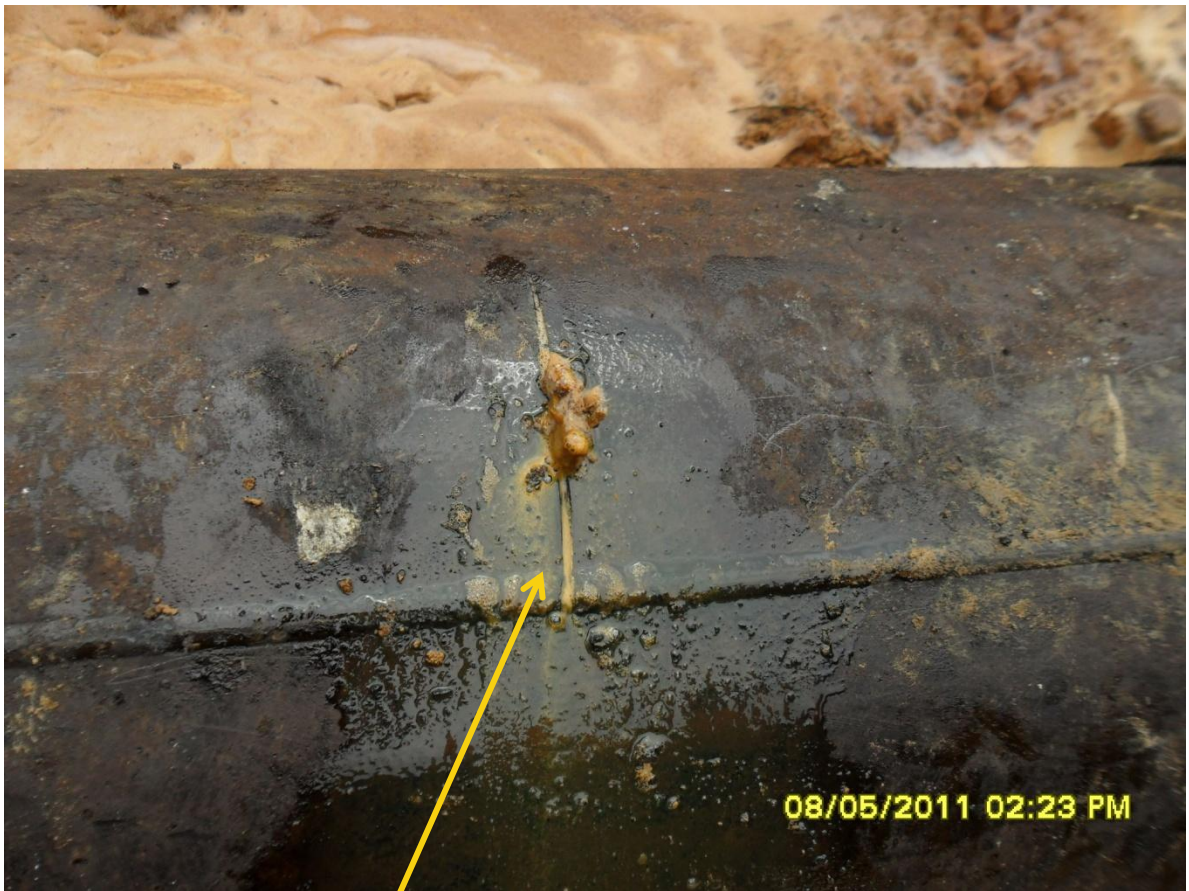
Close-up: Close up of hacksaw cut on 18in Assa-Rumekpe pipeline at Egbeda. Picture was taken during JIV of 8th May, 2011.

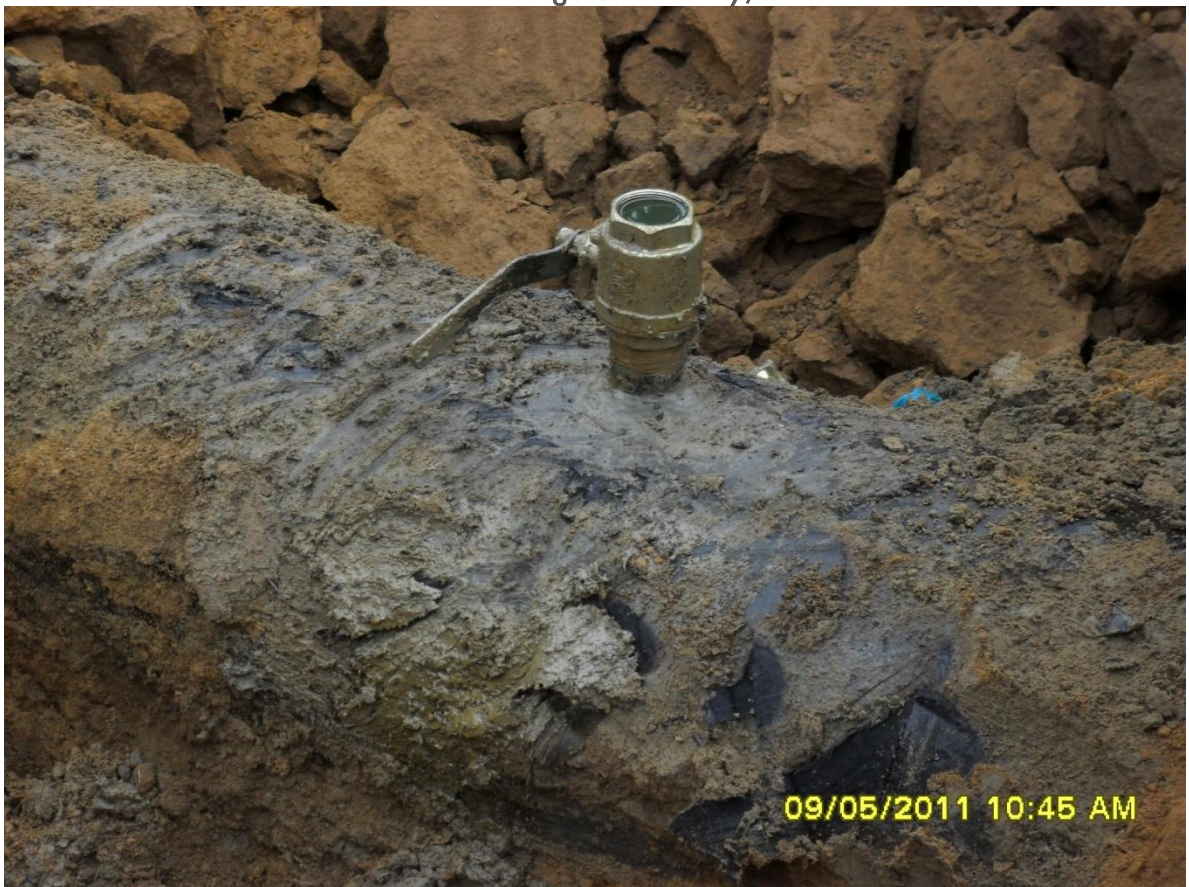
Close-up: Illegally welded point on 18in Assa-Rumekpe pipeline at Egbeda. Picture was taken during JIV of 9th May, 2011.
