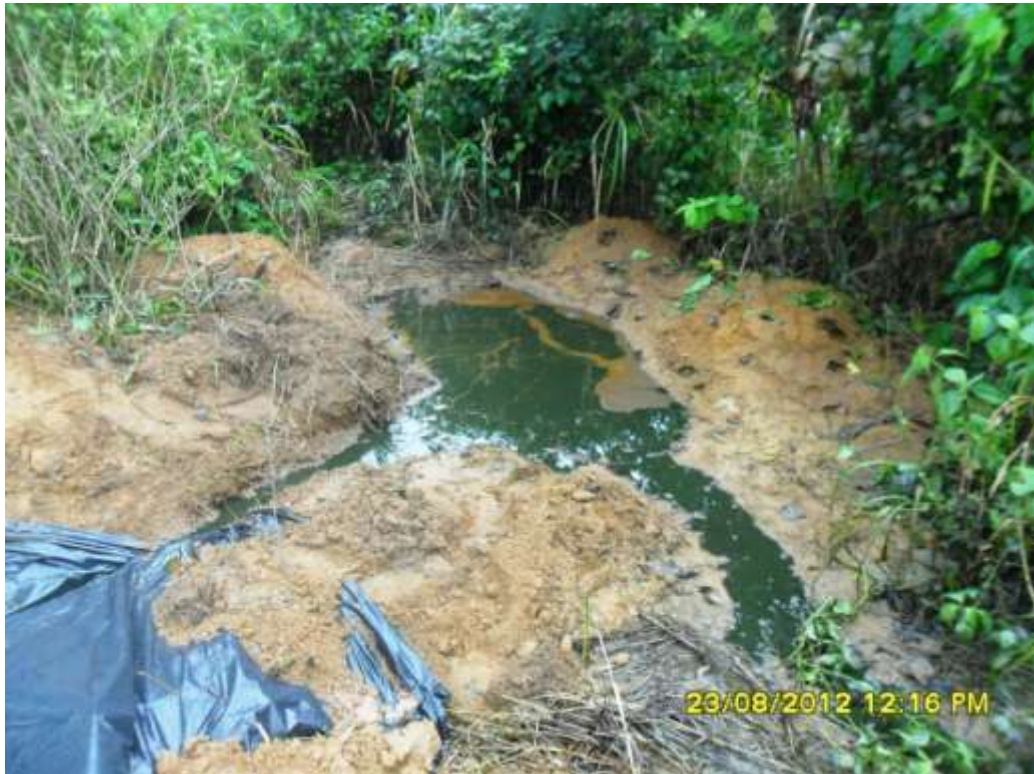
Overview: Part of spill impact on 24" Nkpoku-Bomu pipeline right of way at Nonwa. Picture was taken during Joint Investigation of 23<sup>rd</sup> August 2012

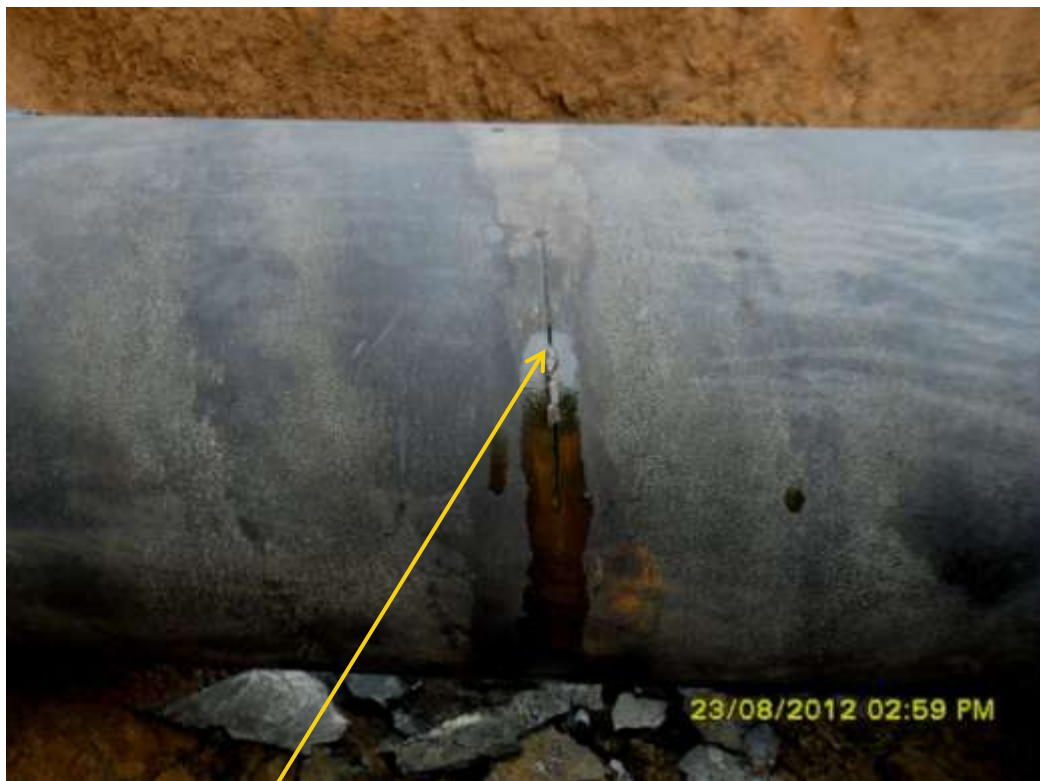
Close up: Hacksaw cut on 24" Nkpoku-Bomu pipeline at Nonwa. Picture was taken during Joint Investigation of 23<sup>rd</sup> August 2012.
