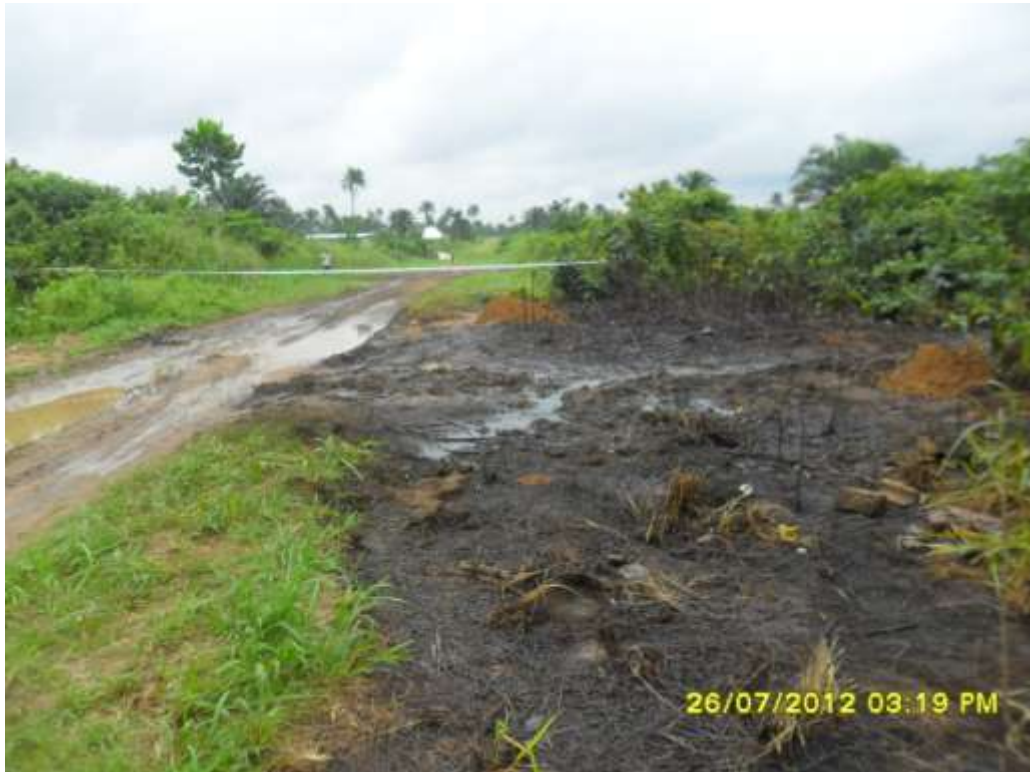
Overview: Part of spill impact on 8" Umuechem-Nkpoku pipeline right of way at Omusele. Picture was taken during Joint Investigation of 26<sup>th</sup> July 2012.

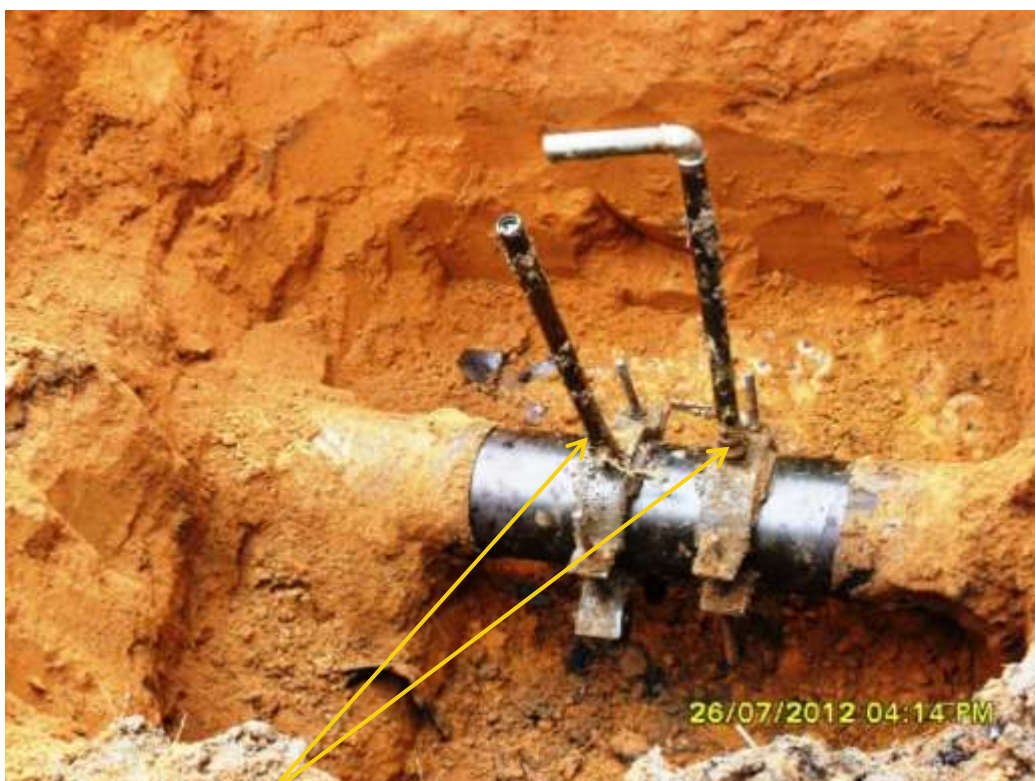
Close up: Illegal fittings on 8" Umuechem-Nkpoku pipeline at Omusele. Picture was taken during Joint Investigation of 26<sup>th</sup> July 2012.
