Overview: Extent of the spill incident impact on 24" Cawthorne channel-Bonny Block Valve Station pipeline route at Kalibiana .

Overview: Extent of the spill incident impact on 24" Alakiri-Bonny Pipeline route at Kalibiama.
Pictures taken during Joint Investigation of 4th - 8th April, 2011

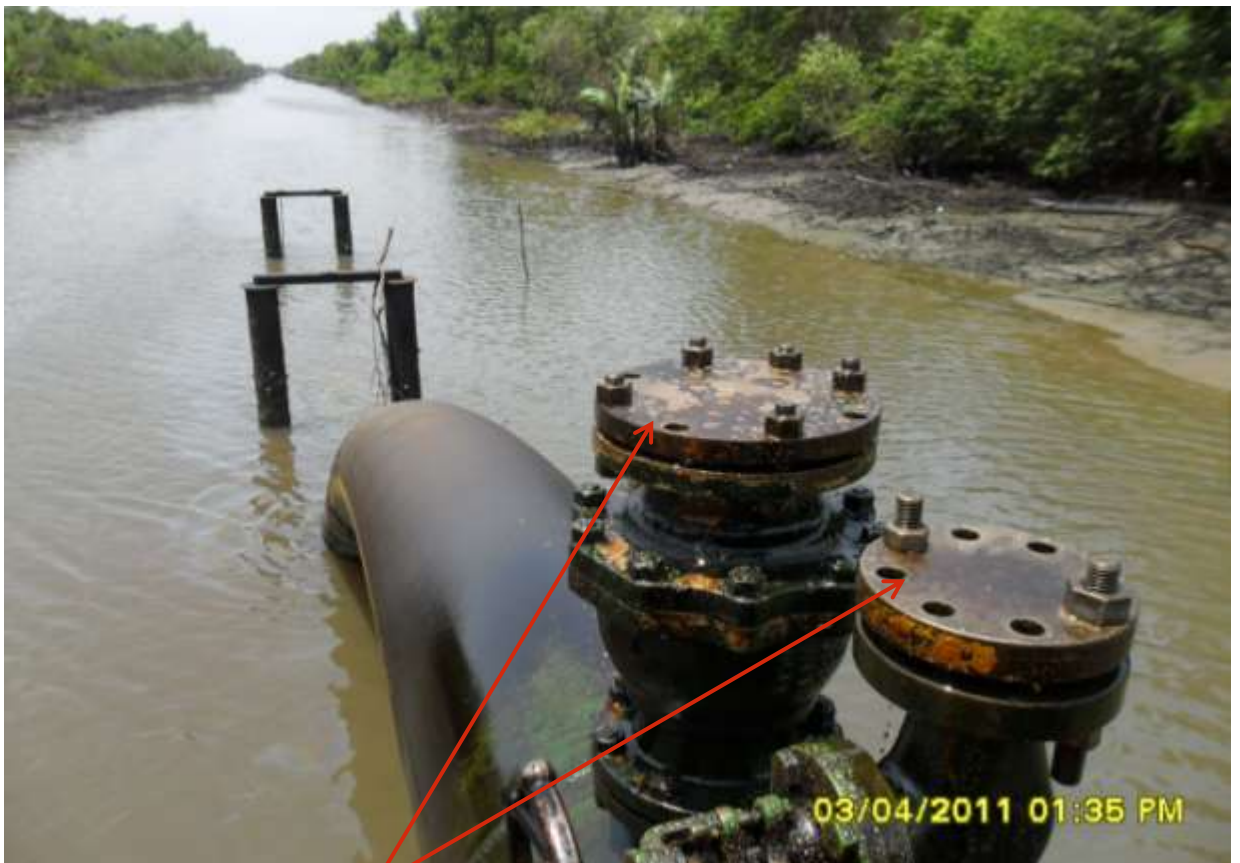
Close-up: Spill due to Tampering with flange nuts & bolts on 24" Cawthorne channel-Bonny Block Valve Station pipeline route at Kalibiana. Pictures taken during Joint Investigation of 1st- 3rd April, 2011

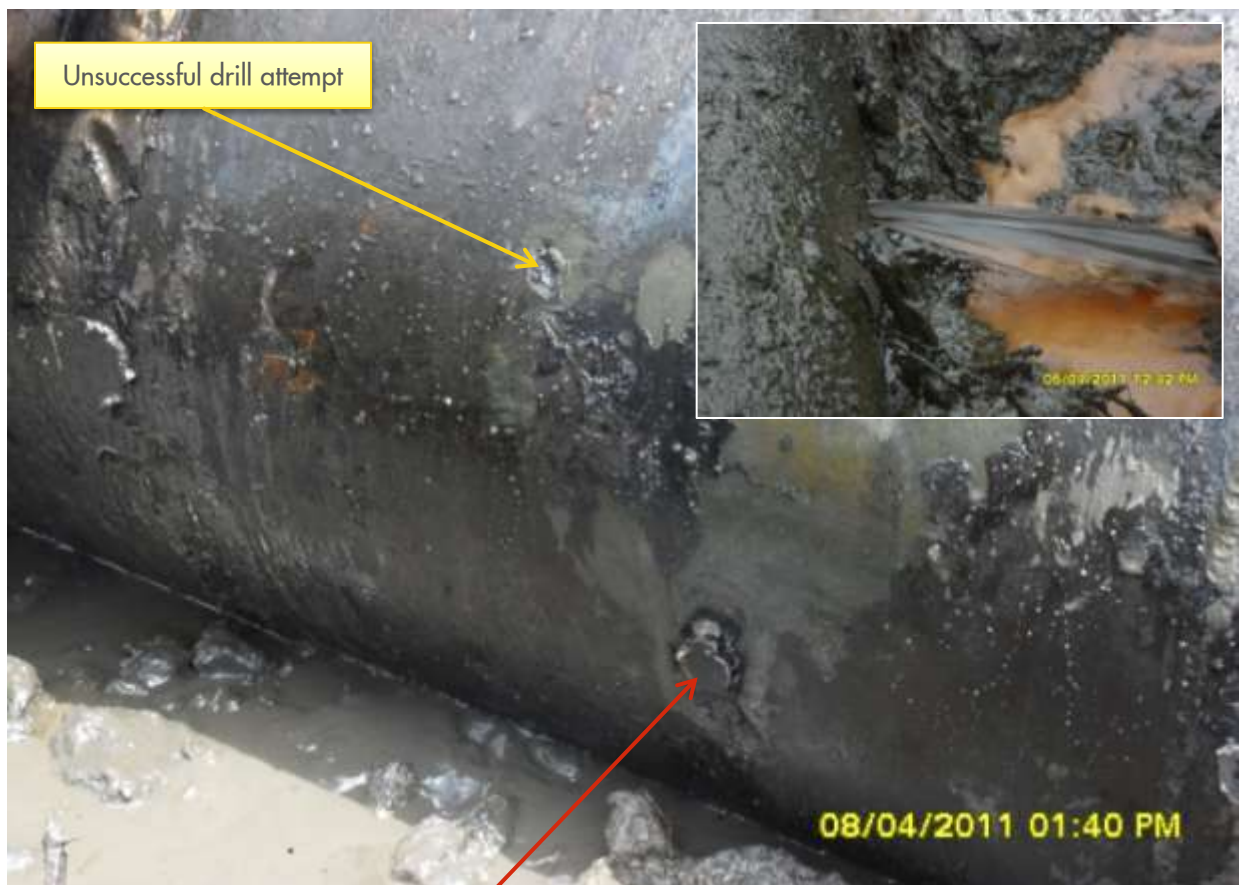
Close-up: Insert shows spill due to drilled hole on 24" Alakiri-Bonny pipeline route at Kalibiama.
Main picture shows spill point after plugging. Unsuccessful drill attempt can also be seen.
