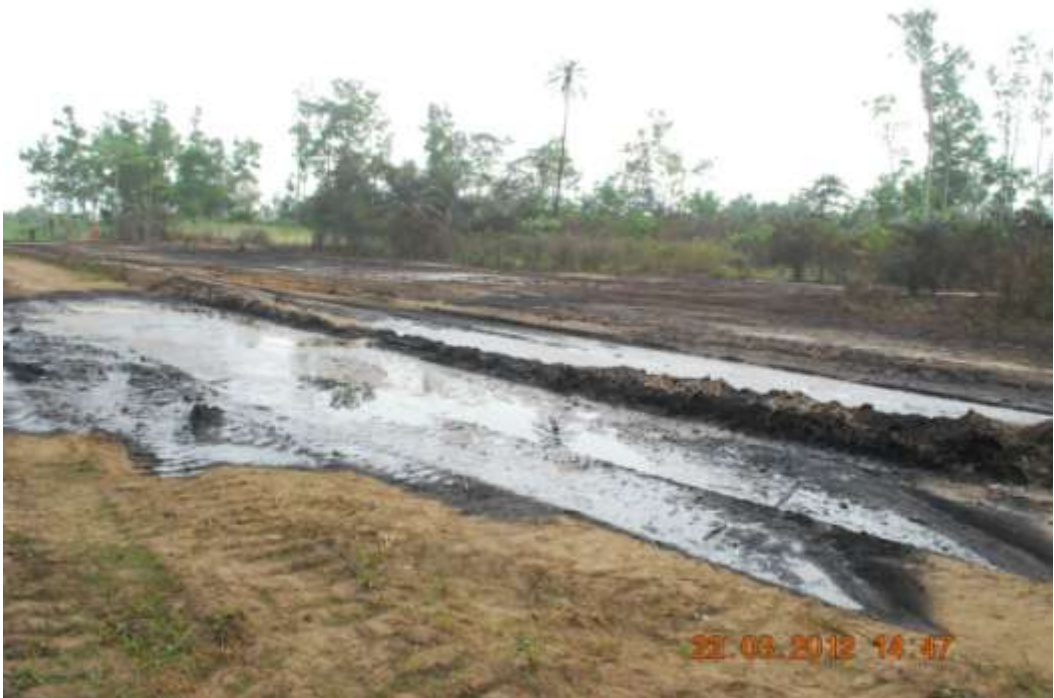
Overview: Part of spill impact on 12" Kokori-Eriemu delivery line right of way at Oteri. Picture was taken during Joint Investigation of 22<sup>nd</sup> March 2012.

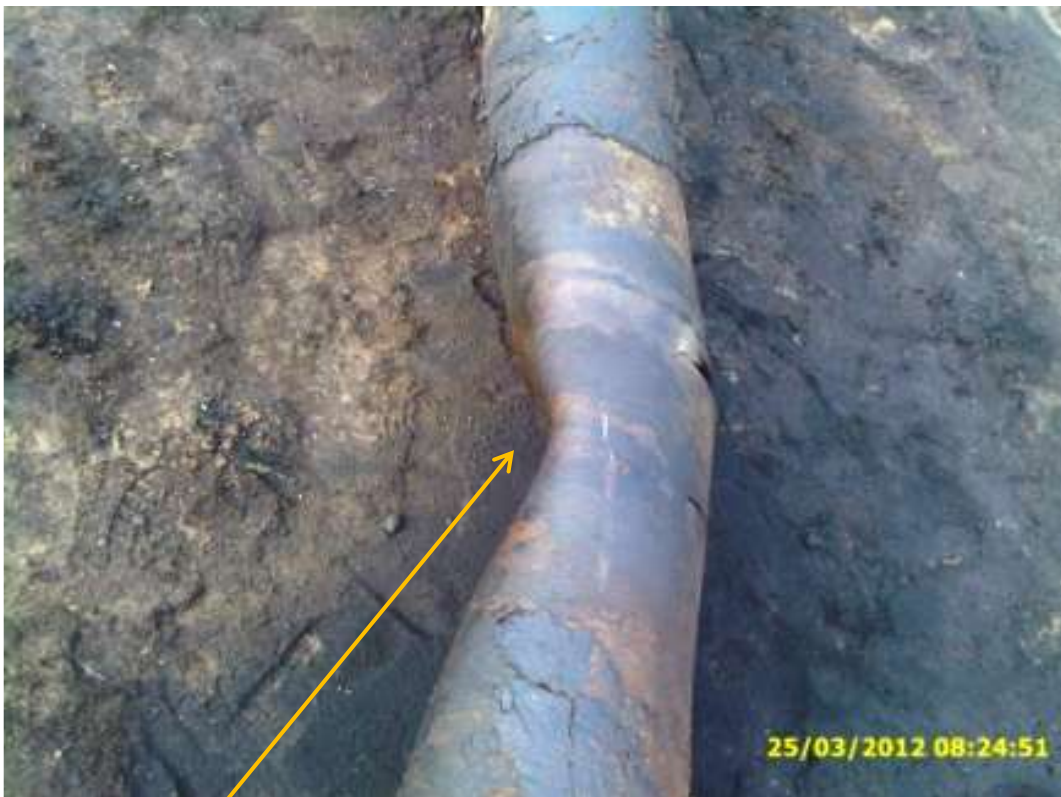
Close up: Inward dent and tear on 12" Kokori-Eriemu delivery line at Oteri. Picture taken during repair of delivery line on 25<sup>th</sup> March 2012.
