Overview: Part of spill impact on 28 inch Trans Forcados Pipeline at Batan . Picture taken during Joint Investigation of 23rd September, 2011

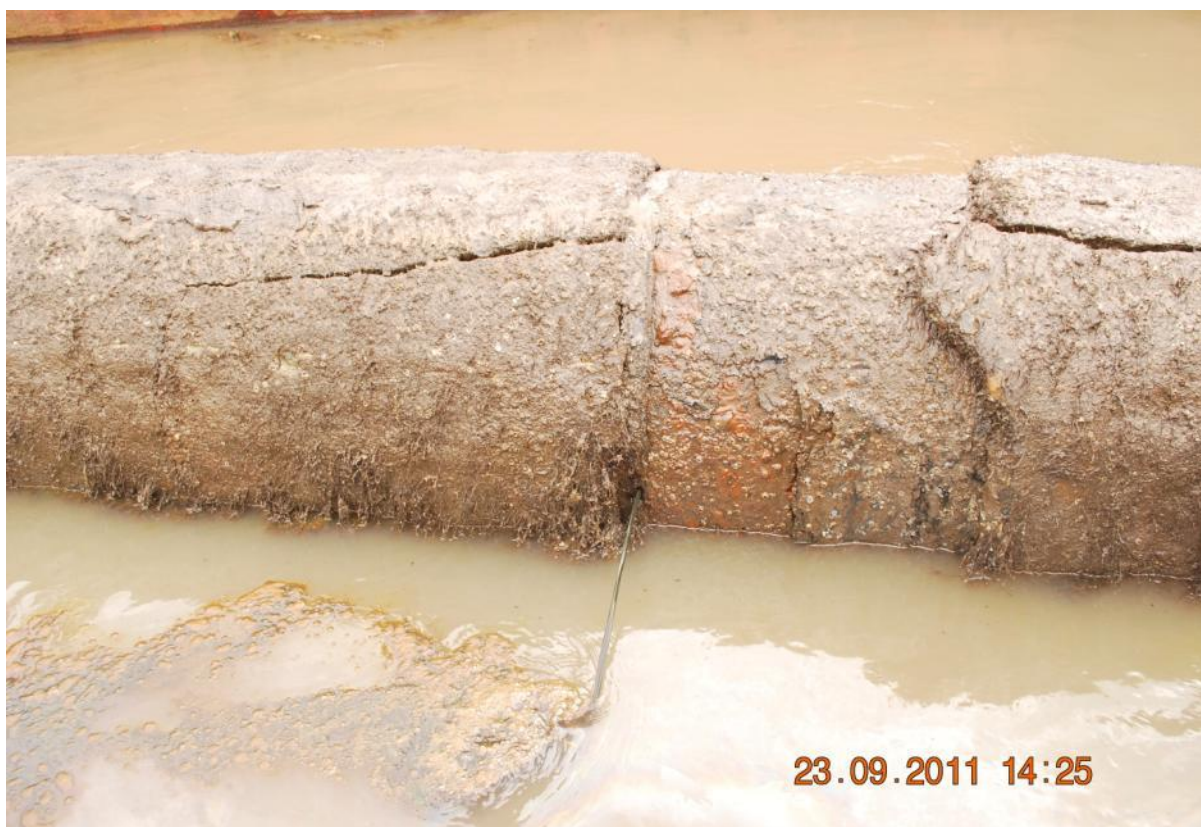
Close-up: Spill due to External Corrosion on 28 inch Trans Forcados Pipeline at Batan. Picture taken during Joint Investigation of 23rd September, 2011 .
