Overview: Part of spill impact on 12" Imo River-Ogale Trunk line at Owaza. Picture was taken during Joint Investigation of 20th August 2012.

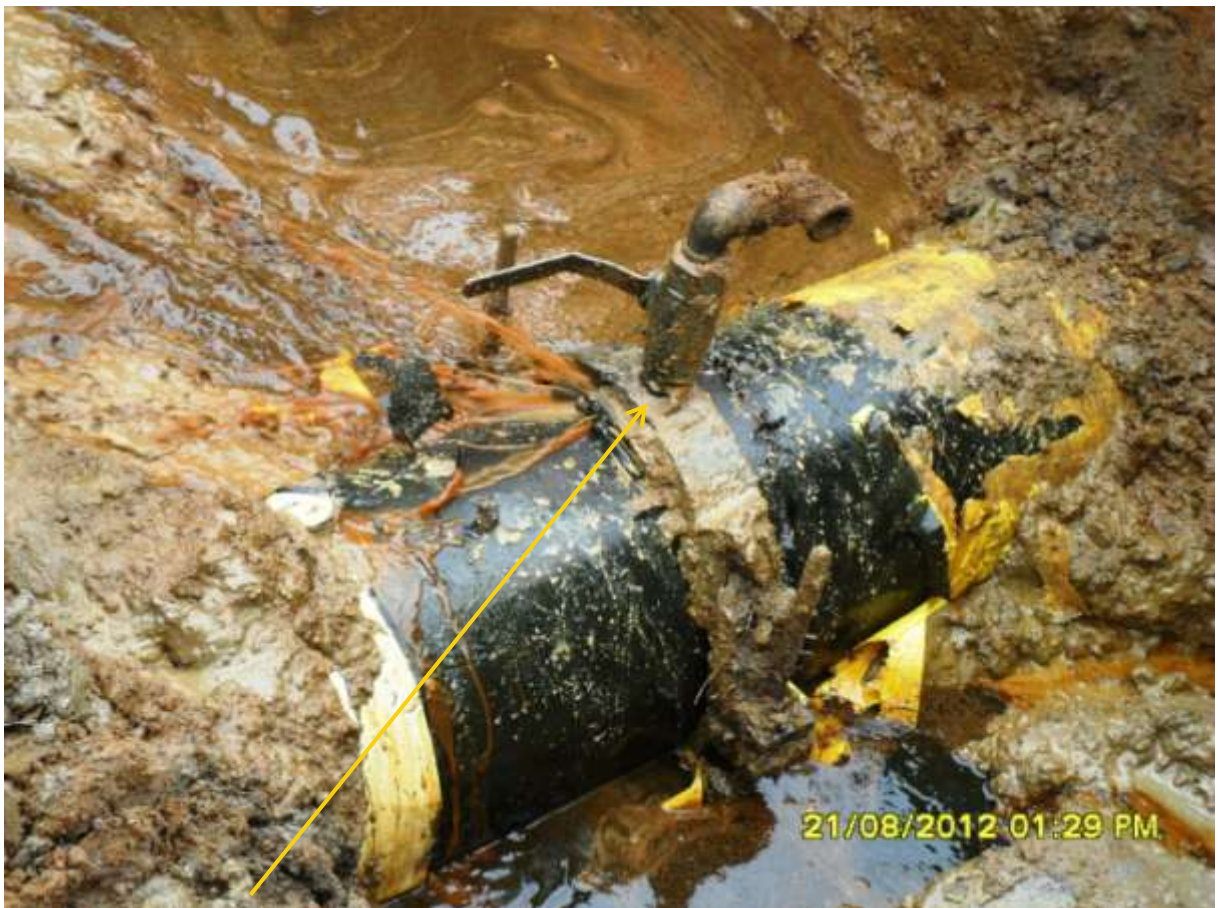
Close-up: Illegal Fitting on 12" Imo River-Ogale Trunk line at Owaza. Picture was taken during Joint Investigation of 21st August 2012.
