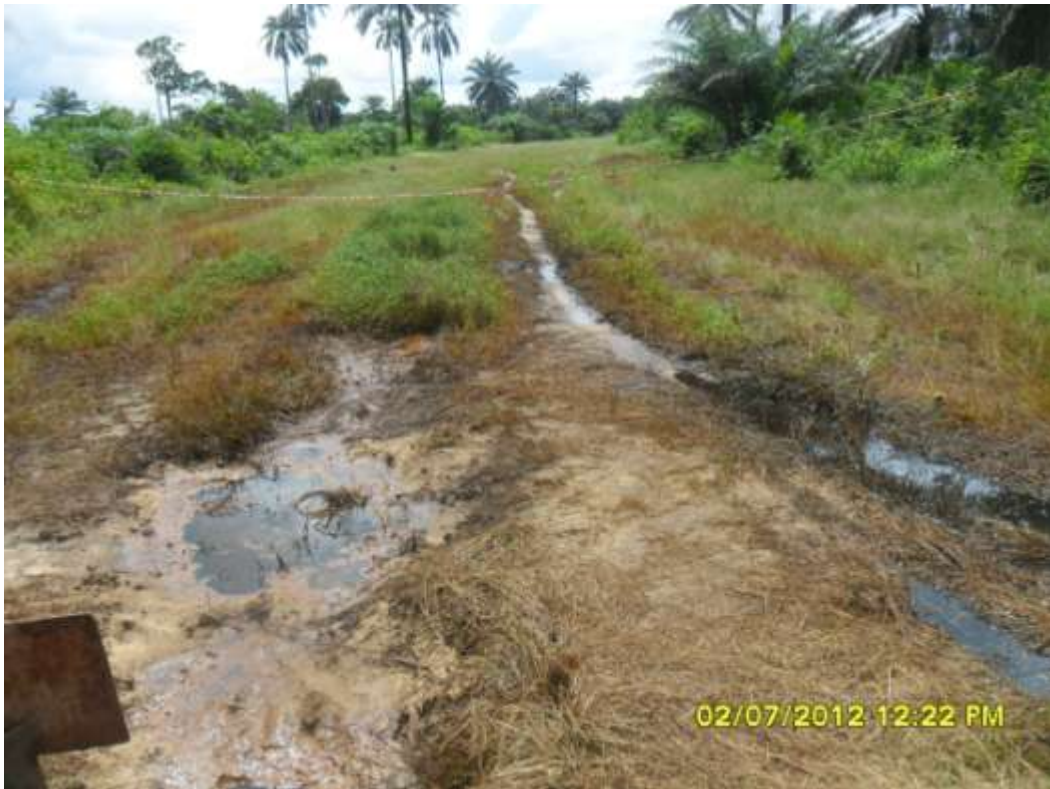
Overview: Part of spill impact on 4" Obele-Ibaa pipeline at Ibaa. Picture was taken during Joint Investigation of 2<sup>nd</sup> July 2012.

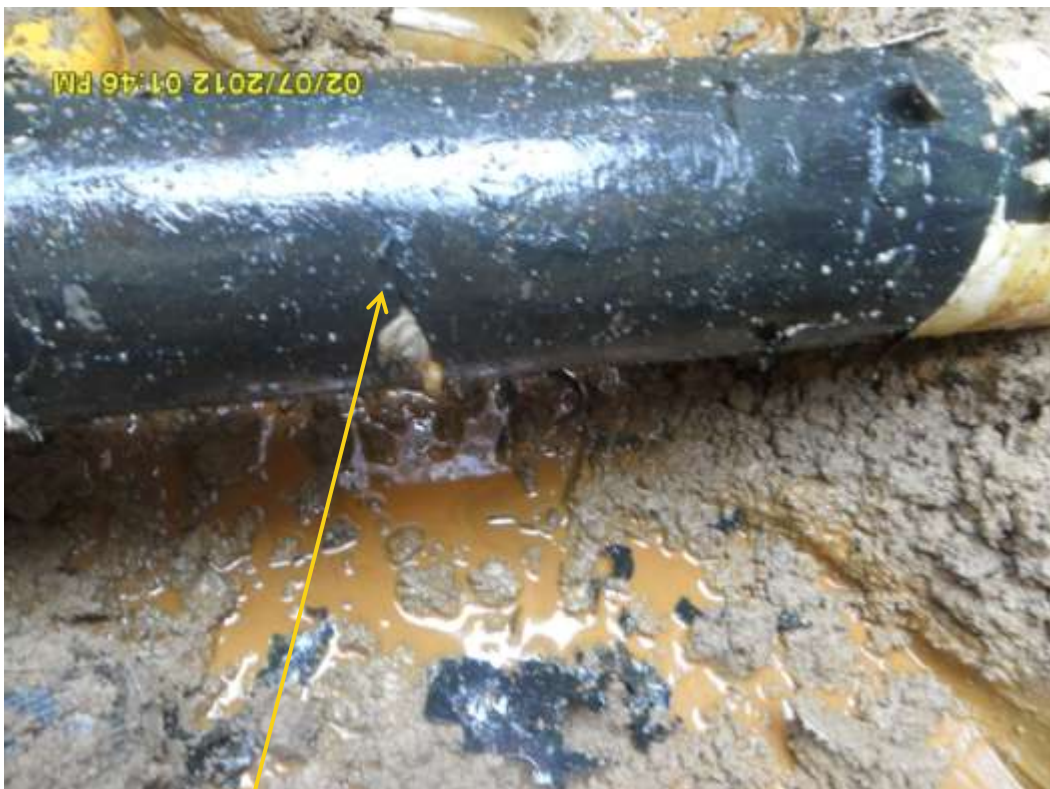
Close up: Spill due to Hacksaw cut on 4" Obele-Ibaa pipeline at Ibaa. Picture was taken during Joint Investigation of 2<sup>nd</sup> July 2012. (Picture was rotated for clarity)
