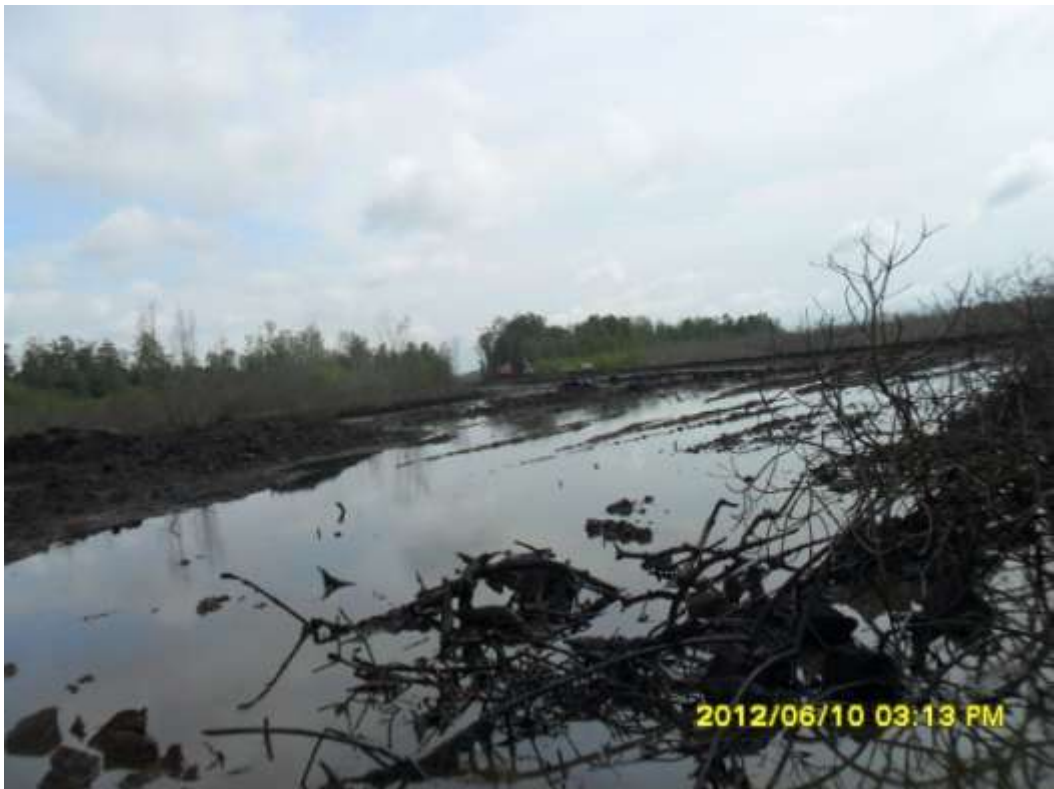
Overview: Part of spill impact on 24" Nembe Creek pipeline right of way at Sego. Picture was taken during Joint Investigation of 10<sup>th</sup> June 2012.

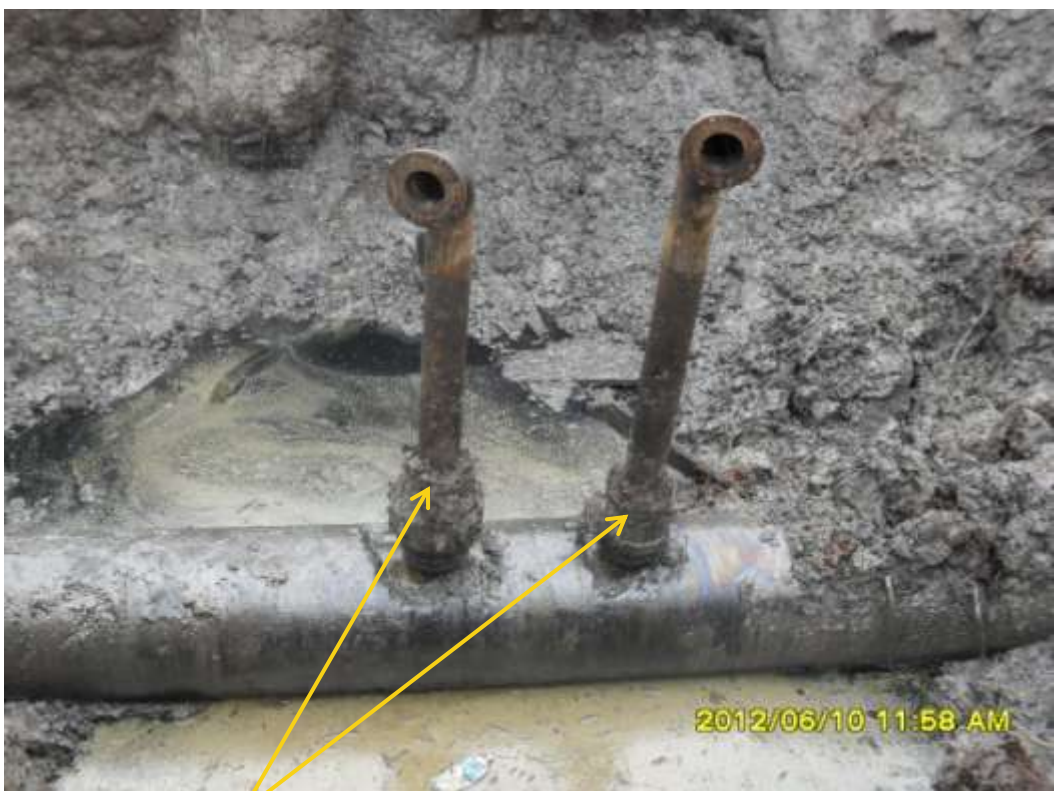
Close up: Illegal fittings on 24" Nembe Creek pipeline at Sego. Picture was taken during Joint Investigation of 10<sup>th</sup> June 2012.

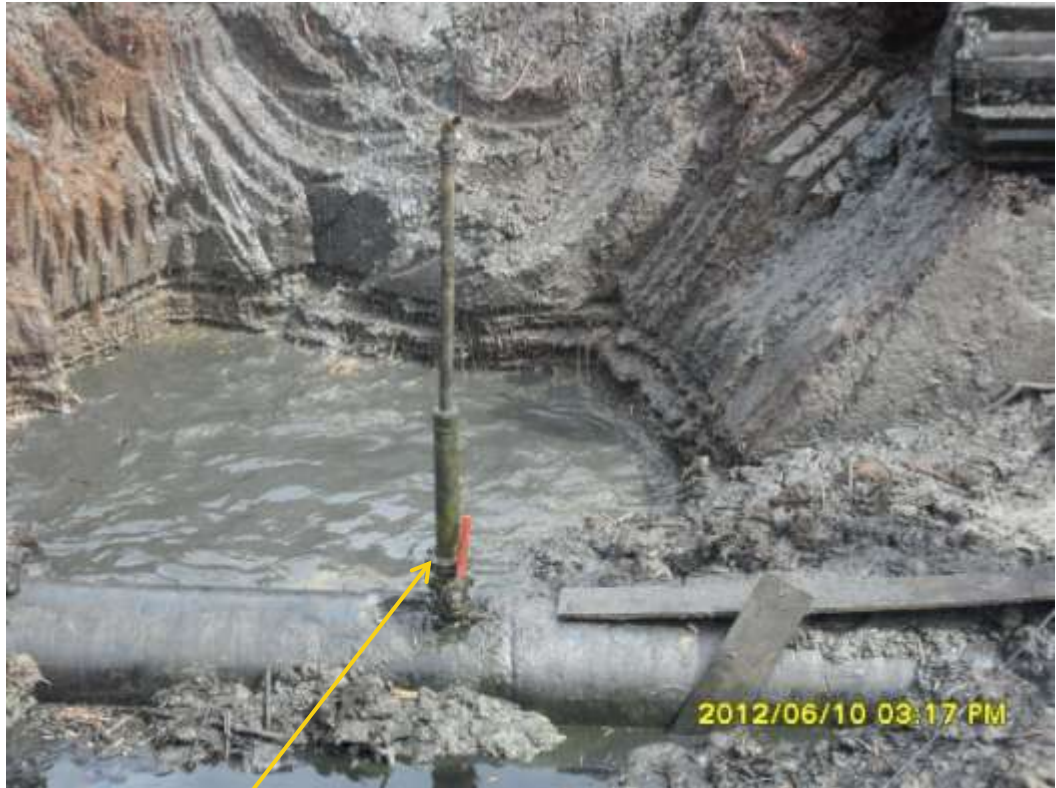
Close up: Illegal fitting on 24" Nembe Creek pipeline at Sego. Picture was taken during Joint Investigation of 10<sup>th</sup> June 2012.
