Overview: Location of spill on 6" Obigbo North pipeline right of way at Ogale. Picture taken during Joint Investigation of 3rd October, 2011.

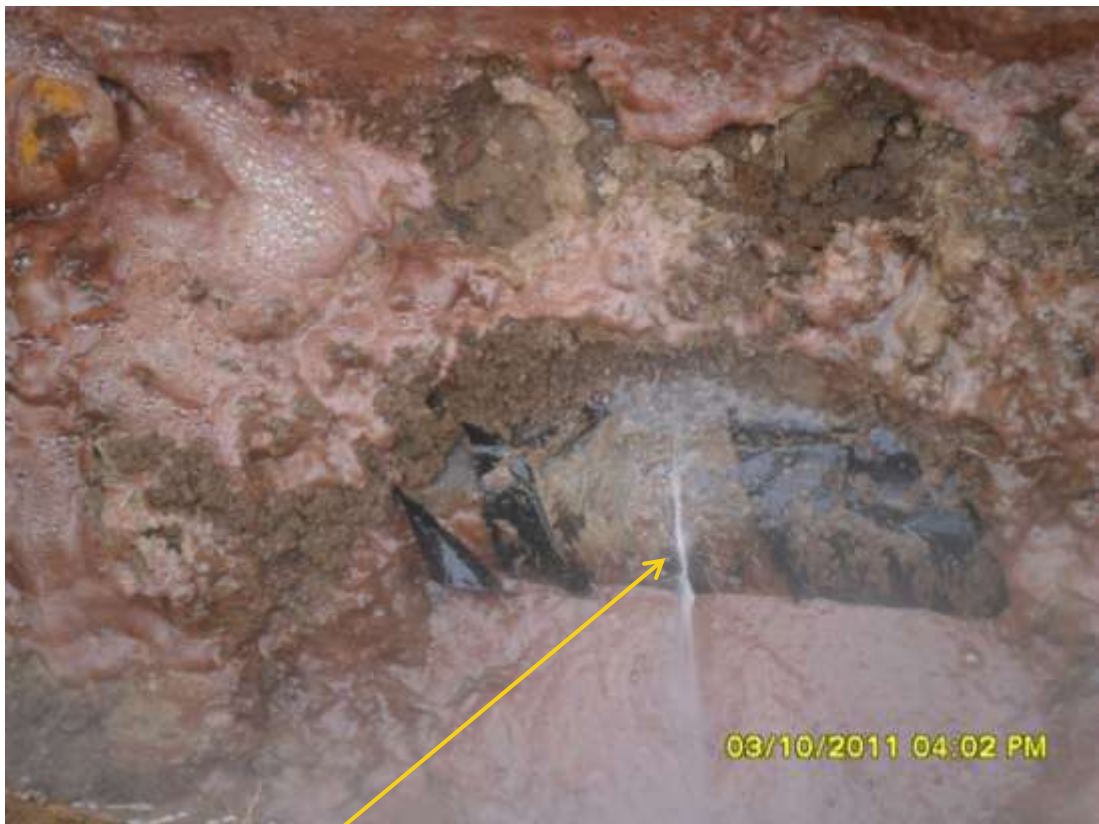
Close-up: Spill due hacksaw cut on 6" Obigbo North pipeline at Ogale. Picture taken during Joint Investigation of 3rd October, 2011.
