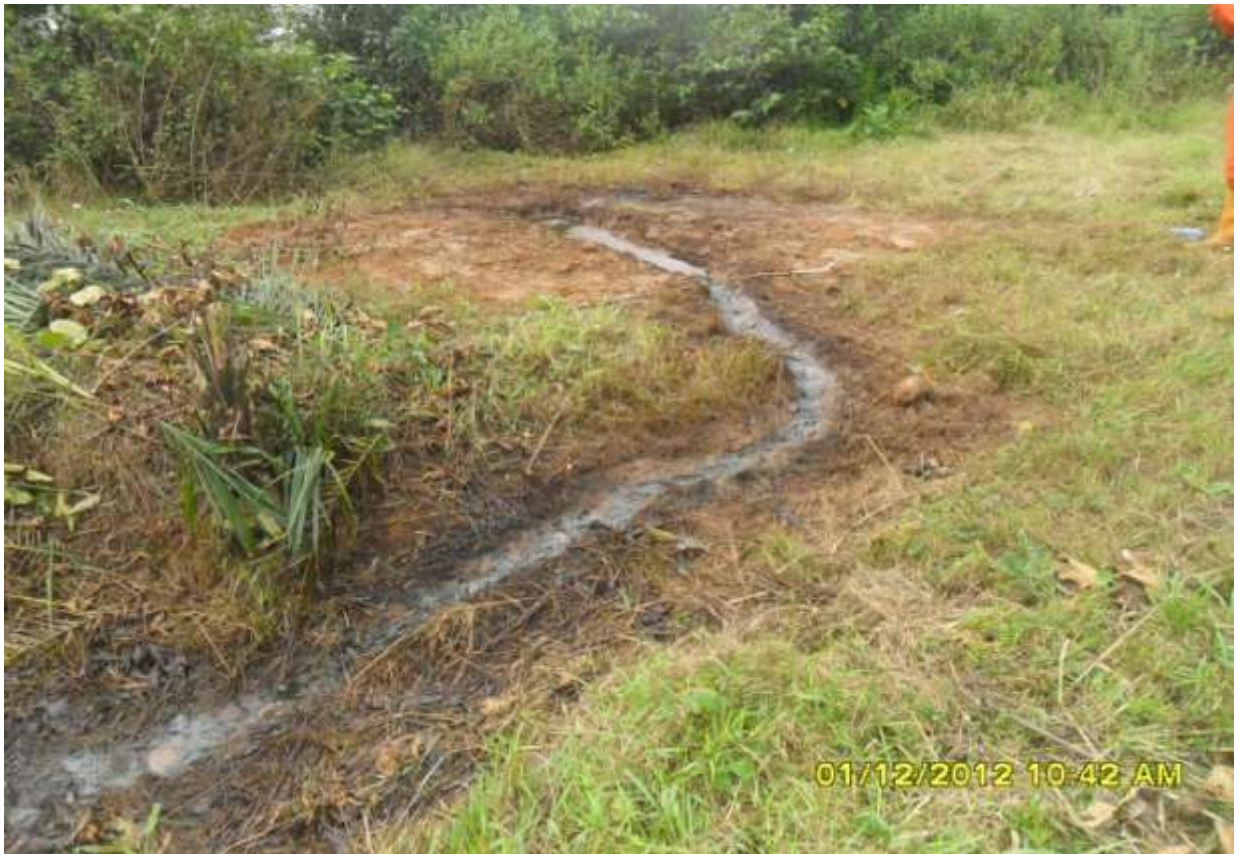
Overview: Part of spill impact on 24 inch Nkpoku – Bomu Pipeline at Egbalor.  
Picture was taken during Joint Investigation of 1<sup>st</sup> Dec. 2012.

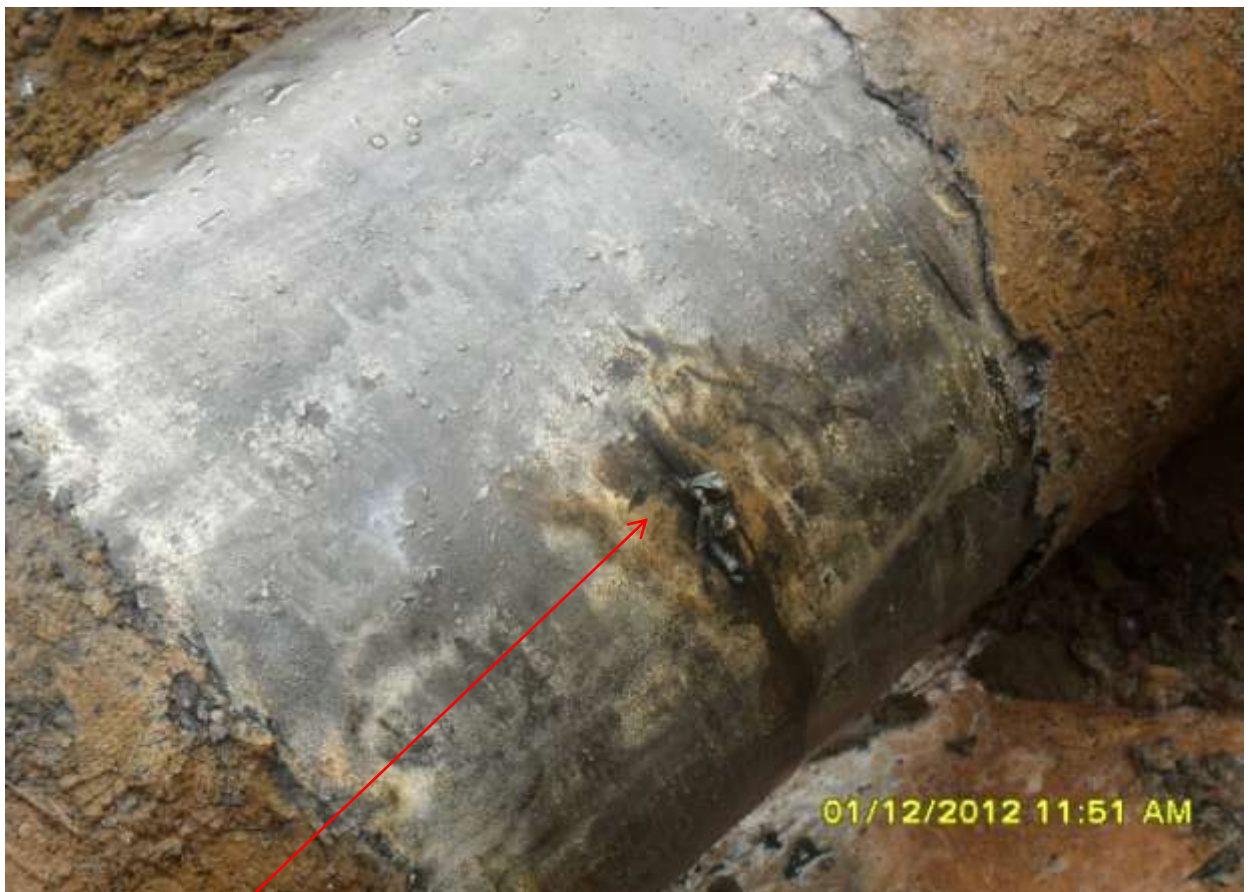
Close-up: Hacksaw cut on 24 inch Nkpoku – Bomu Pipeline at Egbalor.  
Picture was taken during Joint Investigation of 1<sup>st</sup> Dec. 2012.
