FAILURE ANALYSIS FOR PREDICTIVE & PREVENTIVE MAINTENANCE OF MACHINE ELEMENTS

A. ROLLER BEARINGS

B. CENTRIFUGAL PUMP

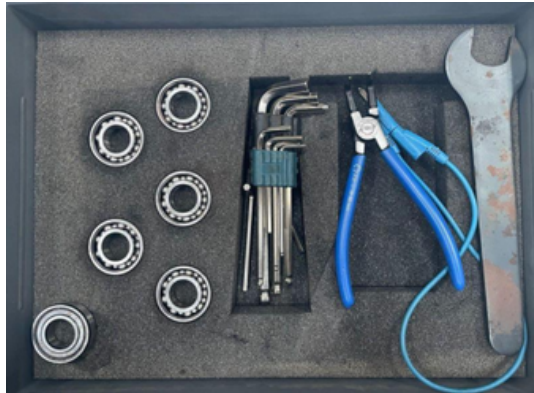
- Healthy bearing showed low amplitude (baseline) and high-frequency vibration. with a consistent drop in amplitude from **2.5 at 0Hz** to **0.5 at 400 Hz** was observed
- Damage frequencies repeated for harmonics and increased in magnitude compared to healthy bearing with large sidebands due to alternating load zones indicating an inner race damage.
- For outer race damage number of harmonics increased with severity from **4 to 6 Hz** to **10 to 400 Hz**
- Roller element damage showed irregularities due to roller body not always passing the damage point. But frequency and harmonics with side bands were observed
- Highlighted limitations of FFT, particularly in non-periodic signals.

- Used **PT 500.12 Rolling Element Bearing Faults Kit** and collected vibration data using **As-020 sensor** with a sensitivity of **100mV/g** and LabVIEW.
- Data was pre processed to remove outliers and voltage data was converted to acceleration data
- Applied **Fast Fourier Transform (FFT)** for frequency-domain analysis and finally visualized results using Matplotlib and Plotly.

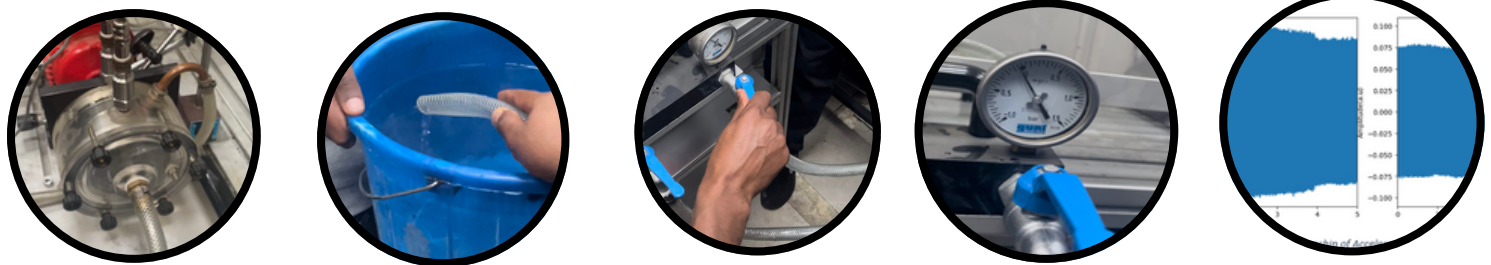
- Used **PT 500.12 cavitation in pumps kit**, **Brüel & Kjær Vibro equipment**, and NI USB 4431 for data collection
- Mounted a **centrifugal pump** with vibrational sensors and collected data through LabView.
- Connected pump inlet and outlet tubes to a water bucket with both intake and outlet tubes fully submerged, using tap water as a working fluid.
- Gradually reduced intake valve openings to induce cavitation and monitored inlet and outlet valve pressures.
- Recorded amplitude and time relationships with sensors during pump operation and applied FFT analysis to understand frequency content.

- The results reveal significant differences in amplitude-time relationships during normal pump operation (**1-2 m/s²**) compared to cavitation conditions (**4-6 m/s²**), indicating potential issues.
- The FFT analysis demonstrated a lower amplitude in the frequency domain during cavitation. Mean amplitude values for sensors under cavitation further highlighted variations: Sensor 1 showed **2 m/s²** in normal operation and **4.5 m/s²** during cavitation, Sensor 2 had **1.8 m/s²** (normal) and **3.8 m/s²** (cavitation), while Sensor 3 exhibited **2.2 m/s²** (normal) and **4.2 m/s²** (cavitation).
- These quantifiable metrics provide insights into the impact of cavitation on pump vibrational signals, aiding in risk mitigation and damage prevention.
