São Cucufate Roman villa

Foreword

This article is offered as an introductory overview of São Cucufate to support the Augmented Reality in Cultural Heritage project research by Ms Anabela Gonçalves Rodrigues Marto. It is not intended to provide an authoritative, comprehensive discussion of the site as a whole, but rather, to focus on a select range of the surviving architectural remains and related material: in all instances readers are directed to the list of publications that are provided, each of which has been authored by scholars who have either worked directly with the material or presented their own interpretations based on the excavated remains. Any mistakes or errors are my own and do not represent the views of the authors listed after this discussion: many of the specific details concerning occupation phases (Roman and post-Roman) and references to specific archaeological material can be found in these works. Much of the commentary below is based on these sources in addition to first-hand knowledge from site visits in 2017 and 2018, together with doctoral research I completed at the University of Nottingham (2004-2007).

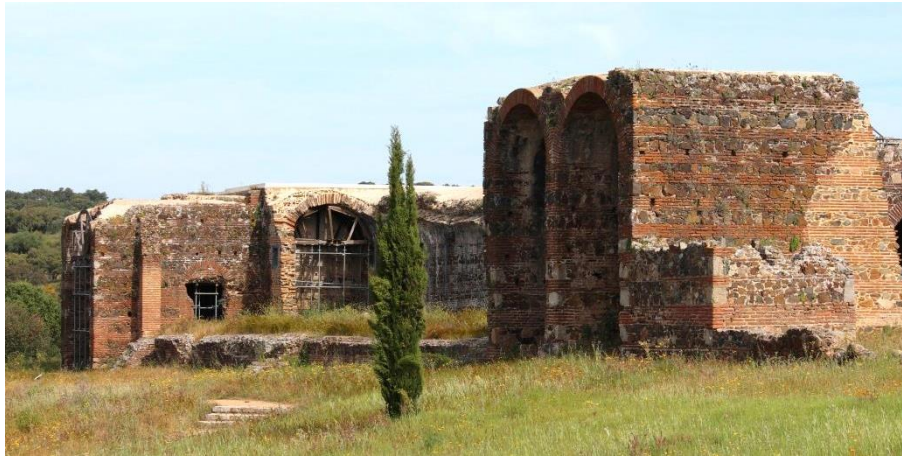
Figure 2. Standing remains from the west wing of the *pars urbana* at São Cucufate. Photo by A.Souter.

The name of the villa arose through the association with São Cucufate, who came to be venerated here in the Middle Ages. Today, the site is well-known for its distinct standing remains which, in some sections, make it possible to explore a series of internal rooms and corridors on the ground floor, complete with ceilings and supporting arches, all of which demonstrate well Roman masonry construction techniques (figure 2). Being able to experience a Roman villa this way is relatively unusual and can be explained, to an extent, by the later installation of a Christian chapel which ultimately saw parts of the western wing preserved, while others fell in to ruin.

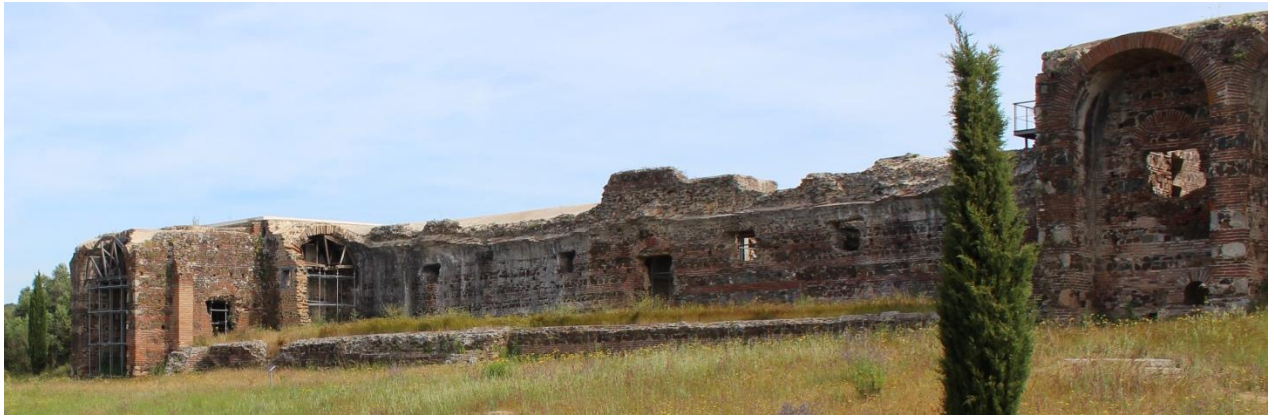
Figure 3. Standing remains from the west wing. Photo by A.Souter.

Figure 3 provides a general view of the south-side of the west wing, dating to the 4th century AD, by which time the villa is sometimes referred to as “palatial” given the extent of the remains. In the centre we see a long raised platform with three separate flights of steps (although that on the right is hidden behind the tree). Behind this is a long wall punctuated by square openings and a central doorway which led to a series of internal storage rooms. The wall belongs to an internal corridor, as demonstrated at the far left end in the form of brick arch: this would have run the full length of the wall, supporting a long barrel-vaulted ceiling, traces of which are preserved within the surviving masonry.

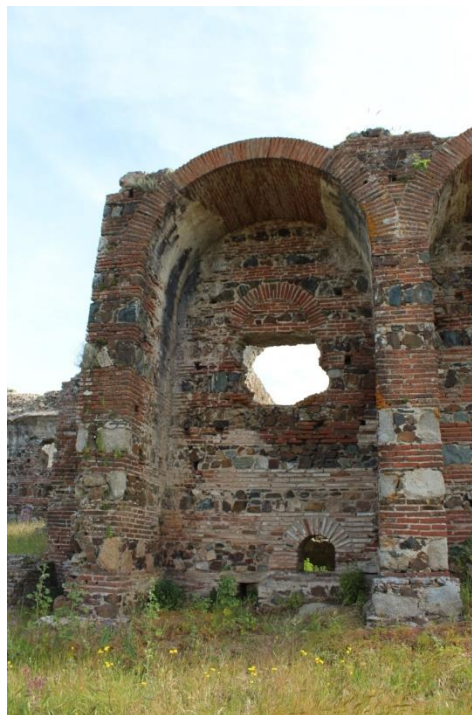
Figure 4. Detail of one of the tall vaulted niches on the south façade of the villa. Photo by A.Souter.

At either end of the raised terrace are two large arched niches. Both these and the walls are made from well-constructed masonry, with distinct alternating bands of flat bricks (*tegulae*) and stone-faced concrete (figure 4). The thickness and strength of these was most likely to support another level up above, but unfortunately this hasn't survived. The same technique was used for the nearby mausoleum, thereby placing the construction of these in the same era,

in the 4th century AD. As with other parts of the building, traces of white stucco survive at the top, within the curve of the arch. This was most likely added to protect the masonry and prevent dampness penetrating the walls; given that other parts of the exterior also feature the same rendering, this would have meant that, from the outside, the building would have had a white-washed appearance, screening the distinct stone-work that is otherwise exposed today. Whether or not the surviving plaster was added in the Medieval or Roman era isn't clear, but, as a technique, the application of stucco to the exterior of buildings was a relatively common Roman practice.

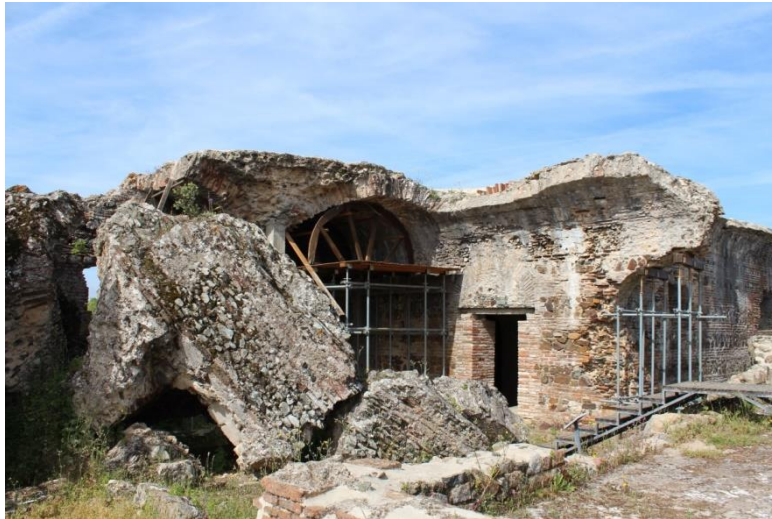
Figure 7. View of the central part of the villa, forming part of the west wing. Located to the right is a large cistern. Photo by A.Souter.

Figure 7 provides a view of part of the interior of the central wing of the 4th century villa, complete with a huge section of collapsed roof on the left, and a doorway (centre right) which leads to a series of storage rooms and later chapel. Modern scaffolding has been installed within some of the vaulted sections, together with semi-circular wooden supports. These demonstrate well the Roman vault construction technique, which involved the installation of a wooden framework on which the series of *tegulae* were placed and set in concrete. Just to the right of this area are remains from the dining room (*triclinium*), immediately adjacent to a large cistern on the north-eastern side of the west wing.

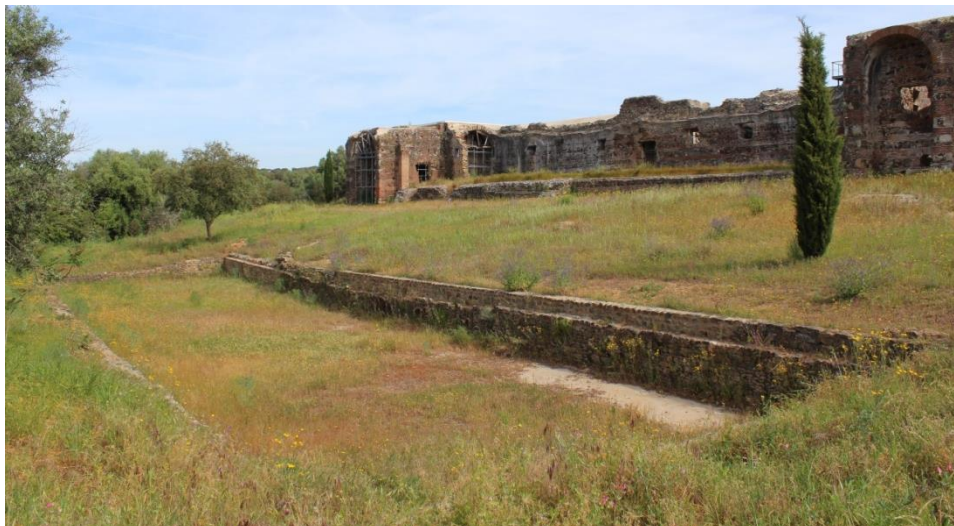
Figure 8. View of the long rectangular pool. Photo by A.Souter.

Crucial to the daily life of the villa was access to water. Walking around the site, visitors inevitably encounter two large basins, variously referred to as pools or cisterns. One of these is located down slope in front of the western wing; measuring approximately 40m by 10m length,

with an access ramp in the south-east corner (see figure 8, although note that the ramp is obscured from view). It is known that this basin was linked to another located uphill to the north via a series of stone-lined channels, examples of which can still be seen today (figure 9). This was clearly a significant feature capable of holding a large volume of water, but its exact purpose isn't clear. The installation of the ramp would indicate the need for access, but for what purpose; to enable cleaning of the interior? Or was this feature used as an open-air *natatio* (swimming pool) in the manner of a Roman bath-house? Given the general agricultural nature of the site, it was more perhaps more likely to have served a practical purpose, possibly for irrigating crops nearby.

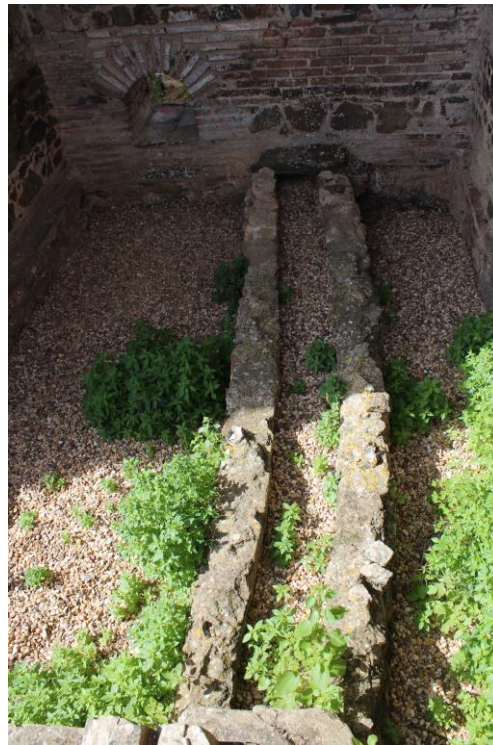
Figure 9. Detail of one of the water channels that supplied water from the north cistern.

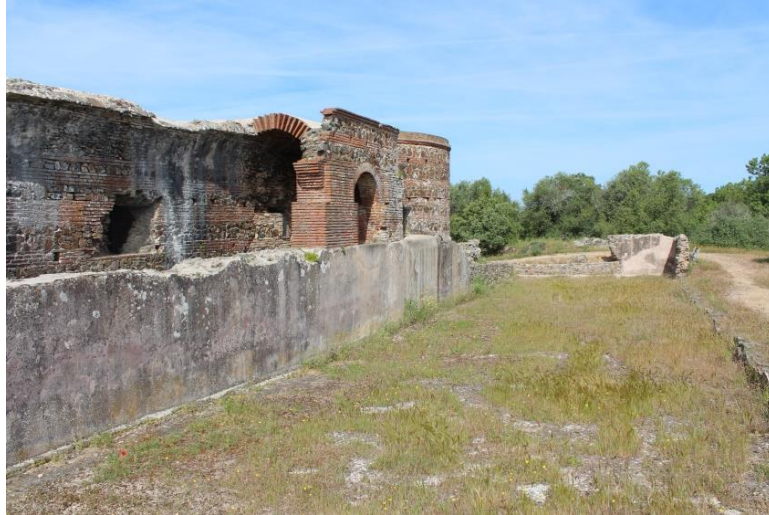
Located on the north side of the western wing is another rectangular cistern, of a similar size to that located downhill to the south; in this case however, the walls survive to a greater height and measure at least 2m, with a water-proof lining known as *opus signinum* (figures 10 and 11). Investigations indicate a small inlet channel at the north-east corner which may have formed part of a small-scale aqueduct, which itself was perhaps supplied by a local spring a short distance from the villa; where this might have been is not yet clear. Furthermore, was the tank covered over, or left open to the elements, benefiting from any rainfall? Combined with the other similar tank to the south, these features demonstrate that the storage and management of water was of much significance for the owners, especially given the long, hot summers that prevail in central Portugal. We know that other Roman villas in the province took similar significant measures to control and manage water supply: one such example is that of Pisões villa near to Beja (Roman *Pax Iulia*) where the owners constructed a dam to supply the estate.

Figure 10. View of the large cistern on the north side of the villa. Photo by A.Souter.

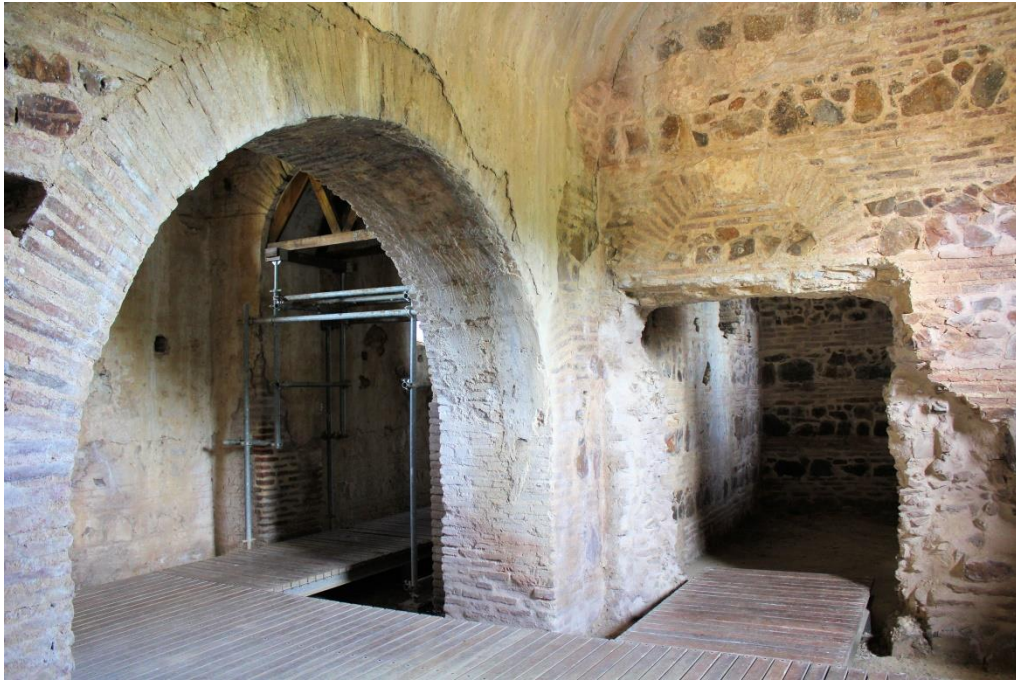
Figure 12. Internal view of the vaulted storage rooms, showing Roman masonry and arch construction techniques. Note also the presence of the plaster work. Photo by A.Souter.

Preserved within the centre of the villa are a series of internal rooms running the full length of the west wing, with strong, solid walls and brick-work arches (figures 12 and 13). Exploring this part of the site today, it is clear that the thick walls provide a relatively dark and cool interior, even when outside the temperatures exceed 25 degrees Celsius. Rather than providing living quarters (which may have been located on the upper floor), investigations here established that these rooms were most likely used for the storage of agricultural produce: the discovery of numerous ceramic jars (*dolia*) throughout the interior suggest that they were used for the storage of wine produced at the nearby press, with some of the other rooms serving as granaries. As with parts of the exterior, traces of plaster work can still be seen, most likely to prevent dampness penetrating the walls and causing structural damage, in addition to potentially ruining any agricultural produce (especially cereals).

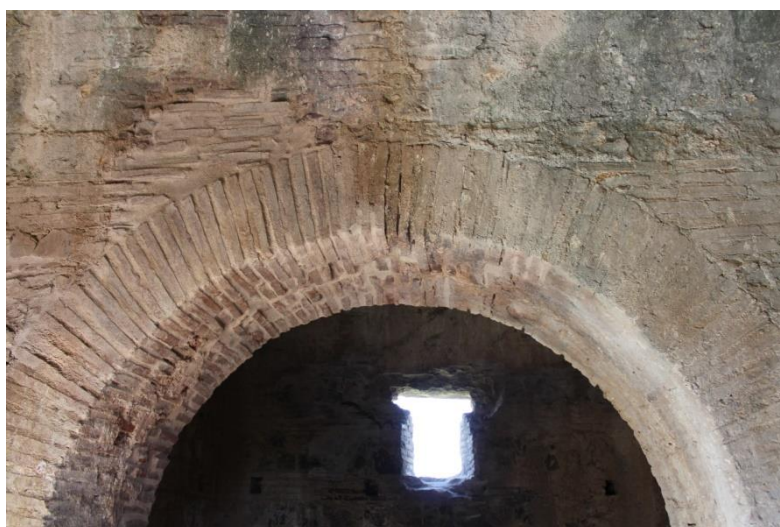
Figure 1. Detail of one of the internal brick-work arches. These demonstrate the use of flat bricks known as *tegulae*. The construction of this type of arch was achieved by using a semi-circular wooden frame supported on scaffolding, upon which series of *tegulae* were arranged and set in concrete. Photo by A.Souter.

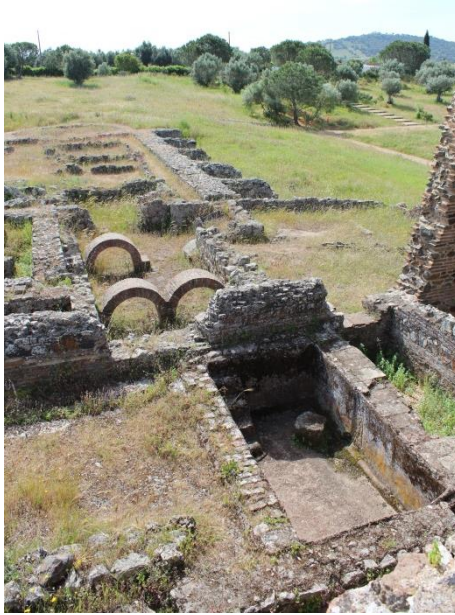
Figure 3. View looking in to the bath-house. Photo by A.Souter.

Complementing the remains from the western sector of the site, other features of interest include a bath-house (figure 16), constructed in the 4th century AD but for reasons unknown never finished, as reflected in the apparent lack of décor (neither mosaics or frescoes are known here). Within this complex, a small plunge pool can be seen in figure 17, complete with a series of steps to enable access: this would appear to have been a *frigidarium* with cool, unheated water. Elsewhere, a hot-room (*caldarium*) was also installed, complete with brick arches and fragments of tiles known as *pilae* to support a floor up above: hot-air from a nearby furnace would have circulated under the floor, via the nearby arch, which, as shown in figure 18, has been blocked in. The incomplete nature of the baths could possibly reflect sudden financial hardship, prioritisation of other more pressing matters, or possibly a change in site ownership. While this is subject to debate and speculation, the apparent cessation of the bath-house, a feature which would normally be expected at a prosperous, flourishing Roman villa, is surely significant for understanding the changing nature of the site in its later phase.

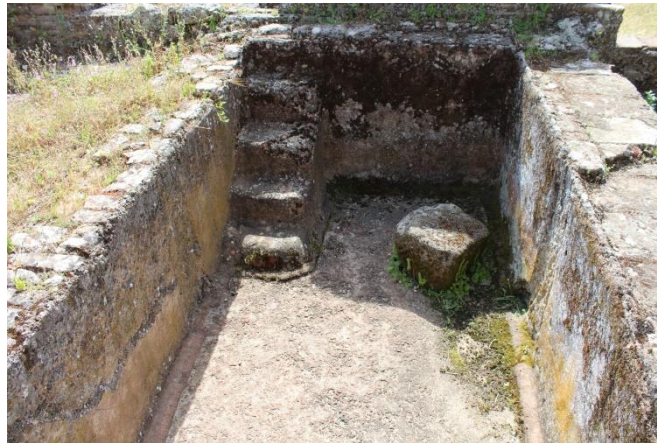
Figure 17. View of the small cold plunge pool with steps and waterproof lining (*opus signinum*). Photo by A.Souter.

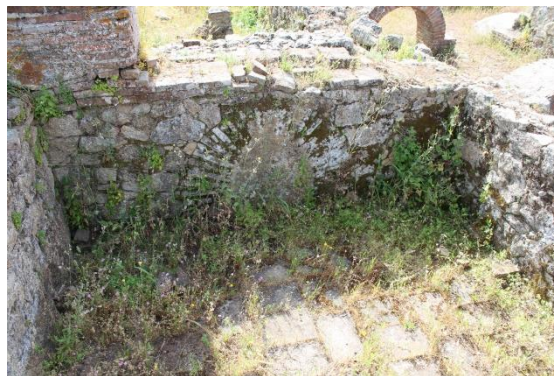
Figure 18. View of the blocked in archway from the hot room (*caldarium*). Photo by A.Souter.

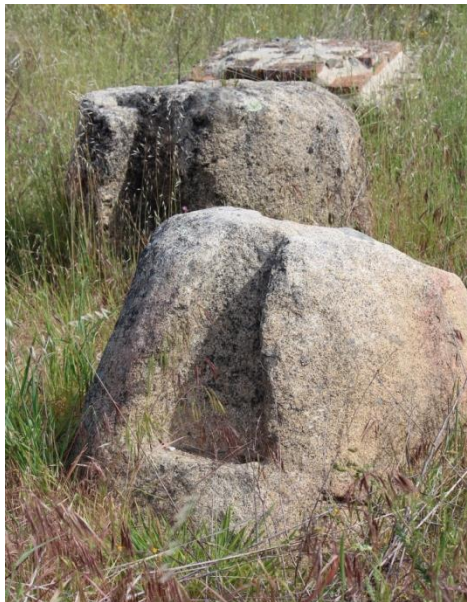
Figure 19. Two large cylindrical weights from the wine press facility. Photo by A.Souter.

Both the weights feature distinct dove-tail sockets on either side, with a small circular depression in the centre of the upper surface. These features were used to secure a framework (most likely of wood, with metal fittings), attached to a tall vertical wooden screw. This formed part of the press, which included adjacent treading areas and tanks full of grapes. J-P Brun has suggested a theoretical reconstruction of the press facility and associated storage room, as per figure 21. The juice was then collected and stored for fermentation, perhaps in wooden barrels or *dolia*, examples of which are known from the *pars rustica*, in addition to the series of rooms within the west wing. The presence of the two presses and associated material therefore indicates the significant role of viticulture for the agricultural life of the villa, with production most likely for marketing purposes, and also on-site consumption. This particular example also demonstrates well that, archaeologically, ancient wine presses typically only survive in the form of stone weights and basins for treading, with any of the wooden apparatus (such as the press beam), long-since perished. Reconstructions such as those by Brun can therefore help us understand how the facility at this villa might have been organised; this is particularly important given that, visiting the *pars rustica* today, apart from the stone weights there are few visual clues explaining how this part of the site once functioned.

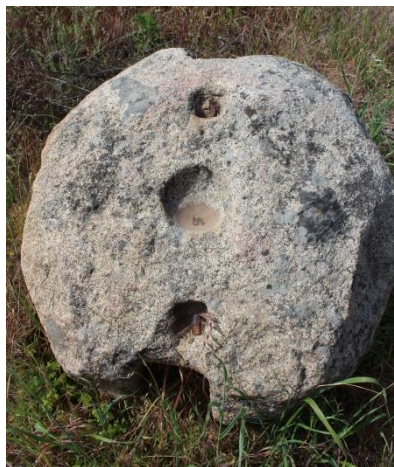
Figure 20. Top view of one of the counterweights. Photo by A.Souter.

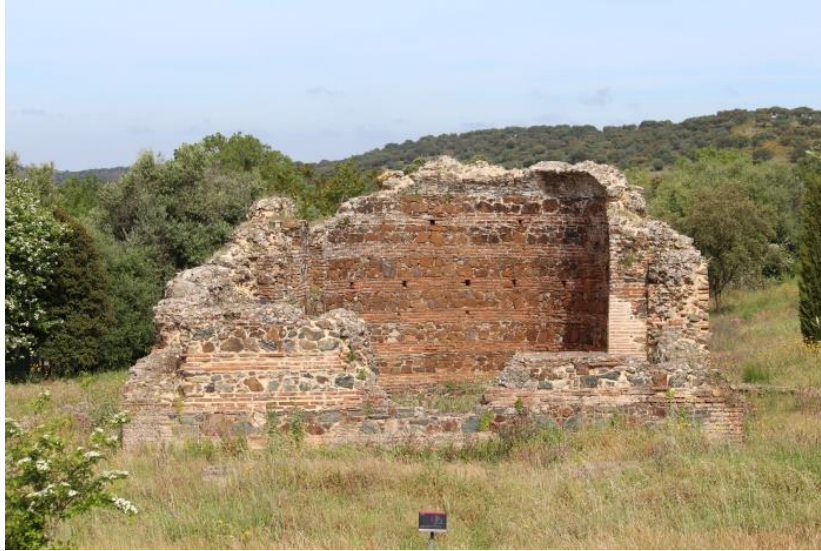
Figure 22 View of the temple/mausoleum, looking north-west. Image by A.Souter.

Finally, located just to the south of the villa some 30m away, is the inner shell of a relatively small structure variously referred to as either a temple or a mausoleum, dating to the 3rd and 4th centuries AD (figure 22). Although it doesn't survive in its entirety, it took the form of a rectangular building with the entrance on the south-east side, with the interior featuring a semi-circular apse and a half-domed ceiling (figure 23). The walls that we see today belong to the inner structure and demonstrate the use of well-constructed Roman masonry, with alternating levels of *tegulae* and stone-faced concrete; in other words, the same technique that was used for the western wing of the villa. Mirroring the general shape of the interior are foundation remains (figure 24) which formed part of an external colonnade, thereby lending an air of elegance and sophistication. Fragments of columnar architecture displayed elsewhere on site indicate that the colonnade may have featured Corinthian style capitals. The discovery

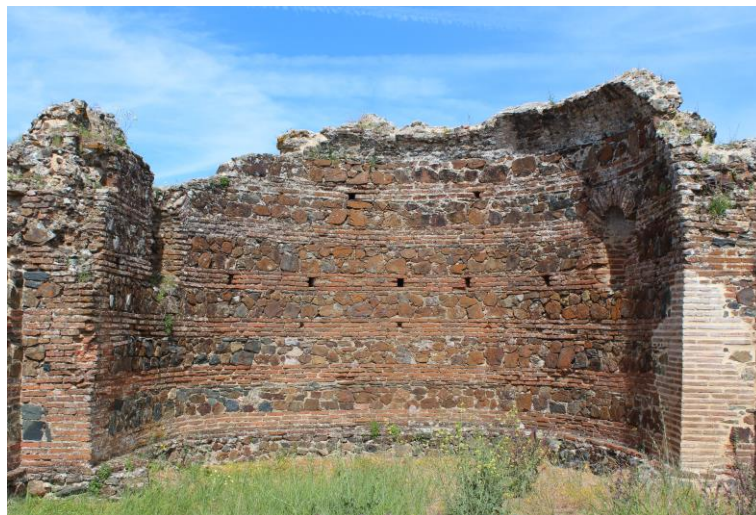
Figure 234. Detail of the masonry from the mausoleum. Photo by A.Souter

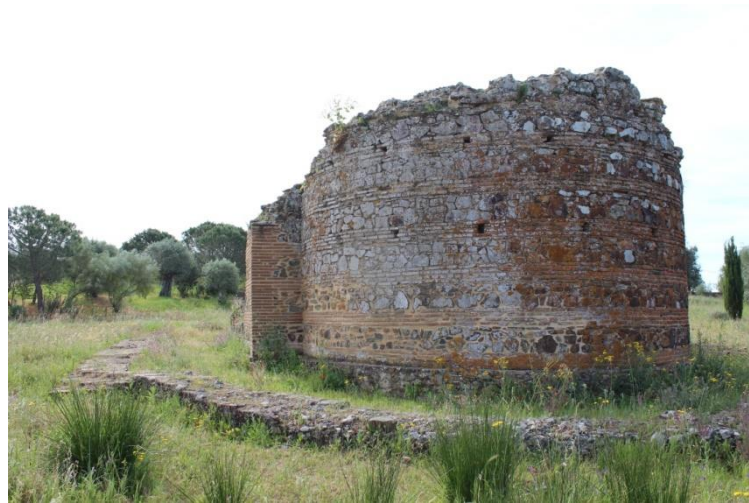
Figure 24. Rear view of the temple/mausoleum, complete with foundation remains from the external wall and colonnade. Photo by A.Souter.
