Property Description Data

Environmental Issues: Historic lumber yard, historic railroad, historic auto body shop

Site Name: Commercial Property

Site Address: 201–207 N 57th Ave N (historic); 5703, 5713–5719 Roosevelt St (current)

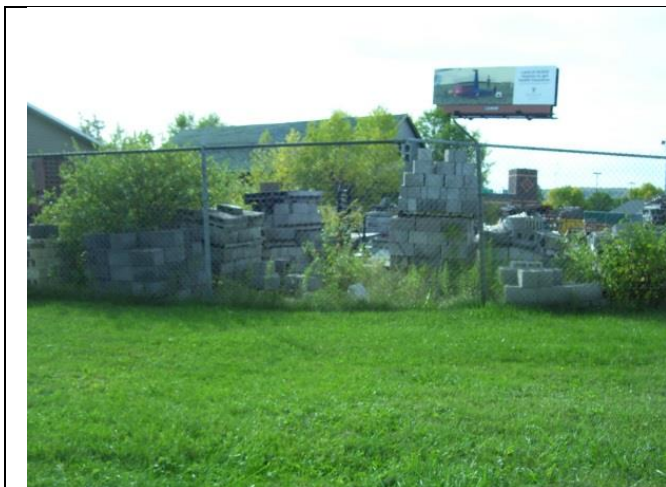
Looking west-southwest across the property

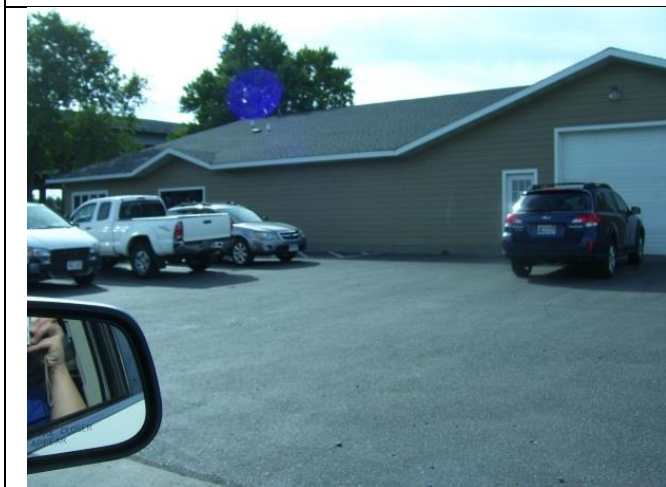
Looking west across the property

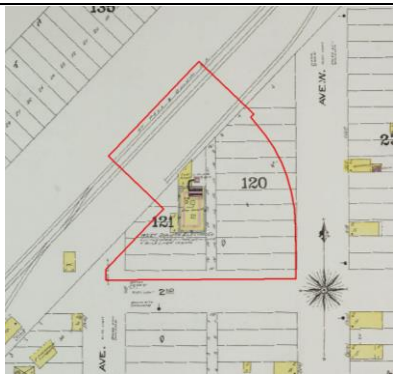
Year	Use	Source (↑ North)
1892-1902	The eastern portion of the property is developed with a rectangular-shaped building occupied by the West Duluth Electric Company, and the northwest portion of the property is developed with northeast-southwest trending railroad tracks.	Fire insurance map, historic plat map

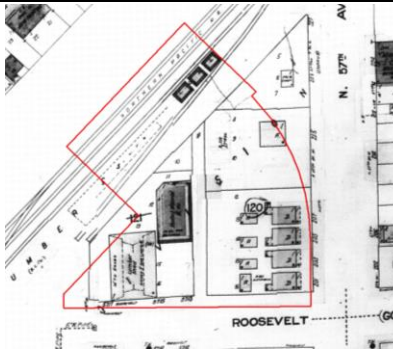
1949 fire insurance map

1892 fire insurance map
1930-1935	No listings were identified for the property	City directories
1939-1949	The southwest portion of the property is developed with a lumber shed and roofing material warehouse. The southeast portion of the property is developed with multiple residences and associated garages. Three unlabeled, square-shaped structures are present in the northern portion of the property within the railroad, and a garage is present in the northeastern portion of the property. No listings were identified for the property addresses. The property address was not identified on city directory listings.	Aerial photographs, city directories, fire insurance maps

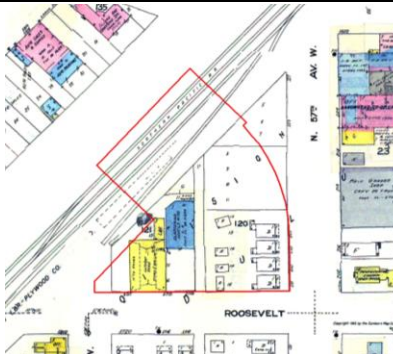
1953-1963	Site land use remains the same, although the garage previously noted in the northeast portion of the site and the three unlabeled structures in the railroad are no longer present. The property address was not identified on city directory listings.	Aerial photographs, city directories, fire insurance map

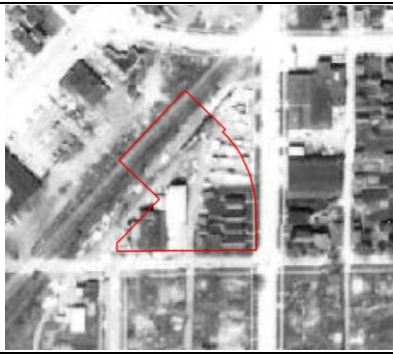
1966 aerial photograph

1963 fire insurance map
1966-1981	Land use of the property appears relatively unchanged, although additional residences are present in the northeast portion of the property. The 1971 to 1981 city directories indicate that the property is occupied by the Duluth Lumber & Plywood Company, and the 1981 city directory indicates that the property is occupied by Duluth Window & Millwork.	Aerial photographs, city directories

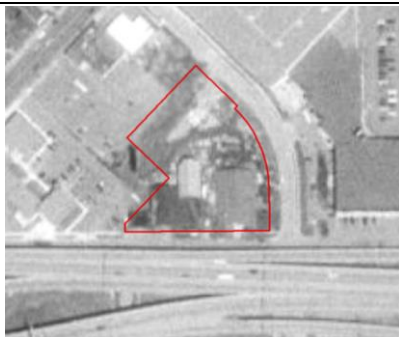
<p>1992 aerial photograph</p>
2005-present	The northern portion of the property appears to be used as an outdoor storage area. City directories indicate that the property is occupied by Quality Collision/Quality Towing and Stretar Masonry.	Aerial photographs, city directories

Year	Use	Source (↑ North)	
1986-1991	City directories indicate that the property is occupied by Stretar Masonry and Skanlon's Marketing & Manufacturing. Don's Auto Body is also listed on the 1991 directory.	City directories	
1992-2001	The railroad previously observed in the northwest portion of the property is no longer present; disturbed soil is present throughout the area. A square-shaped building corresponding to the current building is present in the southeast portion of the property. City directories do not indicate a change in occupancy.	Aerial photographs, city directories
