Property Description Data

Environmental Issues: Current and historic scale house, historic railroads, active VIC investigation VP26150

Site Name: Scale House

Site Address: 420-430 S 61st Ave W (historic); no current address

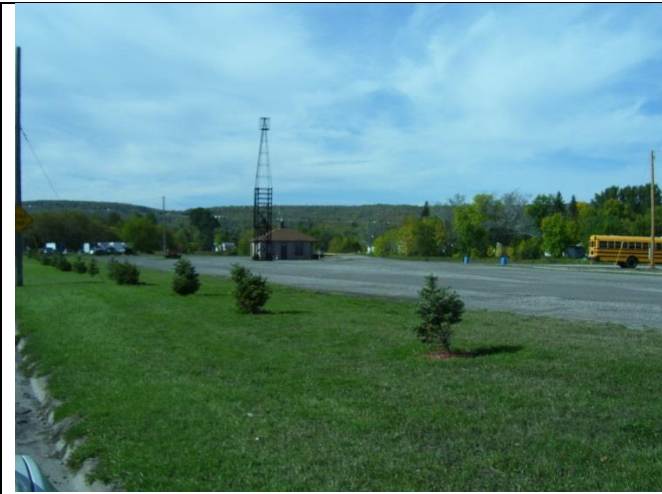
Looking northwest across the property from Waseca Street

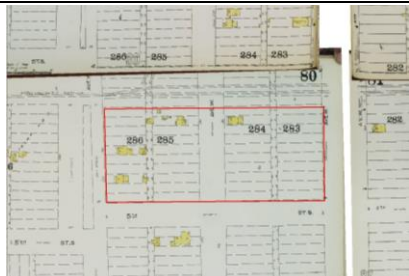
Year	Use	Source (↑ North)
1892-1902	Five dwellings and associated garages are depicted at the property.	<div>Fire insurance map, historic plat map</div>

<div>1892 fire insurance map</div>
1924	The northeast portion of the property is occupied by a railroad and square-shaped structure, and the southwest portion of the property is occupied by a square-shaped structure. Remaining portions of the property are not depicted with structures.	<div>Historic plat map</div>

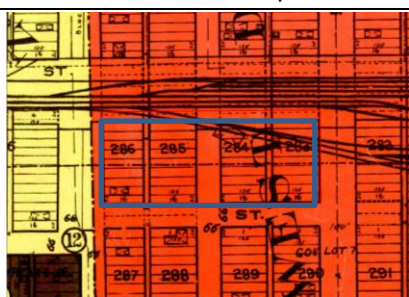
<div>1924 historic plat map</div>

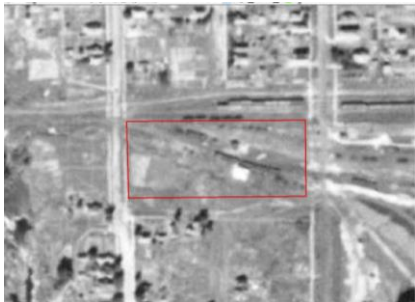
Year	Use	Source (↑ North)	
1939	The northeast portion of the property is developed with multiple railroads; several railcars are present at the property. Structures are not apparent at the property.	Aerial photograph

<p>1939 aerial photograph</p>
1948-1963	Land use at the property remains unchanged, although a square-shaped structure is visible in the west-central portion of the property, and a railroad is present in the southwest portion of the property.	Aerial photographs, fire insurance map

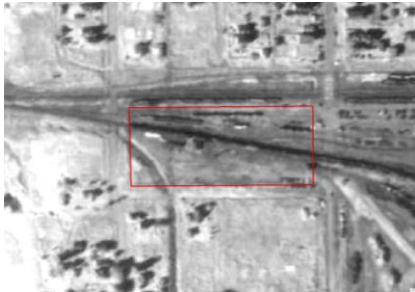
<p>1948 aerial photograph</p>
1966-1972	Land use at the property remains unchanged. Disturbed soil is present in the southern portion of the property.	Aerial photographs

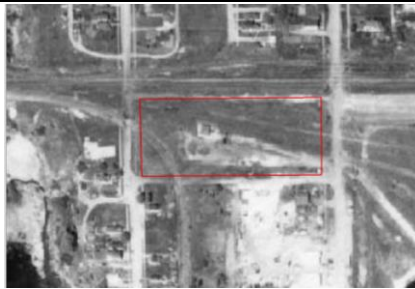
<p>1966 aerial photograph</p>
1980	Land use at the property appears relatively unchanged, although disturbed soil is apparent in the northeast portion of the property.	Aerial photograph

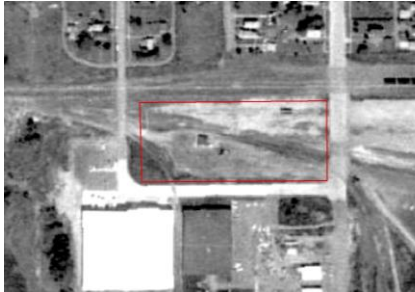
<p>1980 aerial photograph</p>
1992-1997	An oblong-shaped driveway corresponding to the current driveway is present in the southern portion of the property.	Aerial photographs

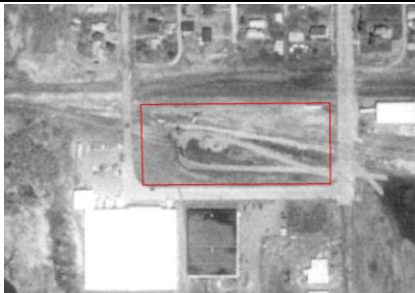
<p>1992 aerial photograph</p>

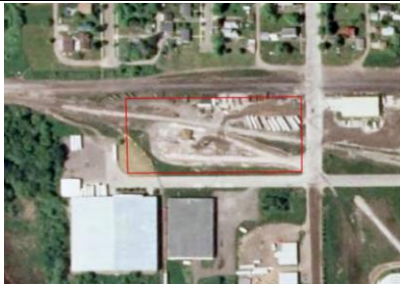
Year	Use	Source (↑ North)	
2005-present	The property appears developed with existing features. Outdoor storage is apparent in the north half of the property on the 2005 aerial photograph.	Aerial photographs

2005 aerial photograph
