Property Description Data

Site Name: Multi-Use Property

Site Address: 6110–6130 Grand Ave (historic), 6110 Grand Ave (current)

Current Use: Duke's Auto, Limited Energy Twin Ports Training Center

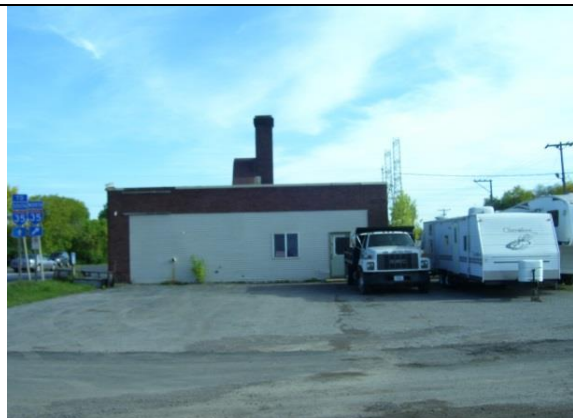
Looking south across the property

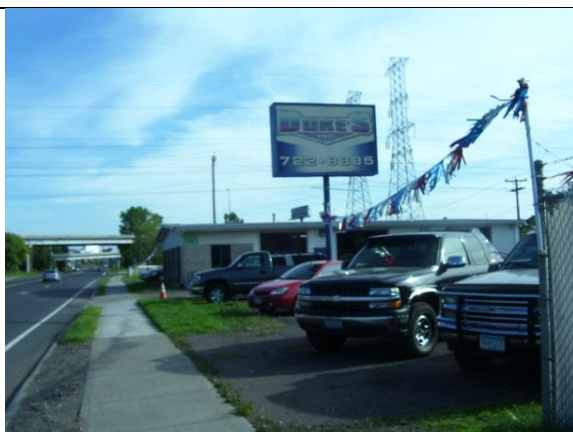
Looking northeast across the property

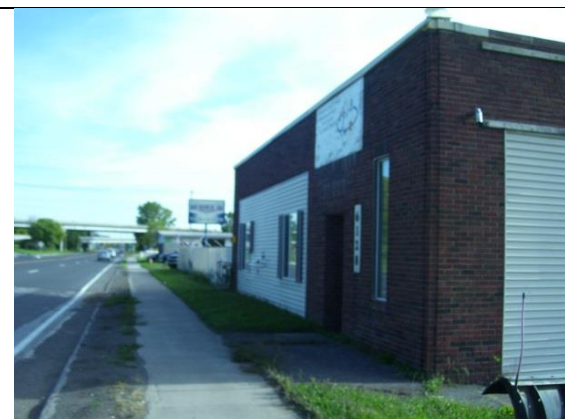
Looking northeast along west boundary of property

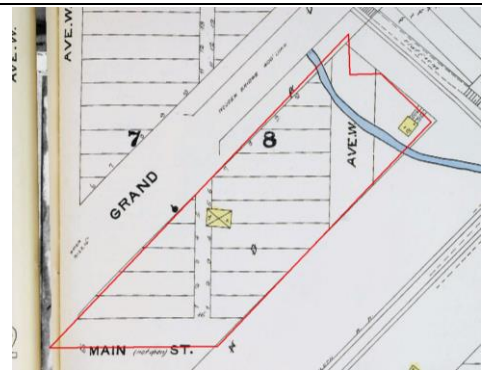
1892 fire insurance map

Year	Use	Source (↑ North)	
1892-1908	Two structures are depicted at the property. Keene Creek is present in the northernmost portion of the property. No structures are depicted at the property on the 1908 fire insurance map.	Fire insurance map

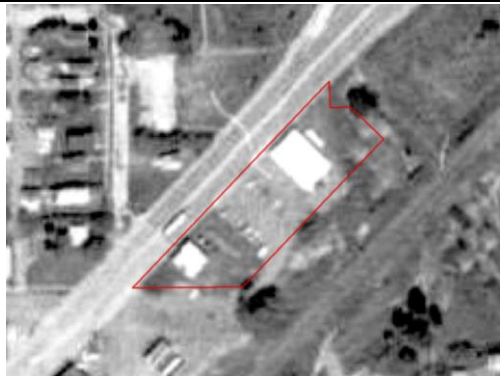
<p>1980 aerial photograph</p>
1991-2001	Significant changes are not visible on aerial photographs. City directories indicate that the property is occupied by Auto Glass Specialists and Trucks of Duluth Storage.	Aerial photographs, city directories

Year	Use	Source (↑ North)	
1980-1986	The southern portion of the property appears developed with a square-shaped building corresponding to a current building. City directories indicate that the property is occupied by Thompson's Auto Service West, Auto Glass Specialists, and the Minnesota Power and Light substation.	Aerial photographs, city directories

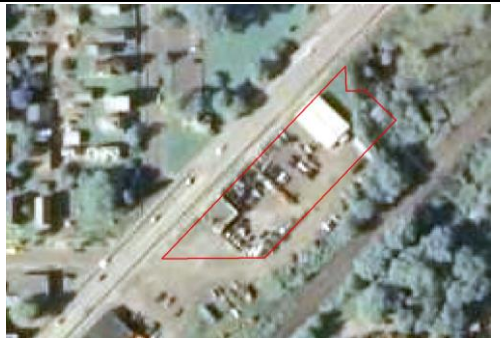
<p>2010 aerial photograph</p>

<p>1997 aerial photograph</p>
2005-2010	The property appears developed with existing features on aerial photographs. City directories indicate that the property is occupied by Auto Glass Specialists, Dukes Towing & Auto Sales, and Riverview Auto Sales.	Aerial photographs City directories
