# Property Description Data

217

**Site Name:** Moline Bakery Machinery

**Site Address:** 200–206 S Central Ave

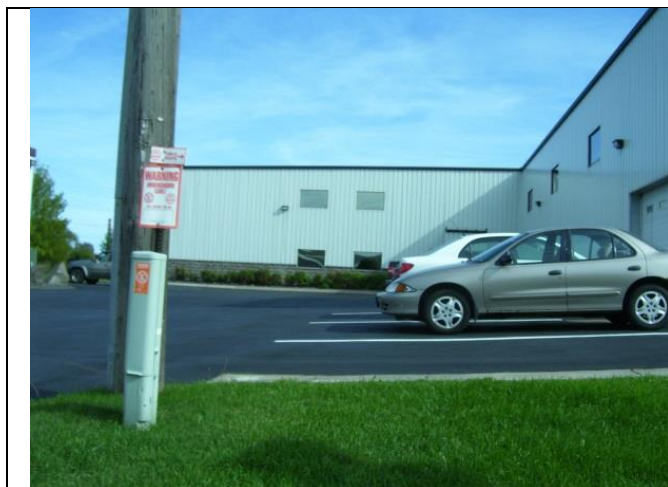
Looking east across the property

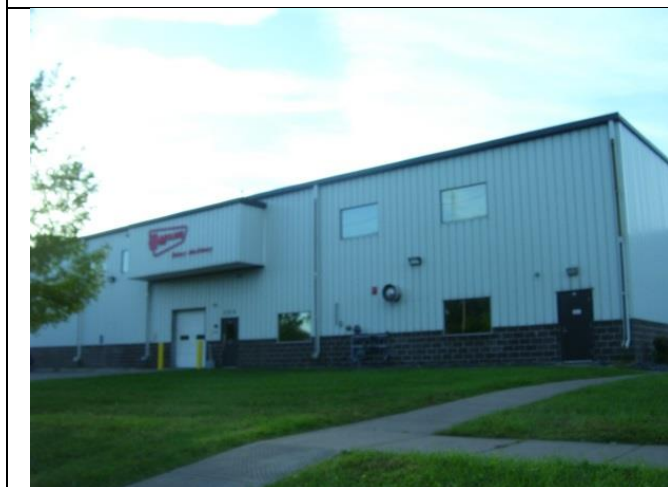
Looking south across the property

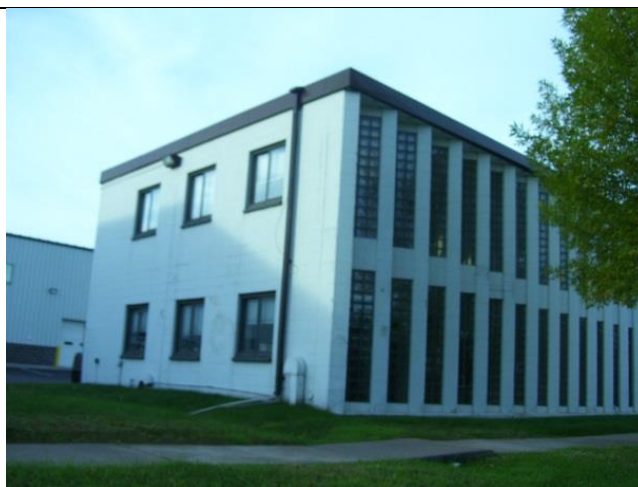
Looking southwest across the property

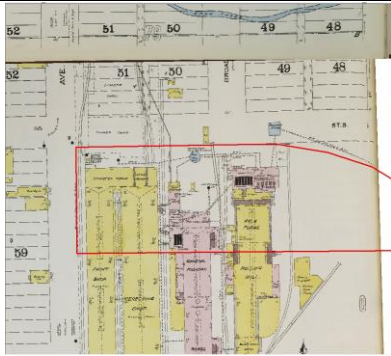
Year	Use	Source (↑ North)	
1892-1902	Partial coverage of the property was provided. The property is part of the Duluth Manufacturing Company. Identified building uses include a transfer table, paint shop, erecting shop, general foundry, axle forge and rolling mill, and pattern shop.	Fire insurance map, historic plat map

<p>1892 fire insurance map</p>
1908-1924	Partial coverage of the property was provided. The property is part of the American Carbolite Company. Notable building uses include the following: warehouse, coal and lime storage, a gas producer room, a transformer and furnace room, a pump house, stock rooms, a chemical laboratory, and a crusher room.	Fire insurance map, historic plat map

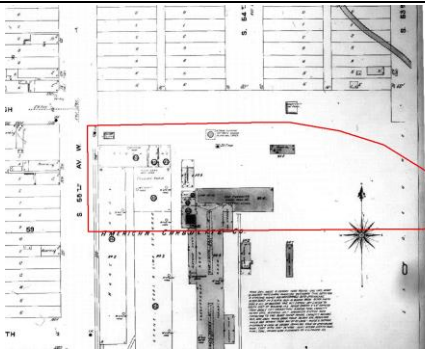
<p>1908 fire insurance map</p>
1930-1939	Land use at the property appears relatively unchanged. No city directory listings were identified for the property.	Aerial photographs, city directories

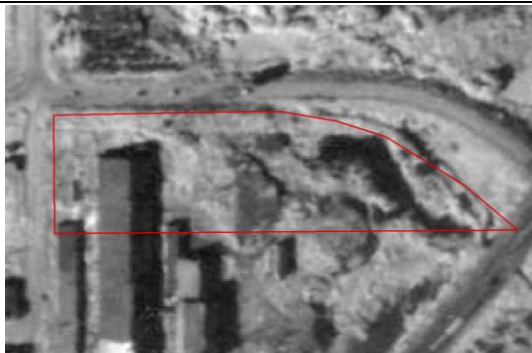
<p>1948 aerial photograph</p>

1948-1953	The property is occupied by the Superior Insulation Manufacturing Company. Notable building uses were not identified. Soil disturbance is visible throughout the eastern portion of the property.	Aerial photographs, fire insurance map

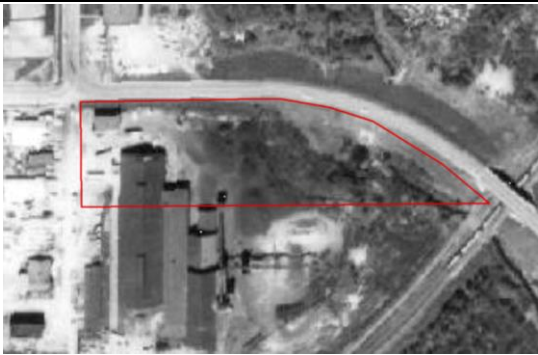
Year	Use	Source (↑ North)	
1956-1966	The property is part of the Zenith Concrete Products Company. Notable building uses include an office, block storage, and a curing area.	Aerial photographs, city directories, fire insurance map

<p>1966 aerial photograph</p>
1972-1986	Structures associated with the former Zenith Concrete Products Company appear to have been removed from the property. However, city directories indicate the property is occupied by the Arrowhead Blacktop Company and Zenith Dredge.	Aerial photographs, city directories

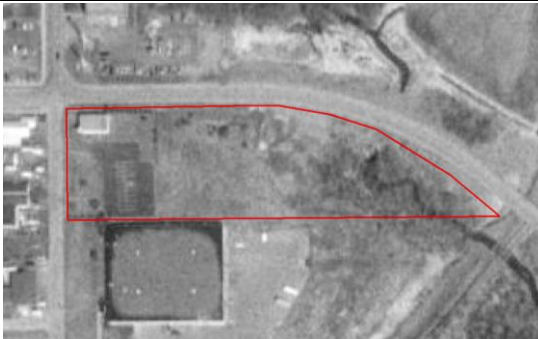
<p>1992 aerial photograph</p>
1996-1997	The property appears developed with a square-shaped structure occupied by Moline Company in the central portion of the property.	Aerial photograph, city directory

<p>1972 aerial photograph</p>
1991-1992	Land use at the property appears relatively unchanged. City directories indicate that the property is occupied by Zenith Dredge.	Aerial photographs, city directories

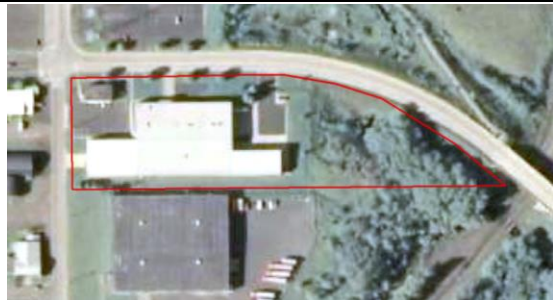
<p>2010 aerial photograph</p>

Year	Use	Source (↑ North)	
2001-present	The property appears developed with the current building. No city directory listings were identified for the property address.	Aerial photographs, city directories

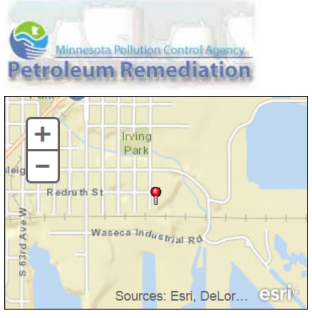
One release was identified in connection with the property address (200 S Central Ave): Leak No. 8083 (reported in December 1994 and closed in October 1995). However, it should be noted that Leak No. 8083 is plotted at 310 S Central Ave (Map ID #221) on the MPCA What's In My Neighborhood (WIMN) website. The requested files for Leak No. 8083 were not received at the time of this assessment to verify its location. A screenshot of the WIMN website is provided below.

Site Name	Zenith Dredge Co
Leak ID Number	8083
Leak Address	200 S Central Ave
City Name	Duluth
Station Type	55807
County	St. Louis
Release Discovered	12-07-1994
Release Report	12-07-1994
Conditional Closure Date	
Complete Site Closure Date	10-18-1995
Contaminated Soils Remaining	U
Offsite Contamination	U
Product Released	Diesel
Project Manager:	<a href="#">Leppala, Steve</a>

Please note, although Leak 8083 has been closed by the MPCA, this investigation was specific to one area at the property. Additional potential environmental conditions exist at the property based on the historic land use and lack of assessment in other areas of the property.
