Property Description Data

Environmental Issues: Demo-licious Transfer Station, historic railroad, historic blacksmith, historic machine shop, truck repair, American Carbolite, manufacturing, closed LUST site

Site Name: Demo-licious Transfer Station

Site Address: 305–331 S Central Ave, 306–320 S Central Ave, 320–352 S 56th Ave, 5501–5519 Sherburne St (historic); 310 S Central Ave (current)

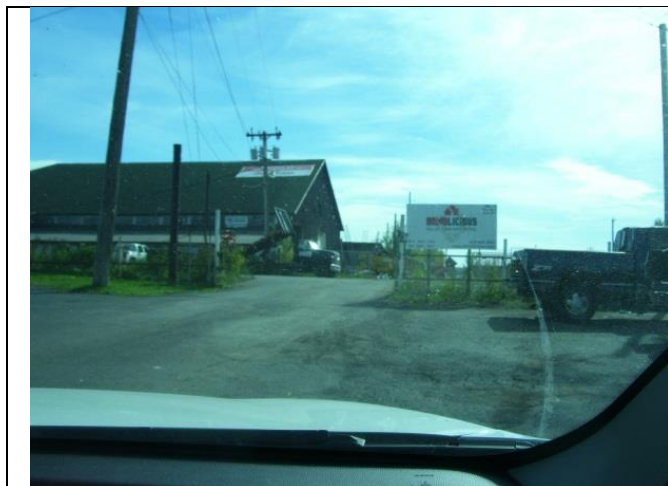
Looking south across the property

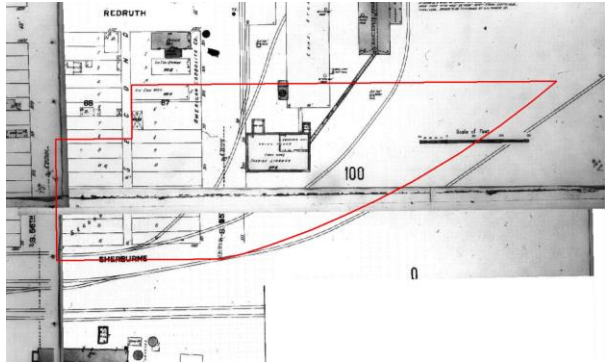
Year	Use	Source (↑ North)
1908-1924	The property is part of the American Carbolite Company. The previously identified warehouse is labeled as a tin can manufacturing area. Other notable building uses not already identified include a coke, coal, and lime storage area, in the north-central portion of the property, and a carbide storage area in the central portion of the property.	<p>Fire insurance map, historic plat map</p>

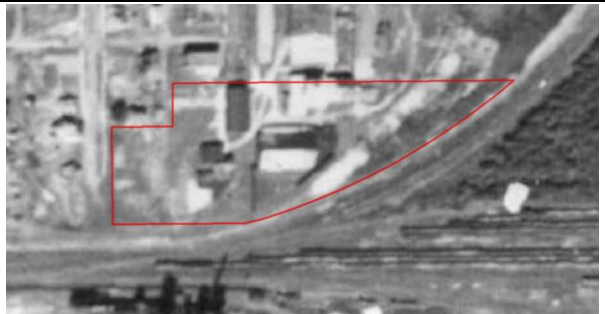
<p>1908 fire insurance map</p>
1939-1946	Land use at the property appears relatively unchanged, although additional rectangular-shaped structures are visible in the western portion of the property. No city directory listings were identified for the property address.	<p>Aerial photograph, city directories</p>

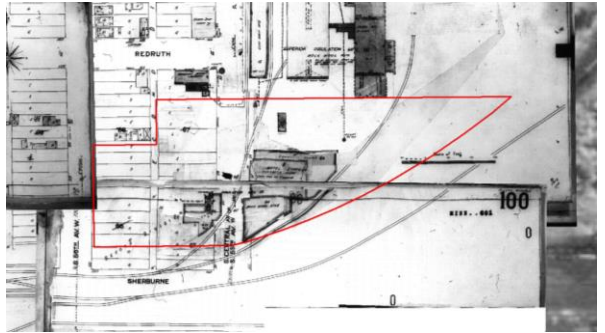
<p>1939 aerial photograph</p>
1948-1955	The property is occupied by the Superior Insulation Manufacturing company. Three structures are depicted in the central portion of the property. These include a storage building (depicted as offices and storage space).	<p>Aerial photographs, city directories, fire insurance map</p>

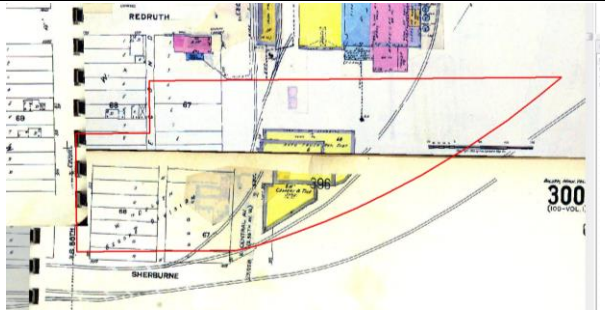
1956	The city directory listing indicates the property is occupied by Arrowhead Blacktop Company.	<p>City directory</p>
1961-1972	Two of the buildings previously noted in the central portion of the property are no longer present. The main building previously labeled as storage contains an auto truck repair shop and cement and tile storage. Unpaved parking/drive areas are present throughout the property. No city directory listings were identified for the property address.	<p>Aerial photographs, city directories, fire insurance map</p>

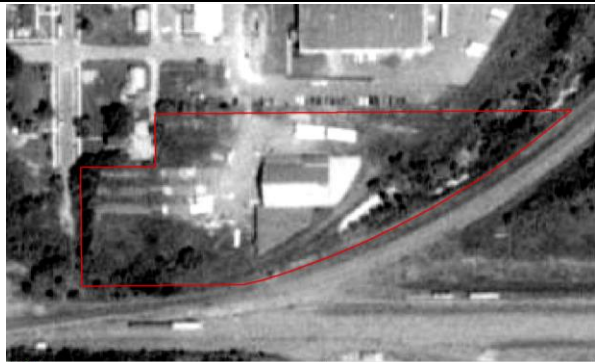
Year	Use	Source (↑ North)	
1980-2005	Railroad tracks previously observed at the property are no longer present. The on-site building remains at the property. No city directory listings were identified for the property.	Aerial photographs, city directories

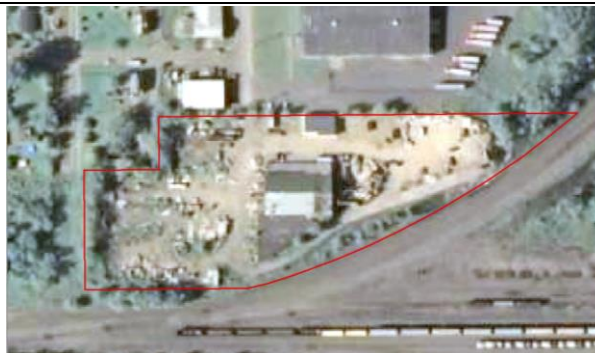
<p>1997 aerial photograph</p>
2006-present	The property appears developed with existing structures. City directories indicate that the property is occupied by the Demo-licious Waste Disposal facility.	Aerial photographs, city directories
