Property Description Data

Environmental Issues: USTs, ASTs, closed LUST, Duluth Manufacturing and Foundry Blacksmith (historic)

Site Name: Coca-Cola Bottling Plant

Site Address: 300–302 S Central Ave

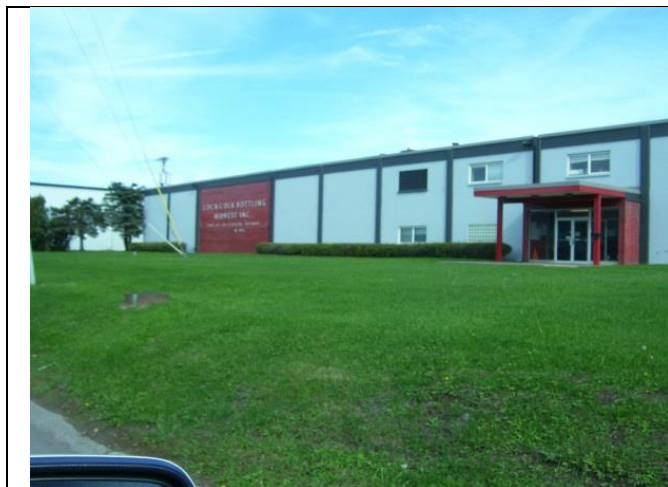
Looking east-northeast across the property

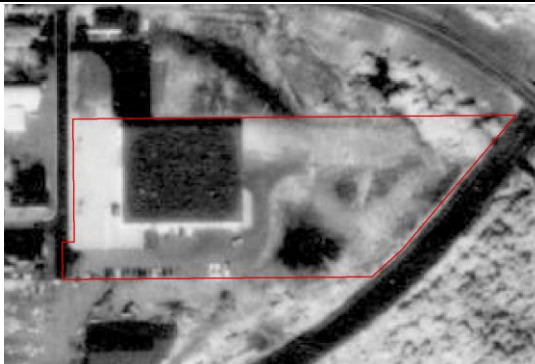
<p>1972 aerial photograph</p>

<p>1966 aerial photograph</p>
1971-1972	The western portion of the property is developed with a square-shaped building occupied by the Coca-Cola Bottling Company. No structures are present in the eastern portion of the property.	Aerial photographs, city directories

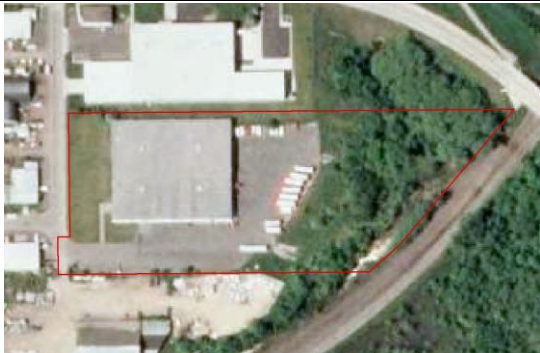
2005 aerial photograph

Year	Use	Source (↑ North)	
1980-present	Land use at the property remains unchanged; however, an asphalt-paved parking/drive area is present to the east of the building.	Aerial photographs, city directories

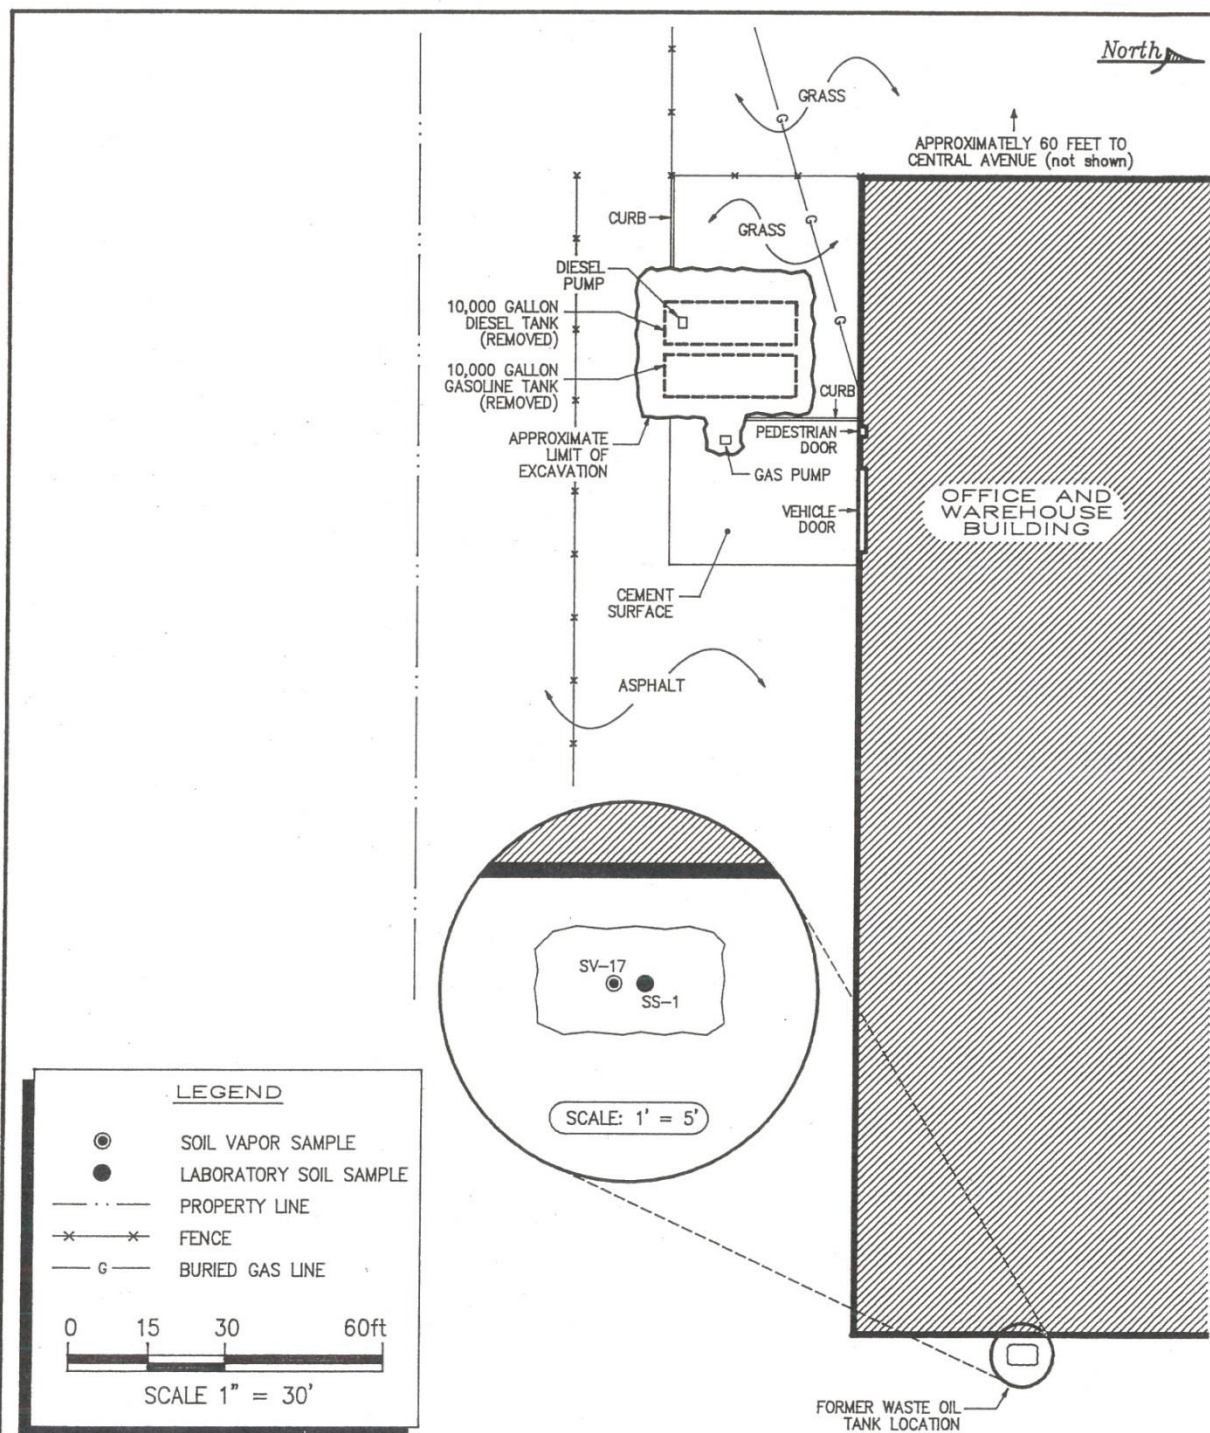
SITE DIAGRAM
COCA-COLA BOTTLING MIDWEST, INC
300 SOUTH CENTRAL AVENUE
DULUTH, MINNESOTA

An Excavation Report, prepared by Nova Environmental and dated November 25, 1991, indicates that one 10,000-gallon diesel UST and one 10,000-gallon gasoline UST were removed on August 19–21, 1991. The report also indicates that a waste oil UST was previously removed from the north side of the building (no removal date was provided).

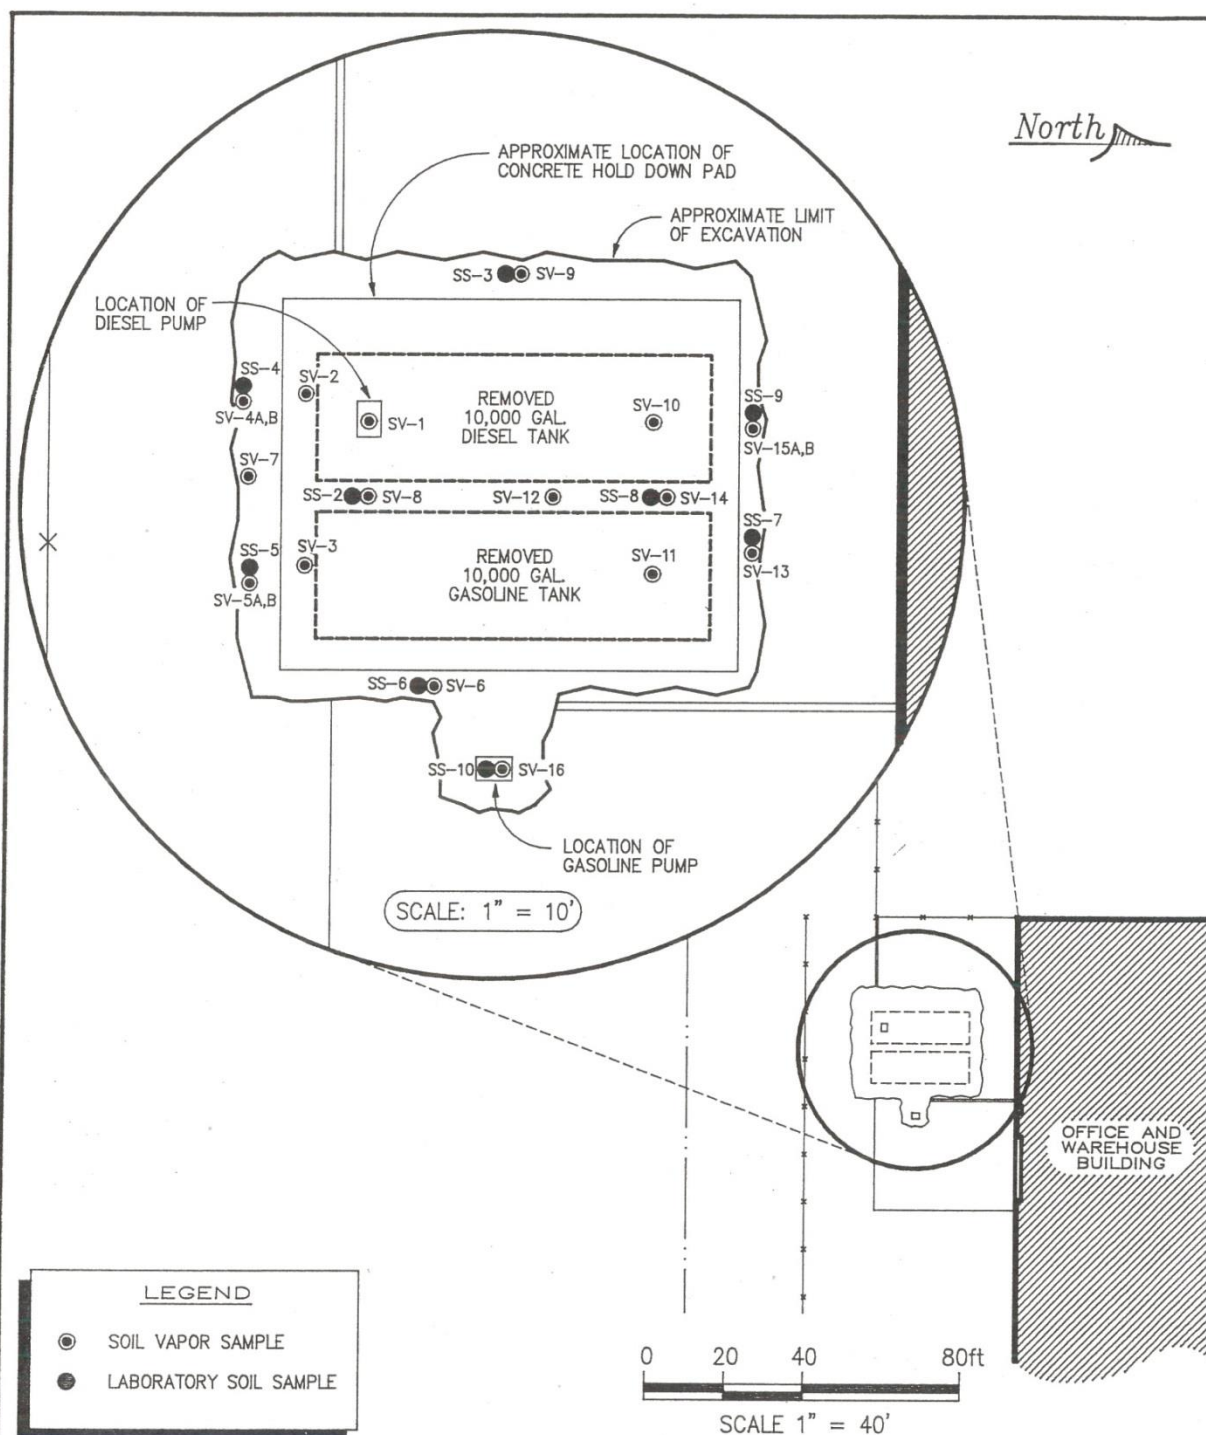
SOIL SAMPLE LOCATION DIAGRAM
COCA-COLA BOTTLING MIDWEST, INC
300 SOUTH CENTRAL AVENUE
DULUTH, MINNESOTA

Excavated soil and soil remaining in the excavation was monitored for the presence of organic vapors; organic vapors were not detected in soil encountered in the excavation below the former waste oil tank. Laboratory analysis of a soil sample collected from the same location did not detect BETX or total petroleum hydrocarbons (TPH) as fuel oil. Vapor monitoring and laboratory analysis of soil encountered during removal of the diesel fuel and gasoline tanks indicated the presence of PID readings of 200 ppm near the fill end of the tanks, and 1,980 TPH as diesel fuel and 723 ppm TPH as gasoline.

After the excavation and removal of approximately 150 cubic yards of impacted soil, organic vapor monitoring from the bottom of the excavation did not detect petroleum hydrocarbons. Laboratory analysis of a soil sample collected from below the north end of the gasoline tank detected 2.01 ppm TPH, below the MPCA action level of 50 ppm. Petroleum hydrocarbons were not detected in the other soil samples collected from below the gasoline and diesel fuel tanks. Organic vapor monitoring of soil exposed on the sidewalls did not detect petroleum vapors.

Based on this information, site closure was requested. The release was closed on February 10, 1992.
