CABINET I/O

Title: EXTERMINATION

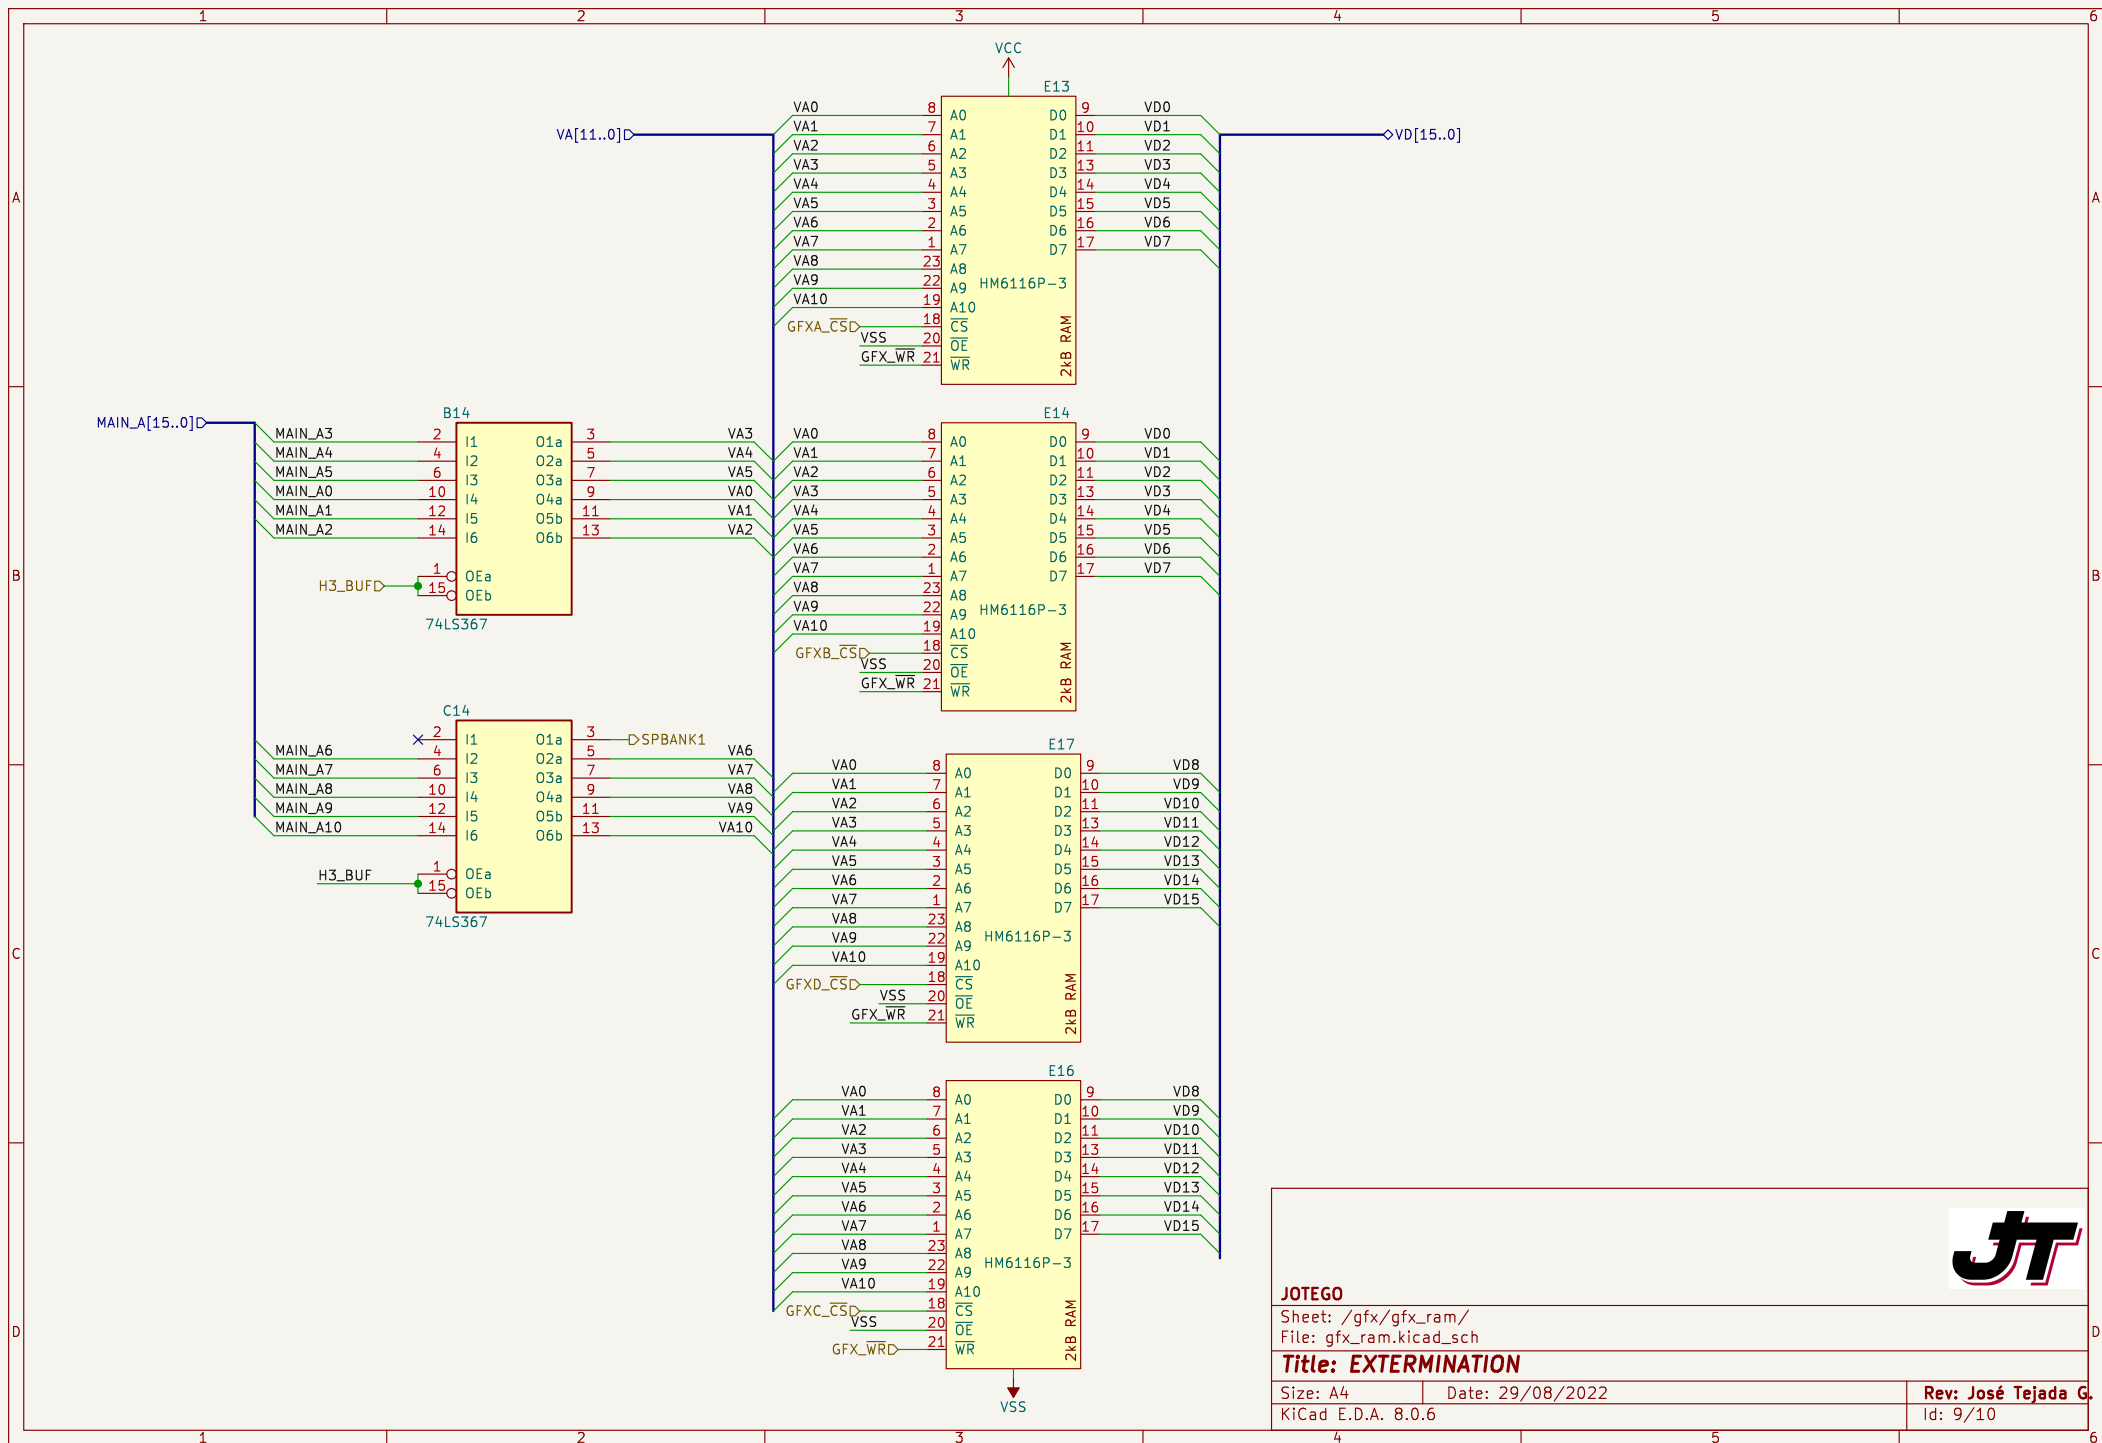
Sheet: /gfx/gfx_ram/
File: gfx_ram.kicad_sch

gfx_ram
