Stepper Motor 9: Audible Noise

TI Precision Labs – Motor Drivers

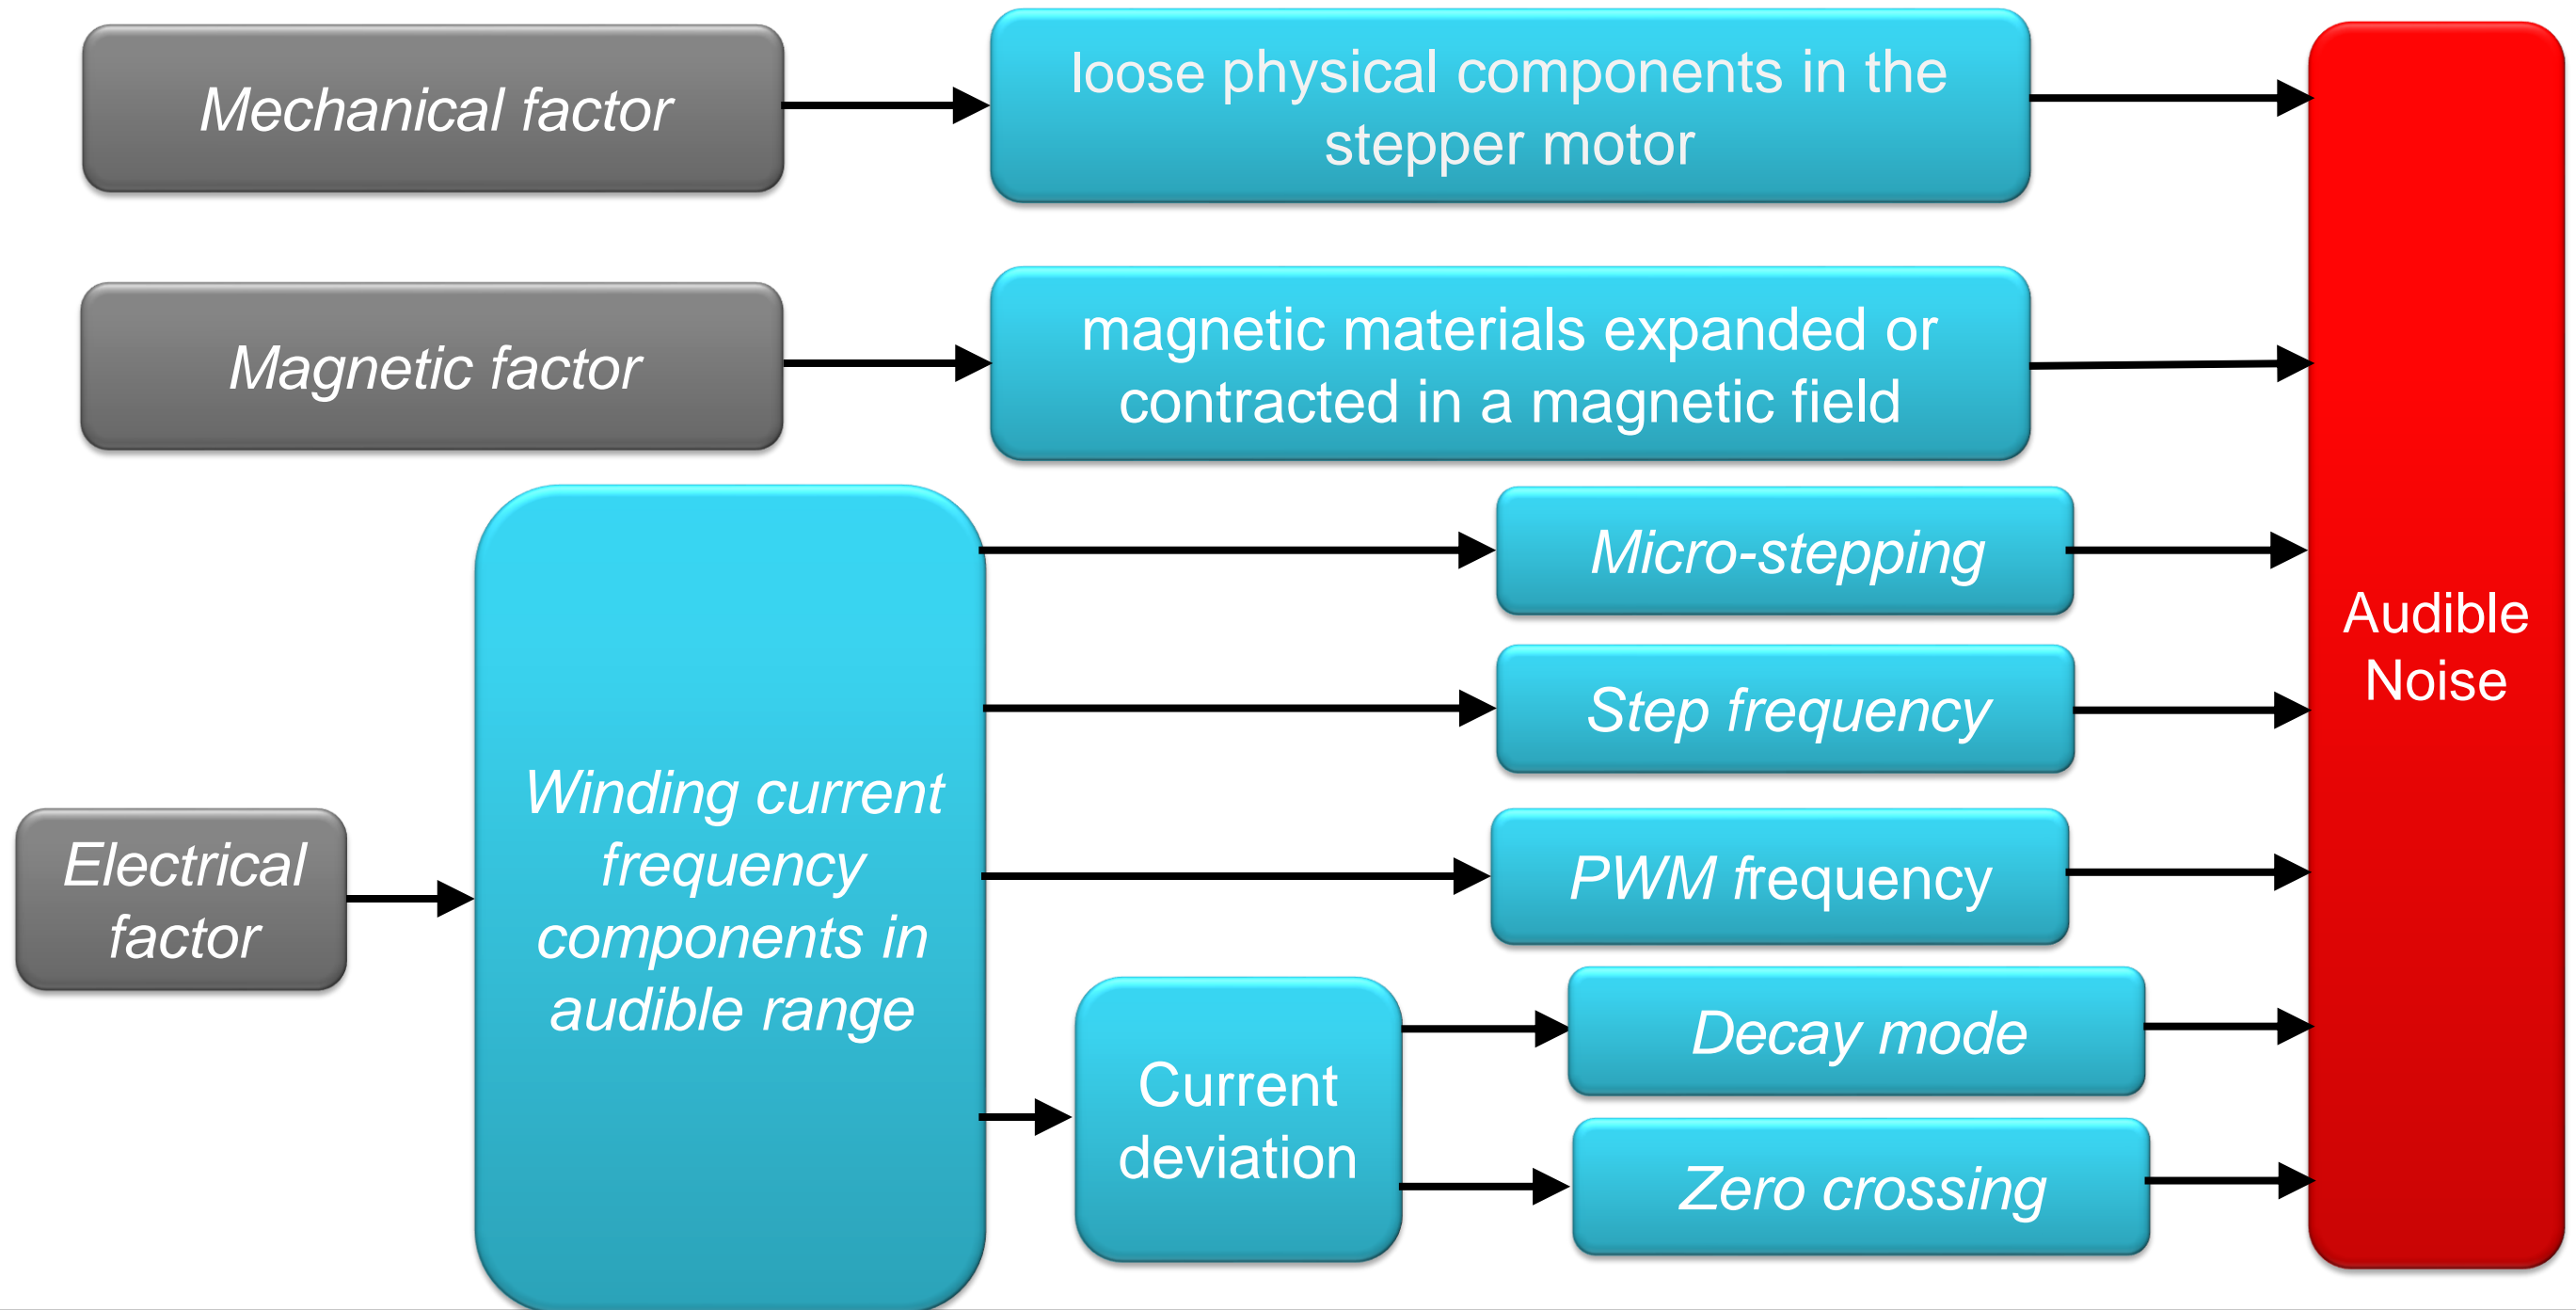
Common stepper audible noise problem

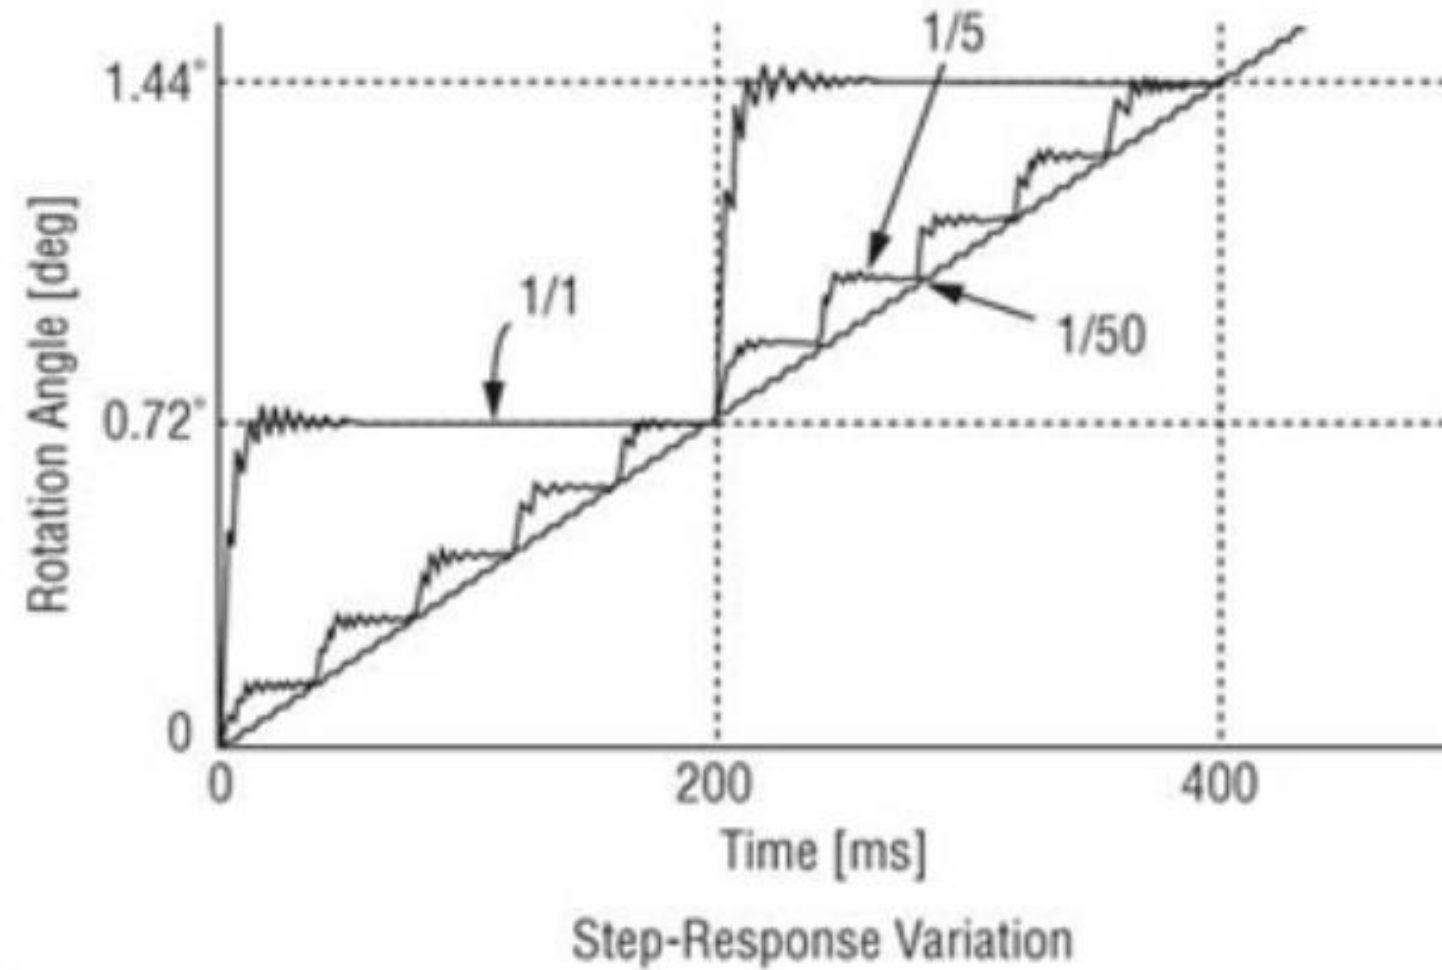
Micro-stepping setting

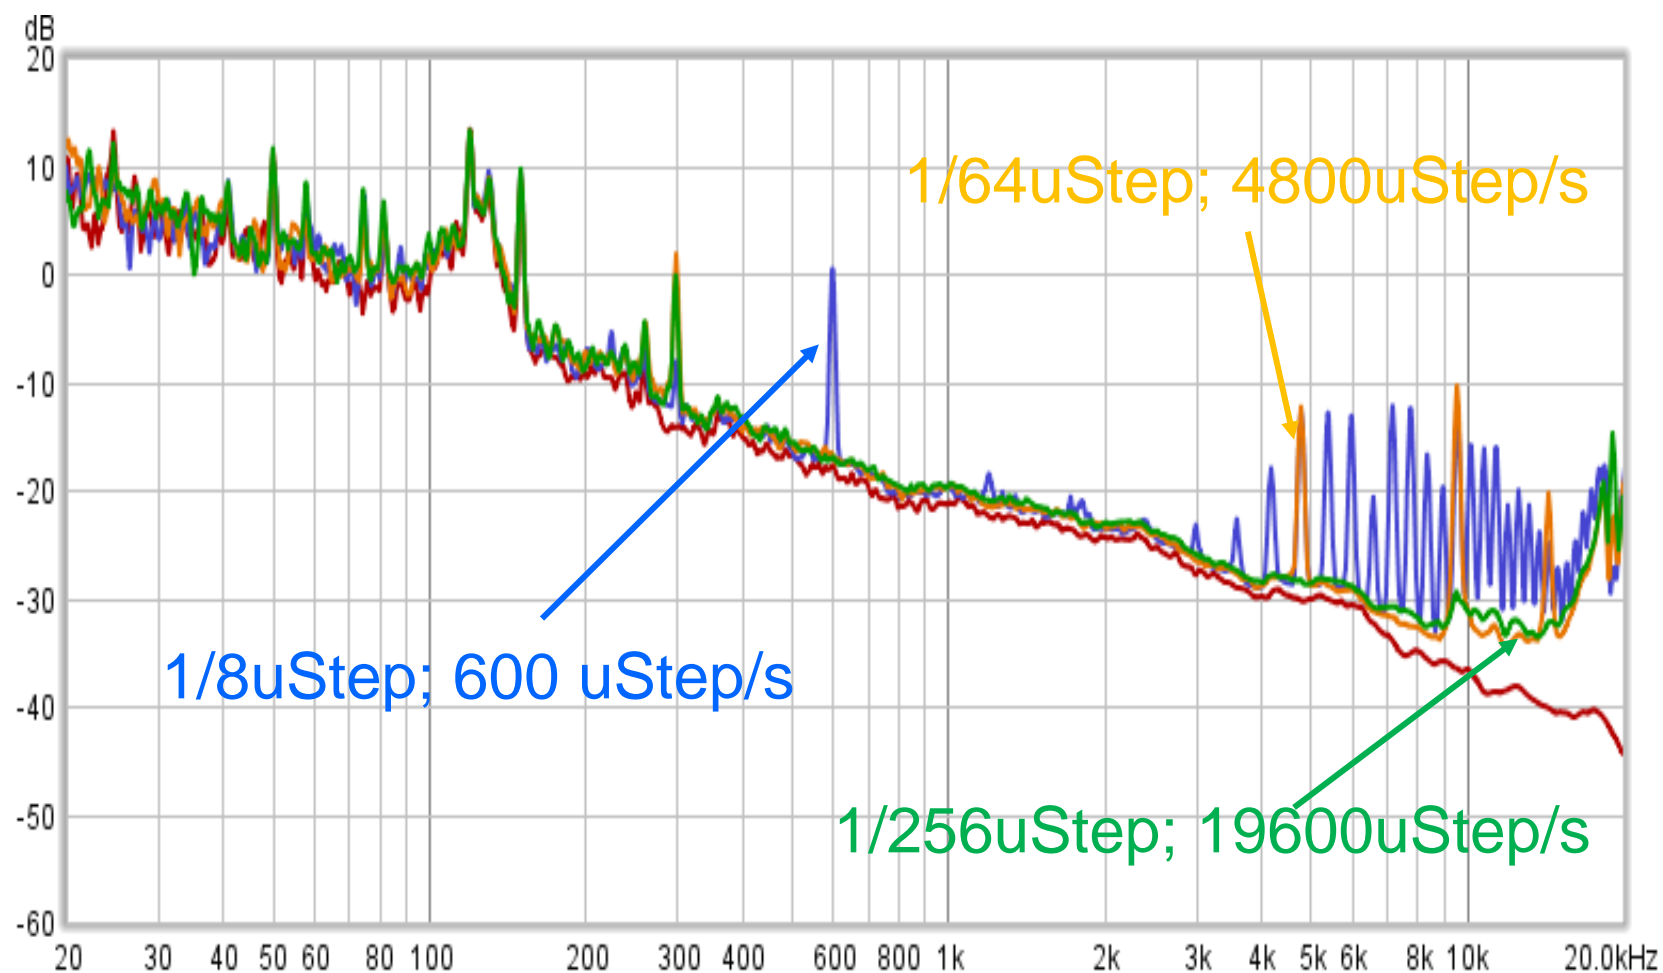
Step frequency setting

Sound pressure level plot

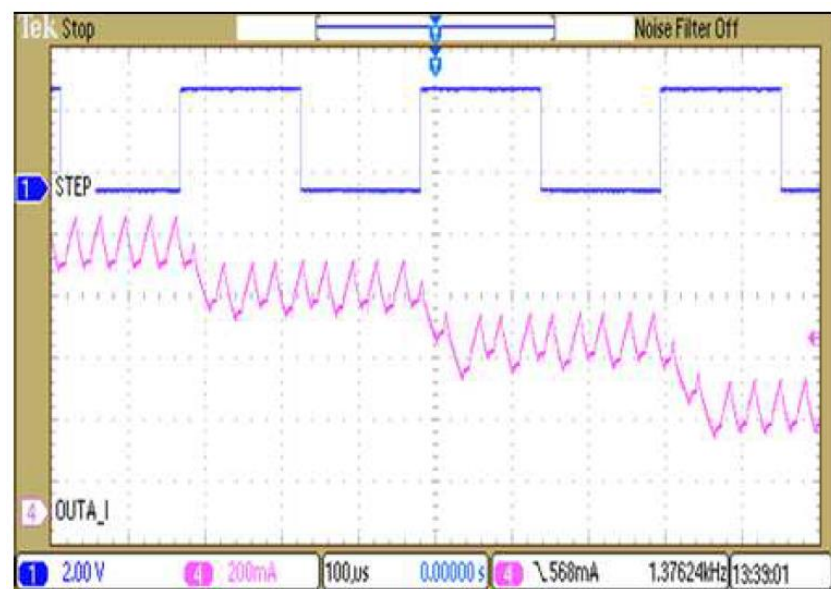
Microstepping Current vs STEP Input, Mixed Decay

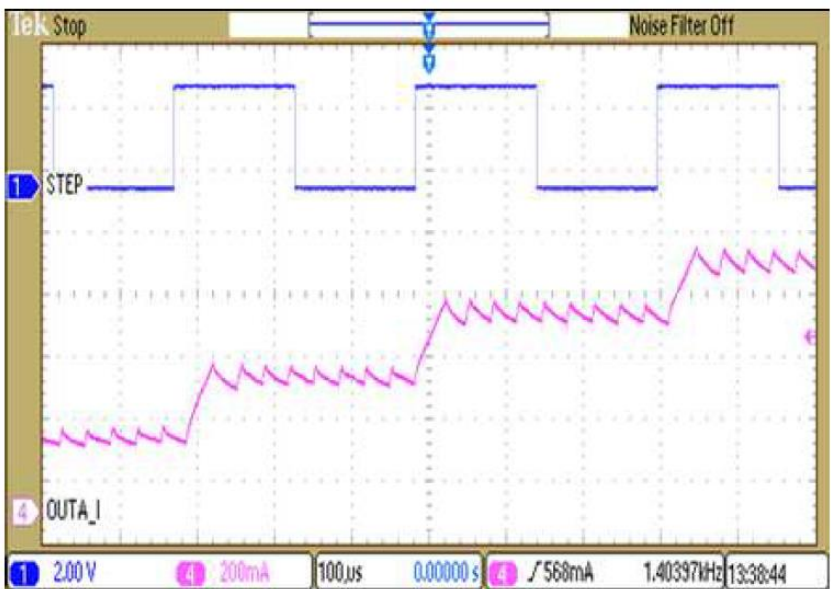
Microstepping Current vs STEP Input, Slow Decay

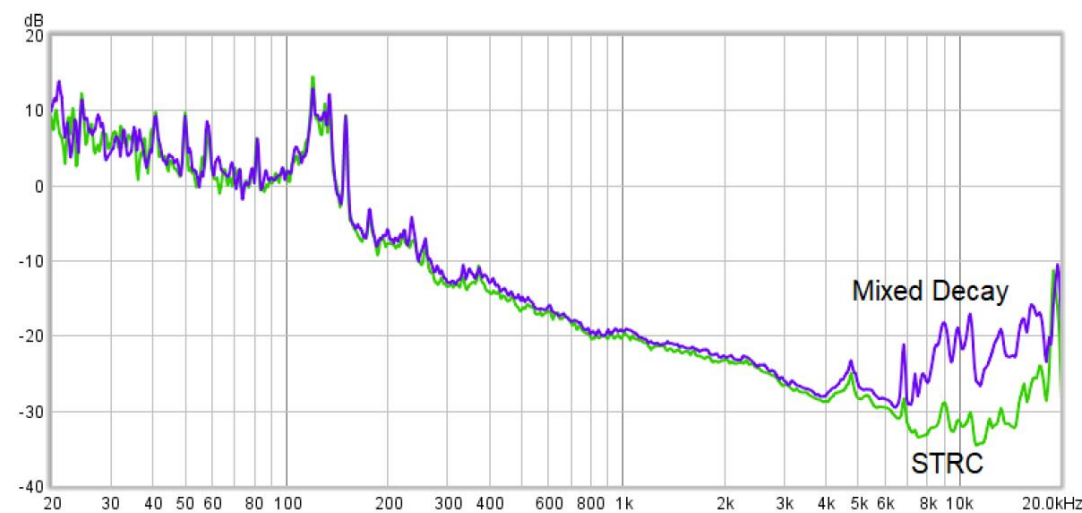
Mixed Decay vs Smart Tune Ripple Control (STRC) at 1/256 Microstepping

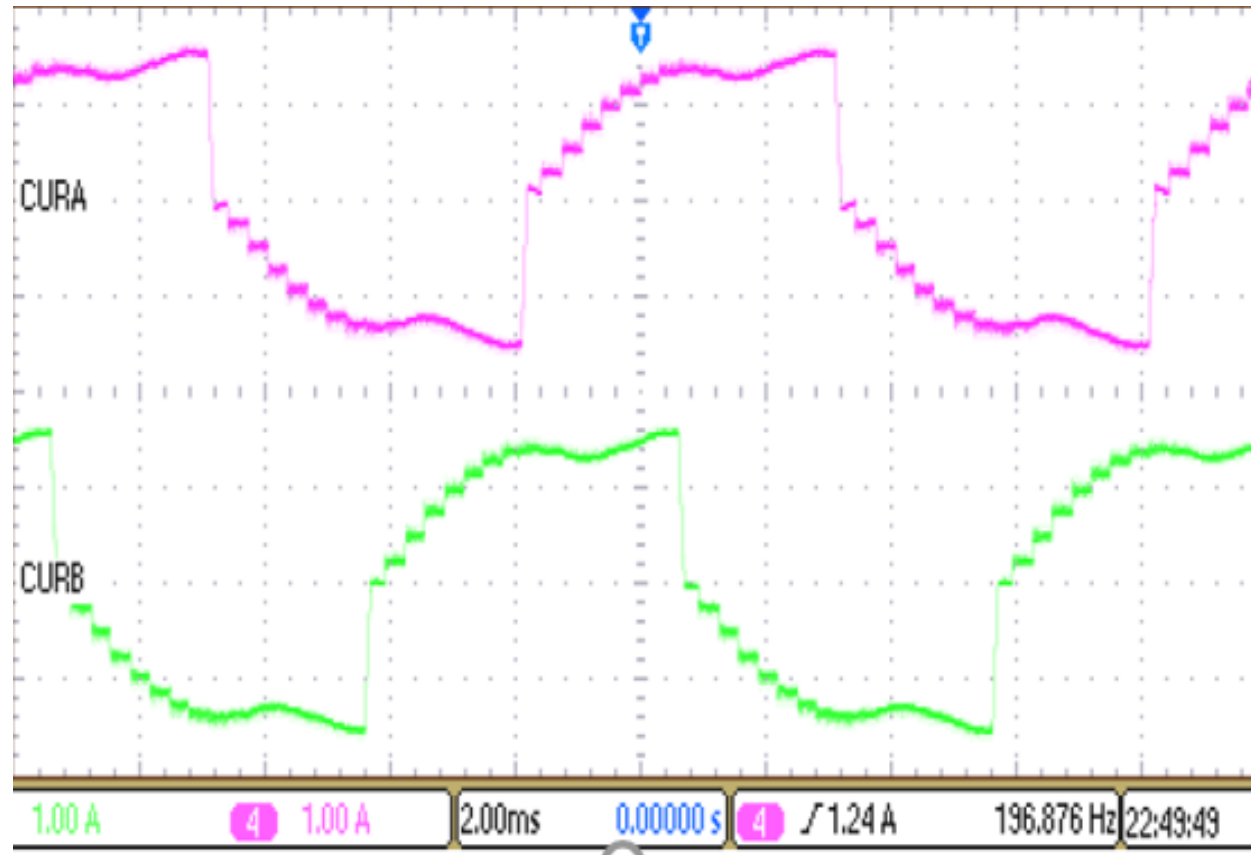
Slow Decay on Increasing and Decreasing Steps

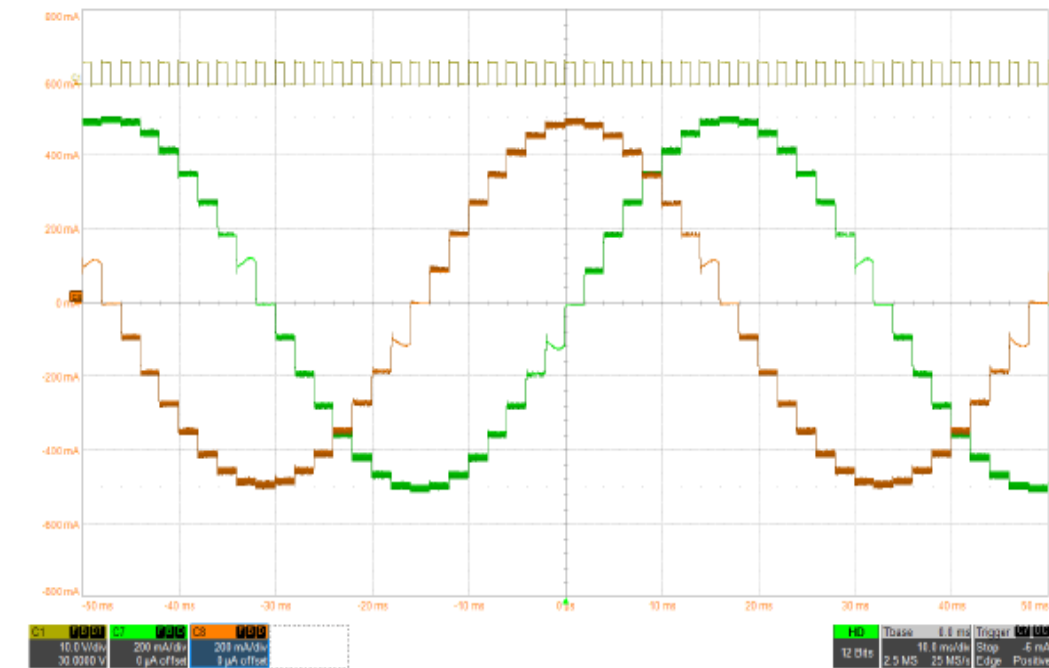
Smart tune ripple control decay

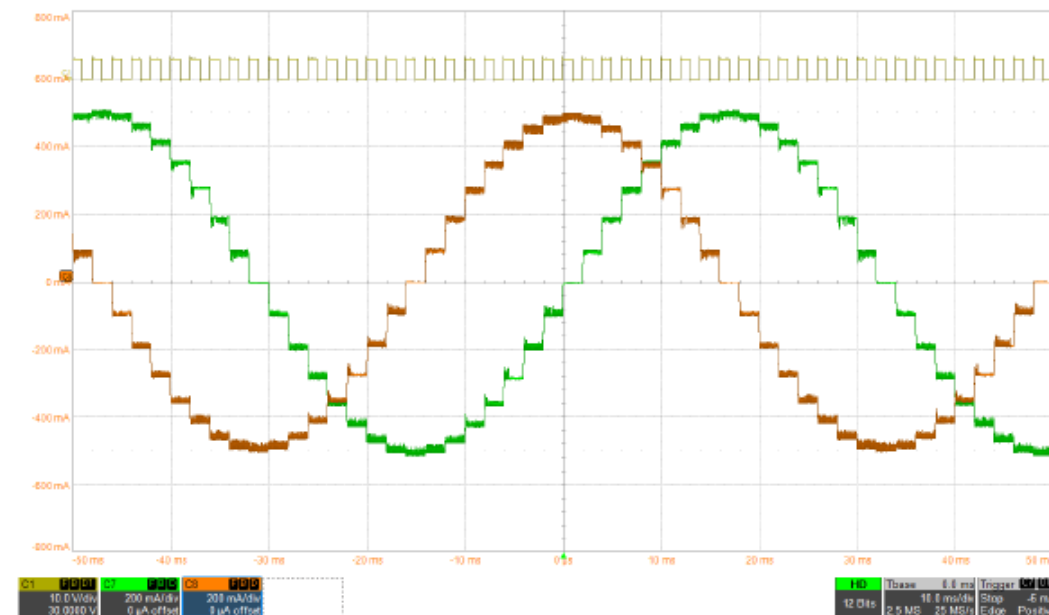
Smart tune dynamic decay

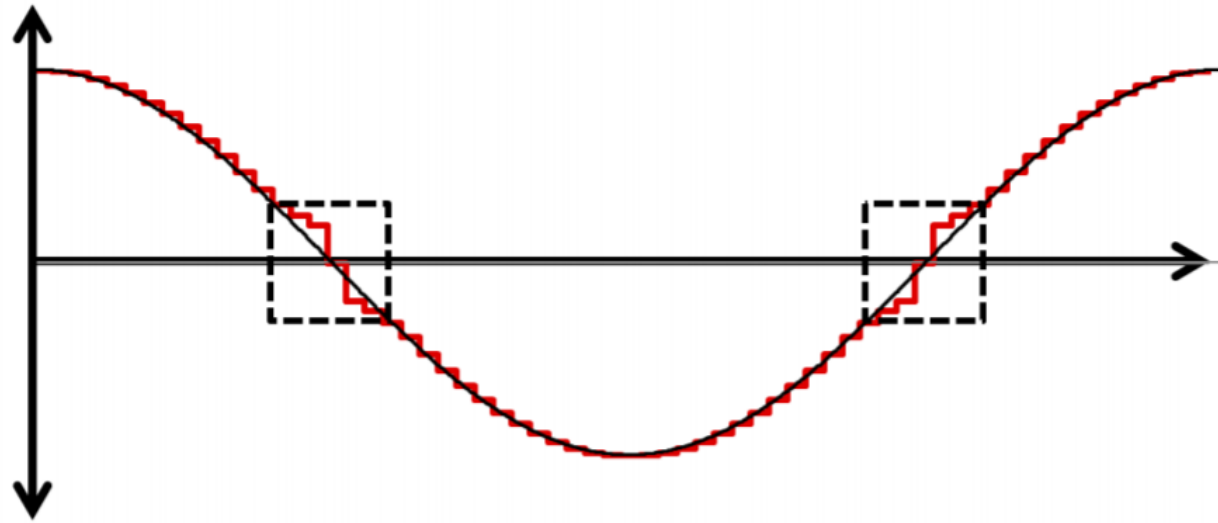
Current Distortion Due to High Blanking Time

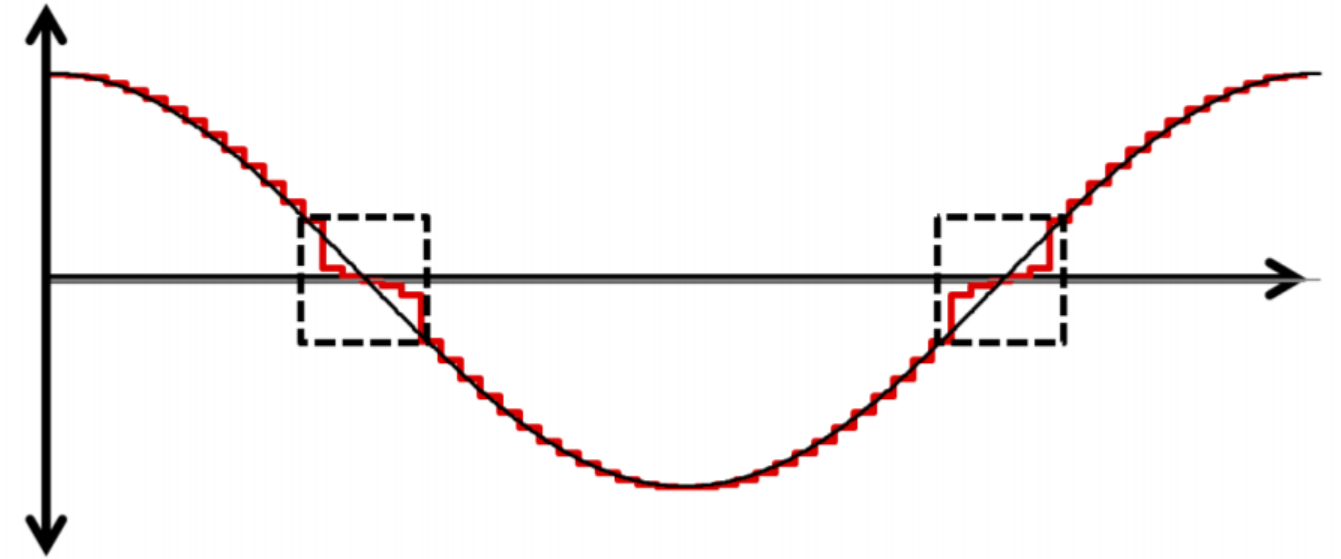
Current Distortion Due to High OFF Time

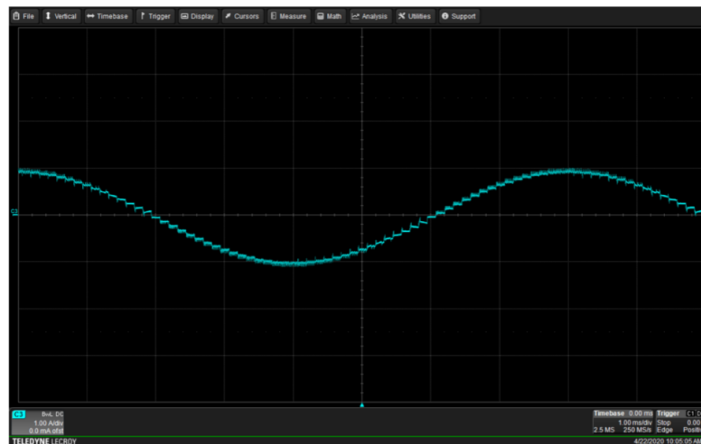
Smoothness of Zero-Cross at 1/16 Microstepping

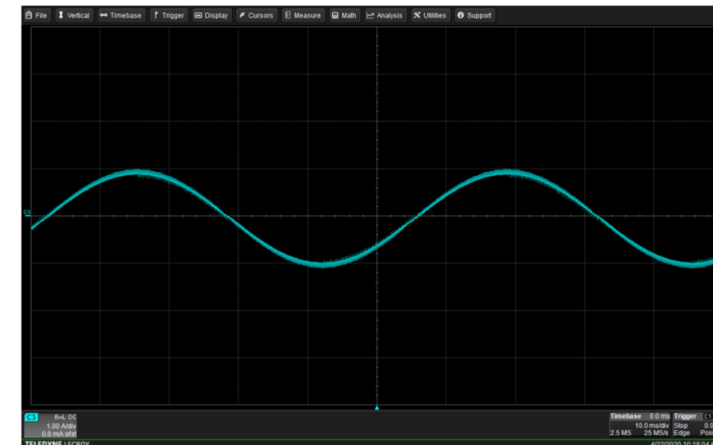
Smoothness of Zero-Cross at 1/64 Microstepping
