ASME/JSME 2004 Pressure Vessels and Piping Conference (PVP2004)

RELIABILITY TESTING OF PRESSURE RELIEF VALVES

Robert E. Gross, Principal Engineer
Email robert.gross@srs.gov
Westinghouse Savannah River Company
Aiken, South Carolina 29808

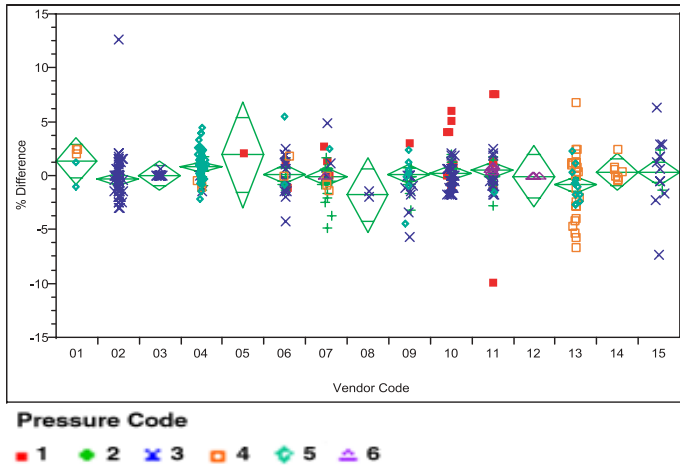
Chart 1. New Valve Pre-Installation Tests

Data was tabulated in spreadsheets to look for trends by comparing vendors, years of service, system pressure, test pressure/set pressure and initial versus average pop pressure. The following charts are annotated to indicate what was concluded from the data. Chart 1 and Table 1 provide a summary of pre-installation test results on 560 new valves.

The specification limit for section VIII valves is +/- 2 psi up to 70 psig set points (not shown) and +/- 3% of set pressure above 70 psig. Mean diamonds indicate no significant difference in average test pressure from stamped set pressure assuming a normal distribution.

It can be seen that about four percent of new relief valves pop outside the upper ASME limit. Several pop at pressure higher than 20 percent of set pressure. It is likely that these particular new relief valves if not pre-installation tested would have in service lifted at +120% of the expected value. Current data suggests that if we want to be sure of the as-installed condition, we must test to verify. For many installations, systems, or services it may be acceptable risk and most cost effective not to test. By statistical analysis a number of manufacturers models are predicted to exceed the upper spec limit by less than 0.15% or 1500 parts per million. Others would exceed the upper limit with 2% of valves, while another vendor would provide a total number outside upper and lower limits of 7%.

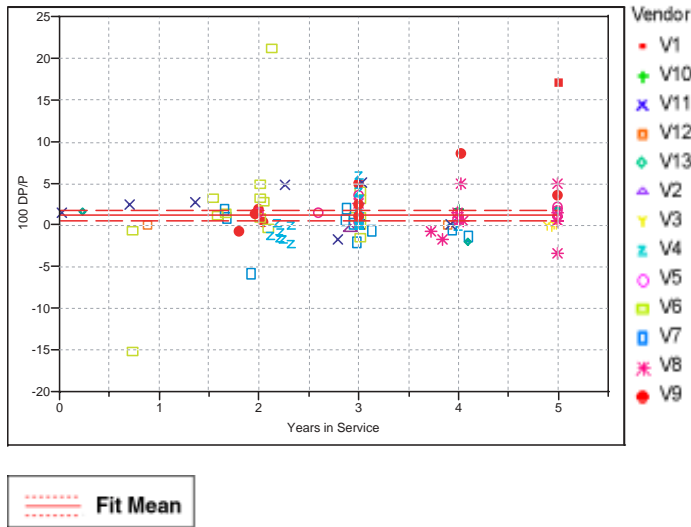
Chart 3. 100 [TP-SP]/SP versus Years in Service and Vendor, Valve Set Points Greater than 70 psig All Services, All Vendors, Used Valves

Chart 3 portrays used valve data by vendor. Also shown is the mean line with uncertainty limits. Except for Vendor 4 and 9, there appears to be no slope or significant trend toward greater Dp/P with increased time in service. The data includes all sizes, all service, and all pressure ranges.

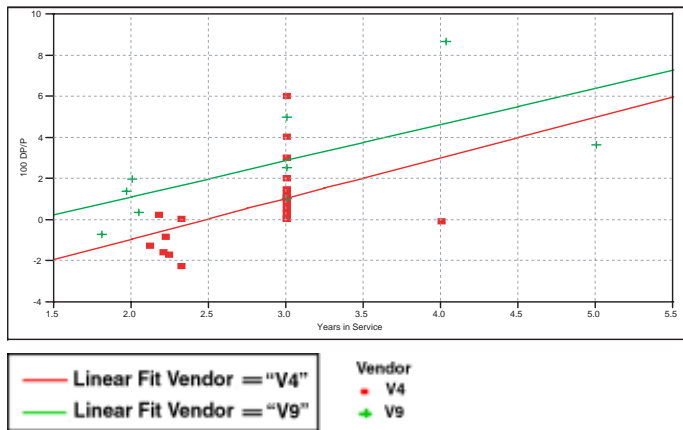
Chart 4. Plot of 100 [TP-SP]/SP By Years in Service Used Valves with Metal-To-Metal Seats Vendors 4 and 9

After looking closely at the data, two different vendor valves (V4, V9) provided significant trend lines. The trend line for V9 shows an approximate 7% increase from set pressure within the first five years of service. It is not known at this time if the range in data was due to valve design or environment.

In the plot shown above, V4 and V9 are both hard seated valves, that is they have metal-to-metal lapped seats to seal fluid pressure. Soft seats were not present in the valves shown above.

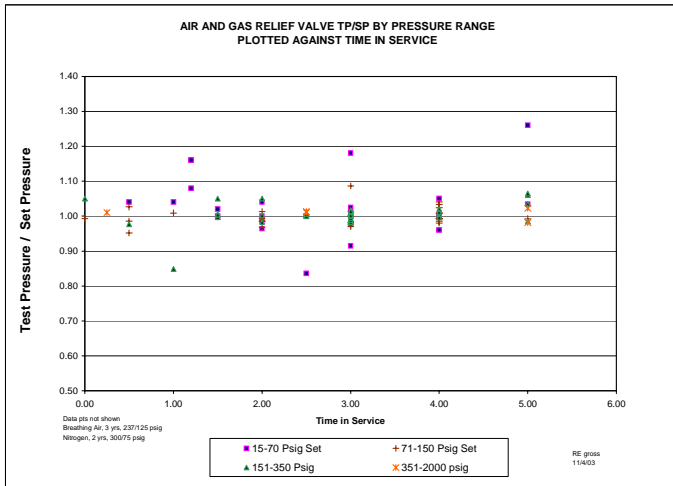
Chart 6. Air and Gas Service All Pressure Ranges Used Valves

In Chart 6, we are looking for a trend toward a higher or lower ratio when viewed by pressure range. It can be noted that the lowest pressure range includes the most scattering of data. This is due to the fact that ASME Section VIII tolerance for set pressure is ± 2 psi for set pressures up to 0.483 MPa (70 psig). Consequently, valves set at 16 psig might vary from 14 to 18 psig and be within tolerance. An acceptable TP/SP in the latter case would be 18/16 or 1.13. A valve set at 4 psig could be as much as 6/4 with TP/SP of 1.5. The remaining set of data shows the ratio TP/SP to be centered between 0.9 and 1.1 which is plus or minus 10% of set pressure. No strong function of pressure range is indicated here.

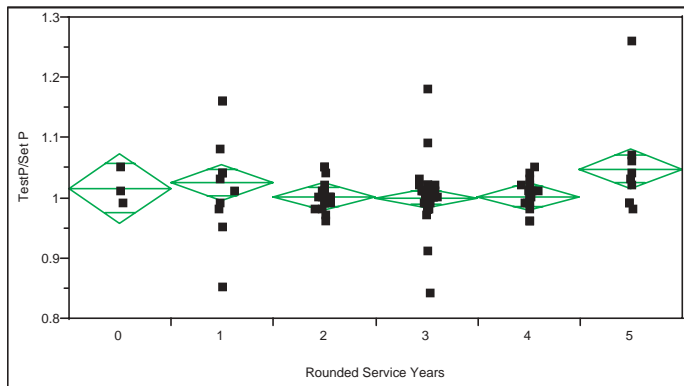
Chart 7. Analysis of Test P/Set P and Rounded Down Years Air and Gas All Pressures

The mean diamonds indicate that there is no statistical difference from TP/SP = 1 within the first four years of service. There could be slight increase in test pressure at five years but the data are not conclusive. Several valves test as much as 20+ % over set pressure. Reasons for the over pressure might include different valve design, set pressure range, size, and environmental or field conditions (e.g., heat and vibration). Additional data may provide further insight, but the data to date does not suggest that shorter test frequencies yield better test results or less risk of exceeding set pressure by more than 10%.

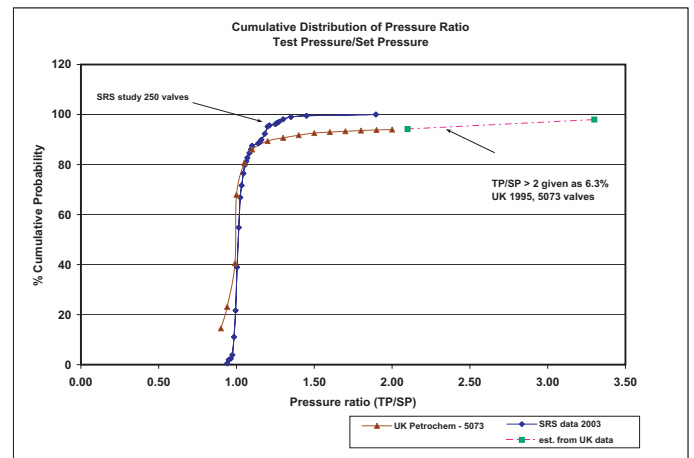
Chart 9. Probability Density Trace of Pressure Ratio for All Services, All Vendors, Time in Service, and All Sizes of Valves

In Chart 9 a comparison of probability density traces from the referenced UK study (Smith, 1995) and the current SRS study is portrayed. Up to the ratio 1.1, these curves are very similar. It is not known at this time whether the SRS curve will flatten out as more data is accumulated.

From this probability density trace, it can be seen that approximately 90+ percent of valves bench tested within 0.9 to 1.2 times the expected value of set pressure. There is a 10 percent chance that a valve will relieve at greater than 20% over set pressure, and less than one-half percent probability that any valve, any service, any vendor or size will relieve at greater than 150% of set pressure after being in service for up to five years. Additional Statistical Analysis revealed that our current test data does not fit normal, log-normal, exponential or Weibull distributions well which leaves us without confidence limits on our conclusions.

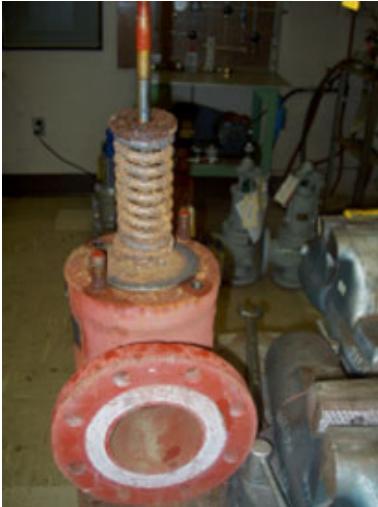
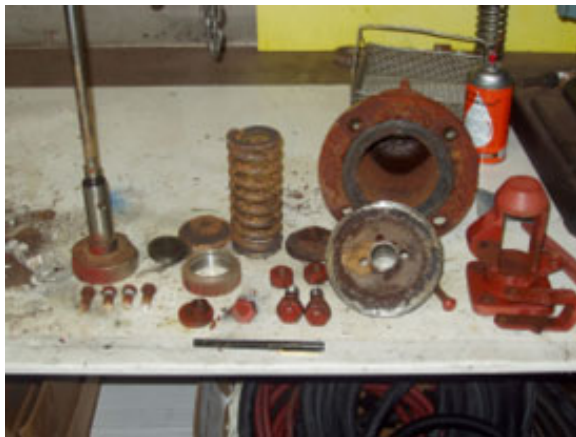
It is readily noticed in Figures 5 and Figure 6 that this valve was installed out in the weather and not protected by a rain cap or provided corrosion resistant parts under the bonnet. When the valve shop tested this valve, it popped loose at 237 psig set point. The valve was dismantled and the spring retaining washers were found rusted to the valve stem preventing free motion of the valve stem.

Figure 5. Nitrogen Valve

Figure 6. Nitrogen Valve with Bonnet and Lifting Lever Removed; Totally Dismantle

This nitrogen service valve was repaired with new parts, and provided a rain shield to prevent water from entering the bonnet.

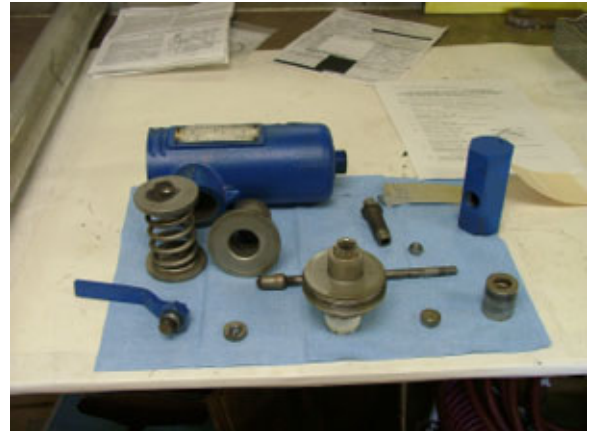
Figure 7. Disassembled Compressor Relief

Figure 7 is a disassembled spring loaded relief used on a reciprocating air compressor second stage. The cold set pressure is 125 psig. The valve was removed from the second stage discharge piping. Shown are the valve housing, spring, retainers, disc, nozzle, stem, and manual exercise handle.

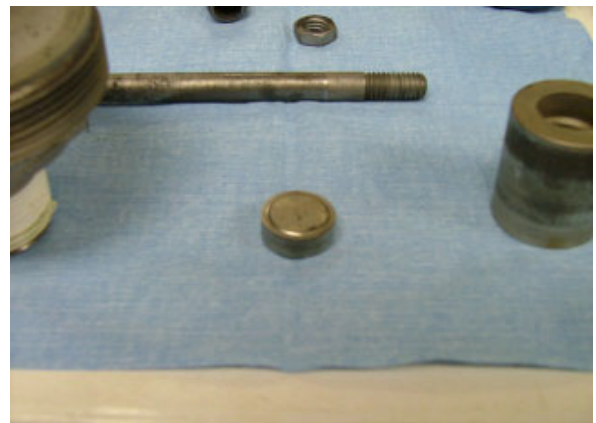
Figure 8. Compressor Relief Disc and Spindle

The failure was excessive leaking by the seat. Seat damage occurs typically because shock pulses of the high pressure piston lift the disc off the seat. After a large number of cycles, a hammering effect begins to develop as the disc and seat fret against each other. Figure 8 is of the disc, disc holder and spindle. The holder shows galling marks on its outer diameter indicated by the silvery vertical slashes seen. The disc can be seen as having an indentation matching the nozzle seat. The depression is approximately 1/64 inch deep. A new disc will be flat across or may even be dished out (convex).

Inspection of the exercise handle, stem, and spring reveals an impression left in the spring adjustment screw by the manual actuation lever working back and forth. Possibly, the velocity/acceleration of the discharge piping of the reciprocating compressor caused the handle to oscillate with sufficient force to decrease the spring tension holding down

on the valve disc. These valves are typically subjected to both vibration and elevated temperature. Both of which have been shown in the past to promote early failure and increase or decrease from cold set pressure (Aird, 1982).

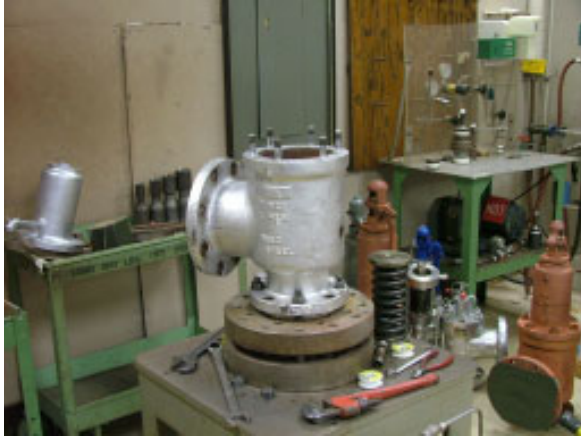
Figure 9. Steam Valve on the Test Stand

This valve is a conventional spring-loaded 4 x 6 inch 100 PSIG Steam valve from a process area. The valve was disassembled on the test stand after failing test. Failure mode was excessive leakage at holding pressure. By procedure, the valve must be able to hold tight at 90% of set pressure. Mechanics place duct tape across the discharge flange and if the tape bulges during the holding test, the valve fails this test.

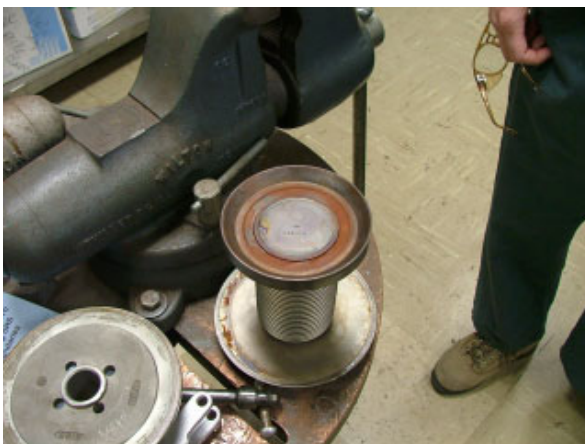
Figure 10. Valve Disc After Disassembly

Figure 10 is a picture of the valve disc after disassembly. The bellows indicates that this is a balanced pressure relief. Outlet port conditions do not affect the set pressure.

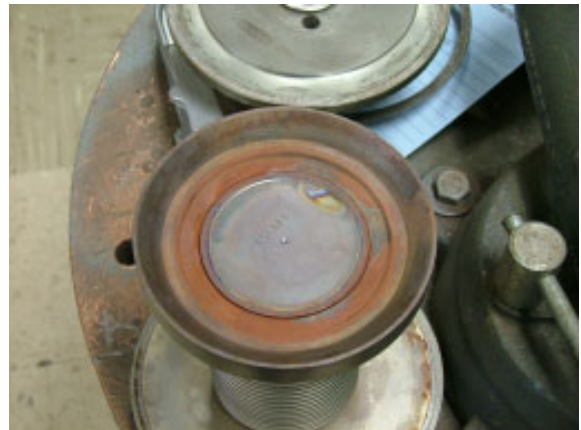
Figure 11. Closeup of the Disc Seating Area

The discoloration in Figure 11 indicates that the valve was leaking by in service causing a hot spot. Typically this condition also causes the seat to be “cut” or eroded by the steam. Eventually the erosion causes a deep enough groove in the seat to be quite noticeable.

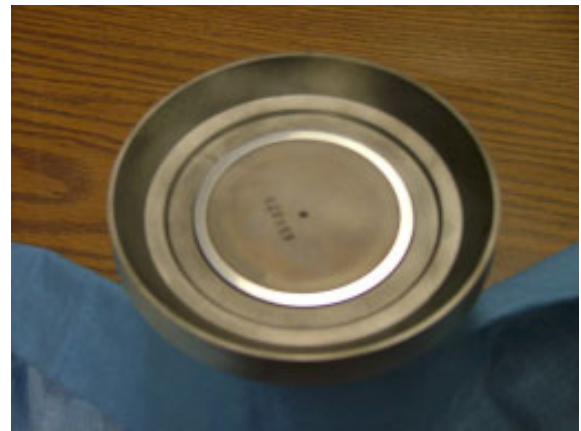
Figure 12. Steam Valve Seat After Rework

The seat area here has been lapped true and flat. When mated with a similarly refurbished nozzle surface factory performance will be expected.

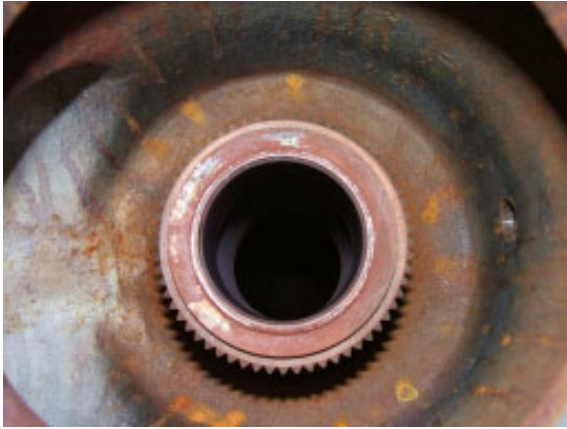
**Figure 13. Steam Valve Disc Before Lapping
Steam Valve Nozzle as Seen After Disassembly in the
As Arrived Condition**

Rust discoloration around the nozzle area is an indication that the valve was leaking in service. Surface finish on the nozzle is not cut appreciably, but is more than likely not flat as steam leakage can lead to slight warping of this critical area.

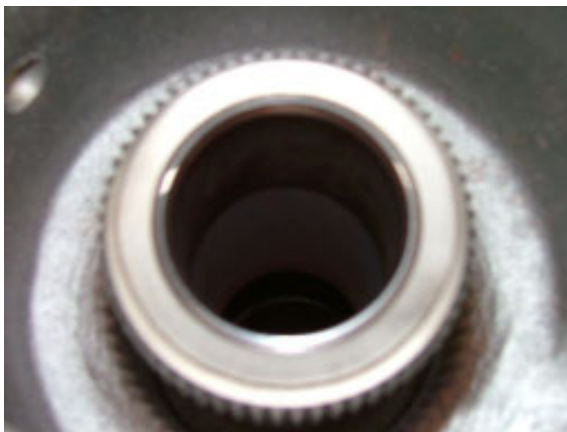
**Figure 14. Steam Nozzle After Cleaning, Polishing and
Lapping**

The like-new condition seen will provide for a tight metal-to-metal seal between the nozzle and disc. The valve will now hold tight near set pressure and will not sizzle during operation. The flat mating surfaces will also promote a good lift off or pop when set pressure is reached.
