Technical Bulletin

Passenger Side Airbag Cover

Number
9501

Model Affected: **911 Carrera Model Year 1995**

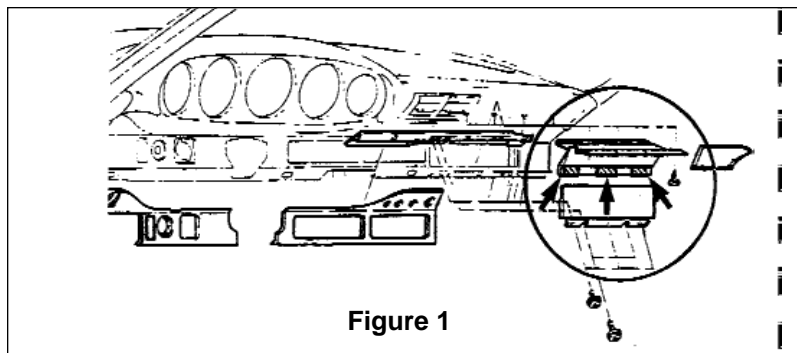
Figure 1

General Information: The two felt strips on the airbag covers on the passenger side of the vehicle have been replaced with three Teflon strips (figure 1) as of July 1, 1994 production from VIN's: 99XSS321420 Coupe
991SS341178 Cabriolet

Due to production reasons a few vehicles built after the above mentioned production date still received the felt strips.

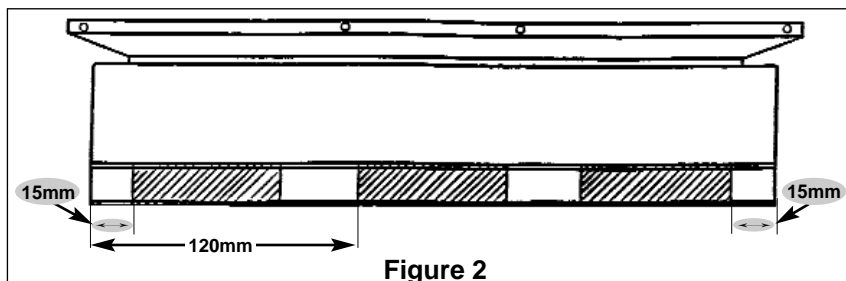
Figure 2

Concern: Noises from the passenger side Airbag covers while driving.

Repair Information: In case of noise complaints from this area, three (3) Teflon strips should be installed on the top cover (figure 2).

- Disconnect battery.
- Remove radio and radio frame.
- Remove Heater/AC vent, Heater/AC control head and frame.
- Remove ashtray.
- Remove kneebare and disconnect wires to the passenger airbag.
- Remove the lower airbag cover (3 bolts).
- Remove the felt strips on the upper airbag cover and install (3) Teflon strips at the dimensions shown in (figure 2). Start with the installation of the Teflon strips on the edge (circled area figure 2).

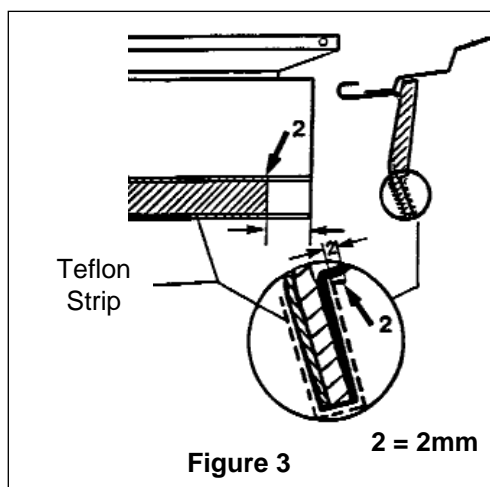
The Teflon strips must be installed approximately 2mm over the top radius of the upper cover (figure 3).
