Pacific Sea Level and Geodetic Monitoring Project: Levelling & GNSS Monitoring Survey Report

Manus Island, Papua New Guinea, March 2019

GEOSCIENCE AUSTRALIA
RECORD 2023/20

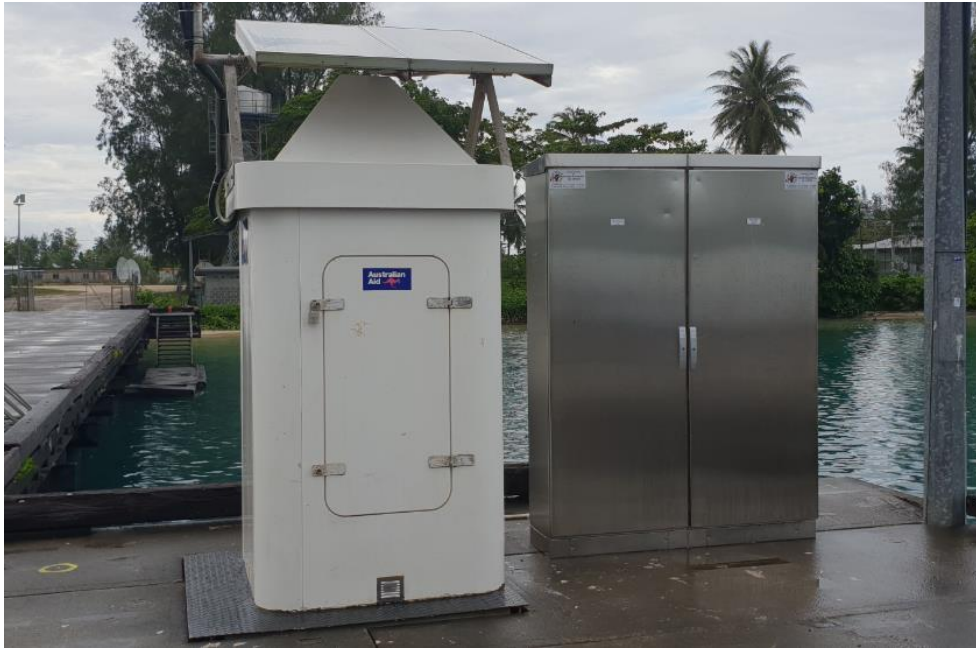
Figure 3.3 Tide Gauge Station at the Lombrum Naval Base Jetty

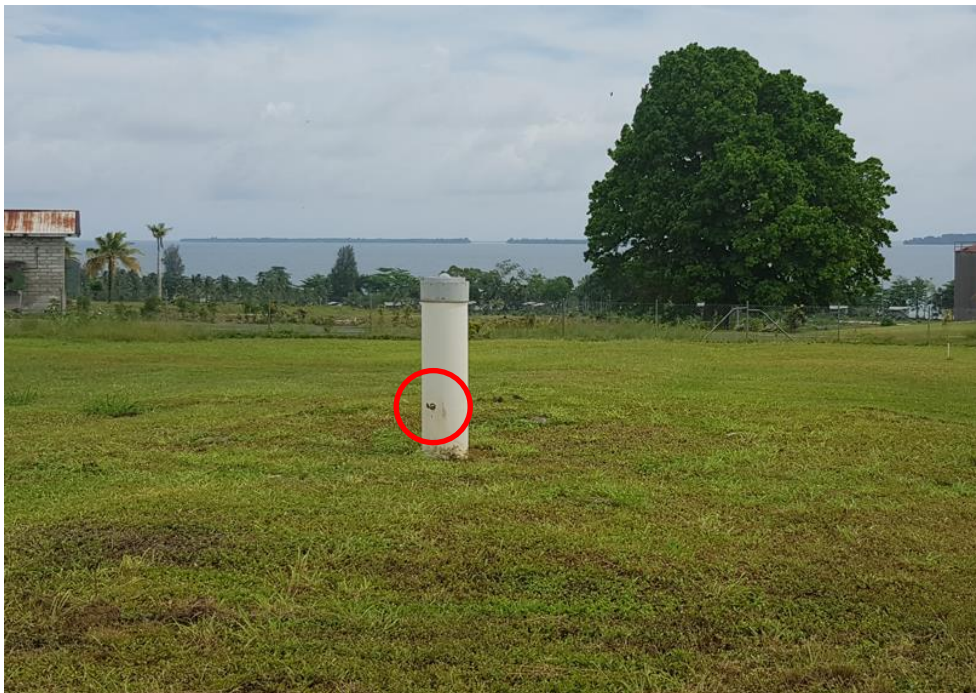
Figure 3.4 GNSS COR Station in Manus Island. The red circle denotes the location of the GNSS CORS benchmark (PNGMBM).
