<p style="text-align: center;">FAULT</p>   <p style="text-align: center;">T00N75D7</p>	<p style="text-align: right;">AIRCRAFT ID:</p> <p style="text-align: center; font-size: 24px;">CC-BGM</p> <p style="text-align: right;">Page: 1 / 4</p>
--	--	--

FAULT DETAILS	ETOPS
<p>MOC N° 410610 DURING JIC MP-B787-25-031 FOUND LUMBAR FUNCTION HARNESS ASSY CONNETORS OF THE SEATS: 1C, 1D, 1H, 1L, 2J, 2H, 2D, 3D, 4D, 4A, 3H BROKEN OR IN BAD</p>

ENGINEERING INSTRUCTIONS FOR TROUBLESHOOTING / REPAIR		E.I. Number: EI-25-6089	
				REV: 0	Page 1 OF 3
Title TEMPORARY REPAIR - HARNESS S37008-908-001 SEATS 1C - 1L - 2J - 3H - 4A WITHOUT SECURE LATCH - D25P				Issue Date 19/11/2022	
Affiliated Company LATAM	Aircraft/Engine/Comp B787	Serial No. 38771	Registration CC-BGM	Sysaid 821904	
Current FH 20103.84	Current FC 3106	ATA Number 25		Barcode T00N75D7	
Case Purpose Evaluation/In Work <input type="radio"/> Closing <input checked="" type="radio"/>		Current Situation: On duty <input checked="" type="radio"/> Administrative <input type="radio"/>			
Data Source: From: OEM <input type="radio"/> DER <input type="radio"/> Local Authority <input type="radio"/> Local Engineering <input checked="" type="radio"/> Re

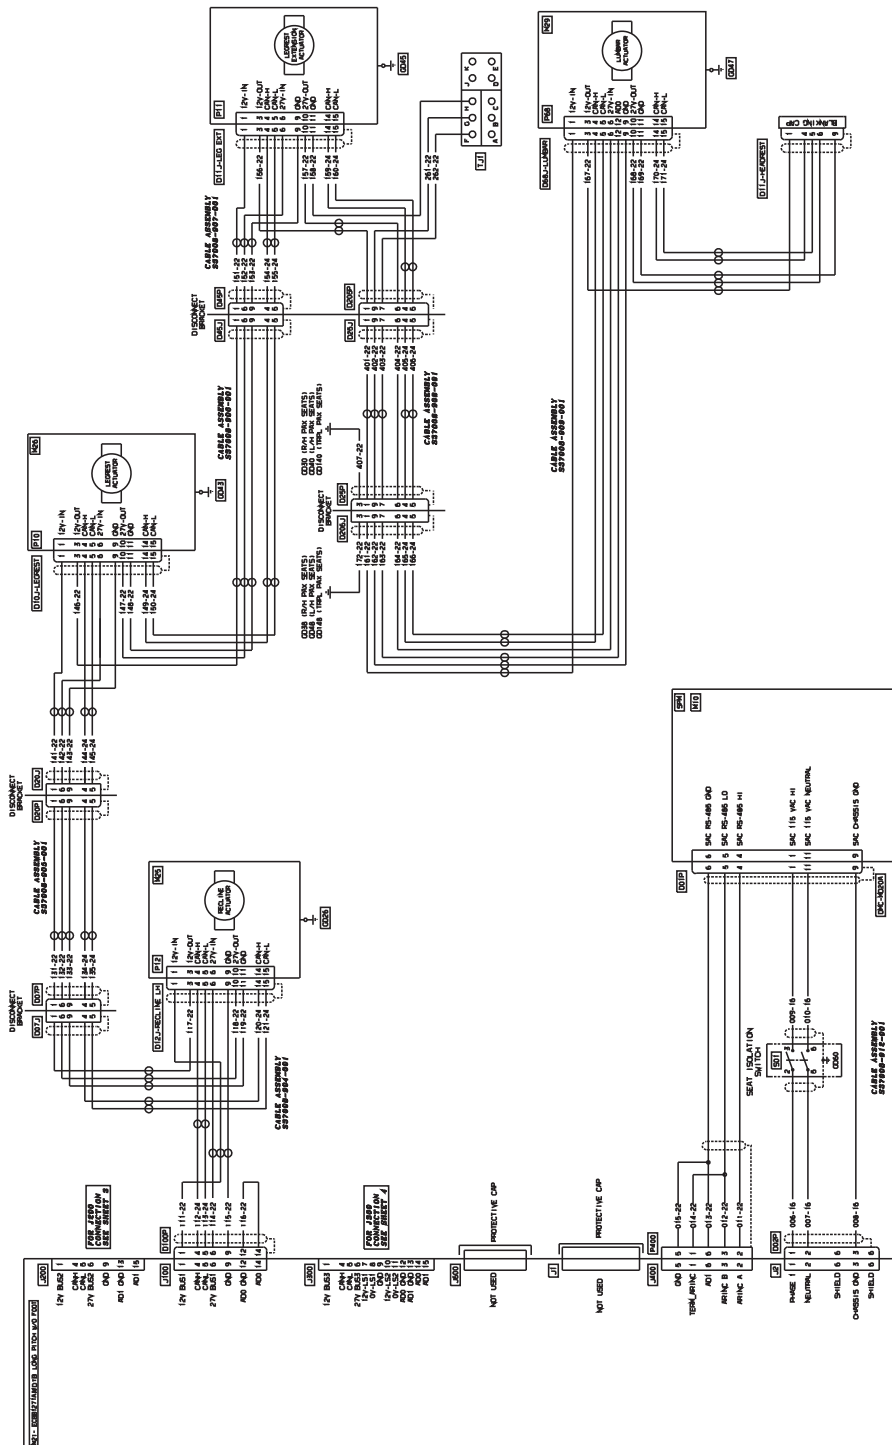
252561-SW-2001-01-02

Power Hook-Up and Pax 1 Actuation System - Precilec wiring diagram

According to CMM 25-25-61, it is requested to perform continuity Wiring check on Harness S37008-908-001 according to wiring diagram Figure 2001/GRAPHIC 25-25-61-99E-002-A01 Page 2002 load in task information.

According to CMM 25-25-61, Perform continuity Wiring check on Harness S37008-908-001 according to wiring diagram Figure 2001/GRAPHIC 25-25-61-99E-002-A01 Page 2002 load in task information.

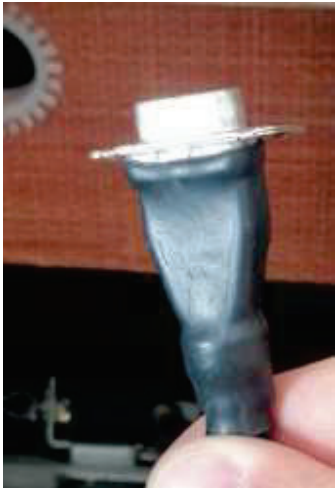
FIGURE 1

1. Instructions must be done in the following sequence:	ACCOMPLISHED BY	INSPECTED BY
GET FREE ACCESS AS REQUIRED TO SEAT 1C – 1L – 2J – 3H – 4A	M	
PERFORM DETAILS VISUAL INSPECTION AND CONFIRM THAT ONLY SECURE LATCH ARE MISSING. (SEE ANNEX). NOTE: IF IT IS FOUND ANY DAMAGE, PLEASE CONTACT ENGINEERING DEPARTMENT FOR FURTHER INSTRUCTIONS.	M	
CONNECT HARNESS CORRECTLY	M	
MAKE A TIE WITH NICKEL BETWEEN THE DISCONNECT BRACKET BASE AND THE TABS OF THE D25P CONNECTOR	M	
PERFORM OPERATIONAL TEST	M	
CONTACT THE MOC FOR CREATING NEW DEFERRED TLI BY 120 DAYS WITH REPETITIVE INSPECTIONS EVERY WEEKLY FOR INTEGRITY OF THE TEMPORAL REPAIR (RE-APPLY IF ITS NECESSARY). THE FINAL ACION IS REPLACE HARNESS P/N S37008-908-001. NOTE: CONSIDER SEATS AS OPERATIVE. NEW BARCODE: _____ MOC #: _____	M
