Results of Storm Water Quality Sampling around Arboretum Creek in December, 2019:

FOAC Technical Memorandum #4¹

-- Dave Galvin 1/8/2020

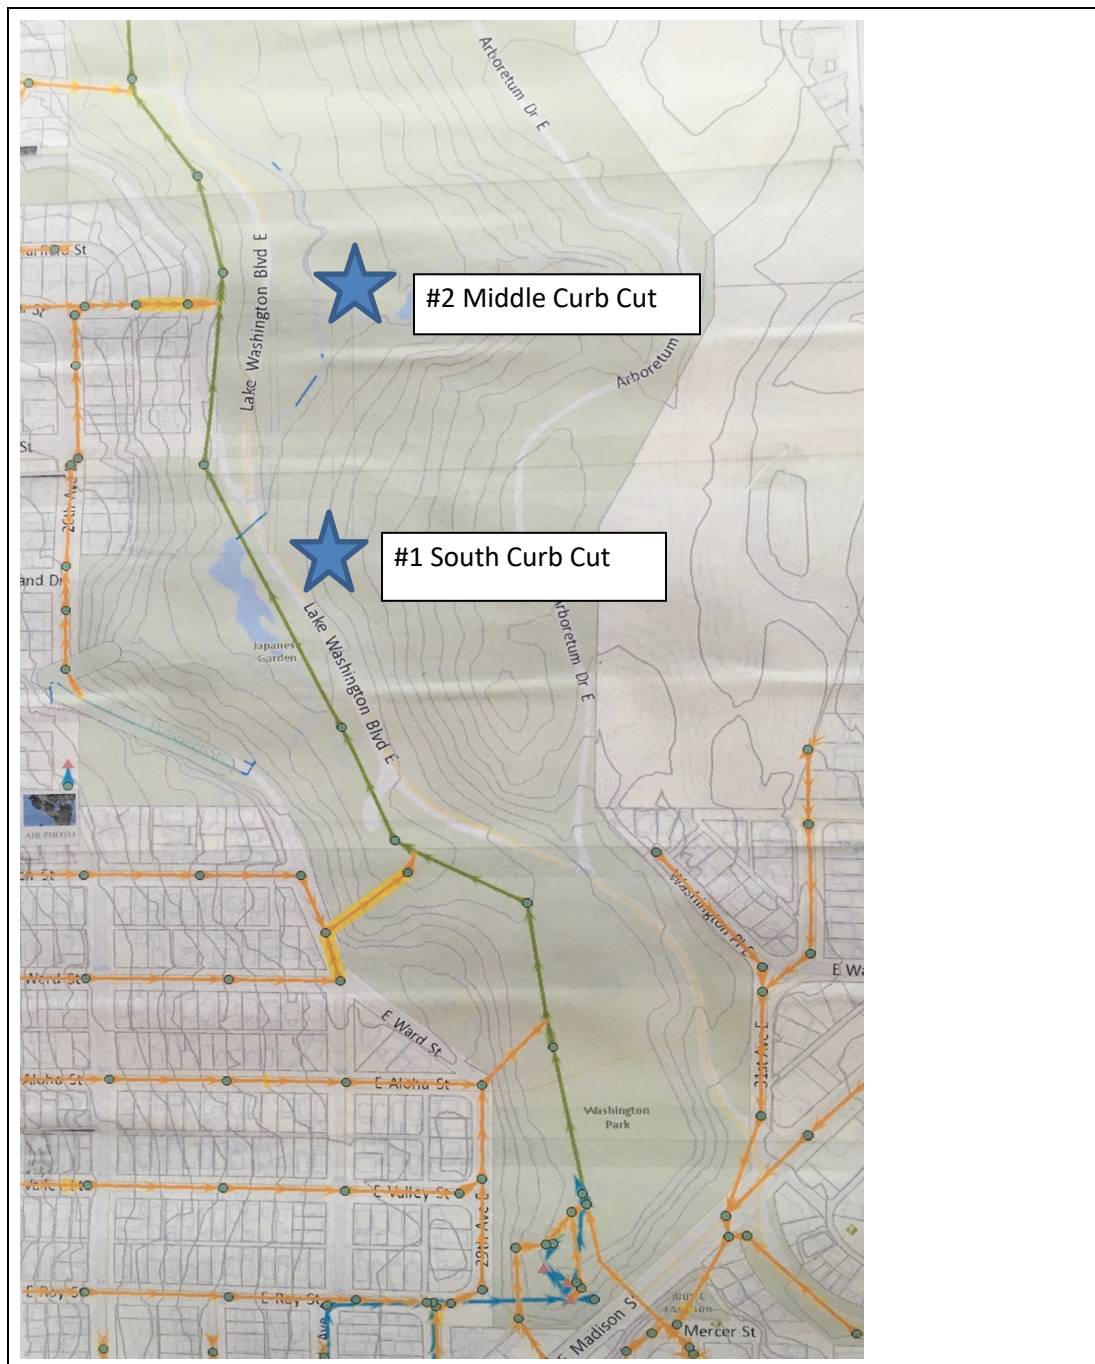
Figure 1. Map locating the two curb-cut sampling sites along Arboretum Creek.

On **December 20, 2019**, the Seattle area experienced 2.69 inches of rainfall for the largest single-day total in ten years and the 15th wettest day ever recorded since records began in 1945. Larry Hubbell seized the moment to collect three water samples. He selected two curb-cut locations immediately adjacent to Lake Washington Blvd. between the Japanese Garden and Boyer Ave. E, where stormwater runoff flows directly off the roadway into Arboretum Creek. He also sampled the main creek to the north, just upstream (south) of the Wilcox Bridge where the stream enters a culvert before discharging into Union Bay to the north. Figures 1 and 2 show the locations of these three samples. It should be noted that the location of his grab sample from the stream near the Wilcox Bridge was downstream from where the Woodland Garden Ponds tributary joins the stream. However, it was upstream from the point where the Lake Washington Blvd. runoff, which originates near the bridge, joins the stream. The small pipe containing the road runoff enters the stream from the east just before the stream disappears into the culvert.

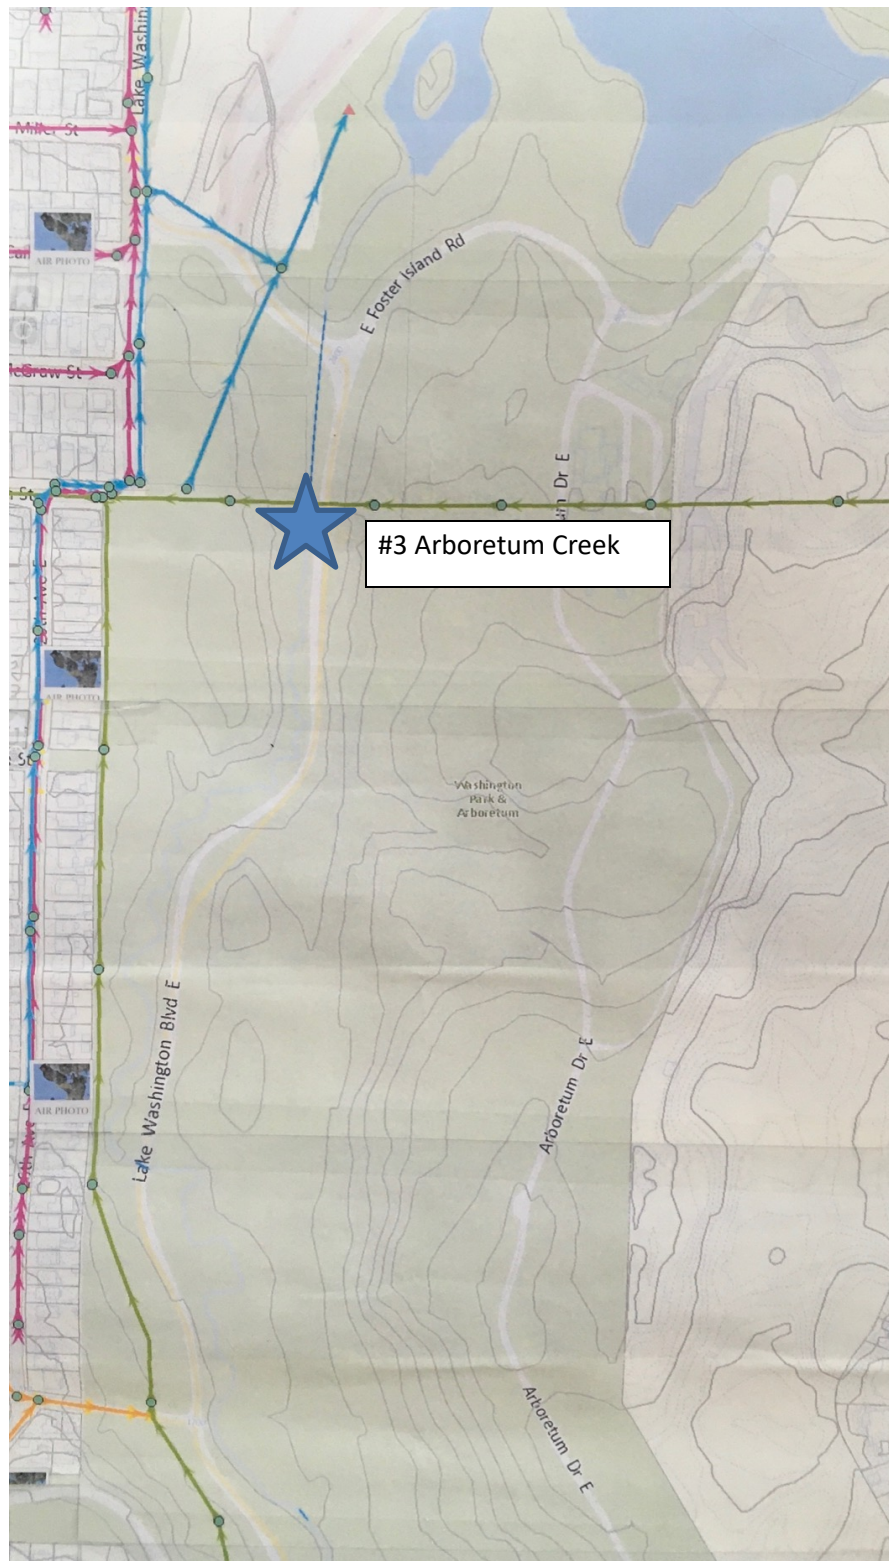
Figure 2. Map locating the third sample in the creek just south of the Wilcox Bridge.

No diesel or lube oil was detected in the downstream sample within the creek. Dilution from drainage within the Arboretum that is not influenced directly by road runoff is the likely explanation. As noted earlier, a significant amount of flow from the blvd. was entering the creek just downstream of where this sample was taken; it is likely that more diesel and lube oil could have been entering the creek due to the high flows from this significant storm.
