ULTRA HIGH PERFORMANCE CONCRETE BRIDGE BEAM TESTING AS MONITORED WITH DIGITAL IMAGE CORRELATION

Arinze Iwunze, Dr. Michael McGinnis

The University of Texas at Tyler

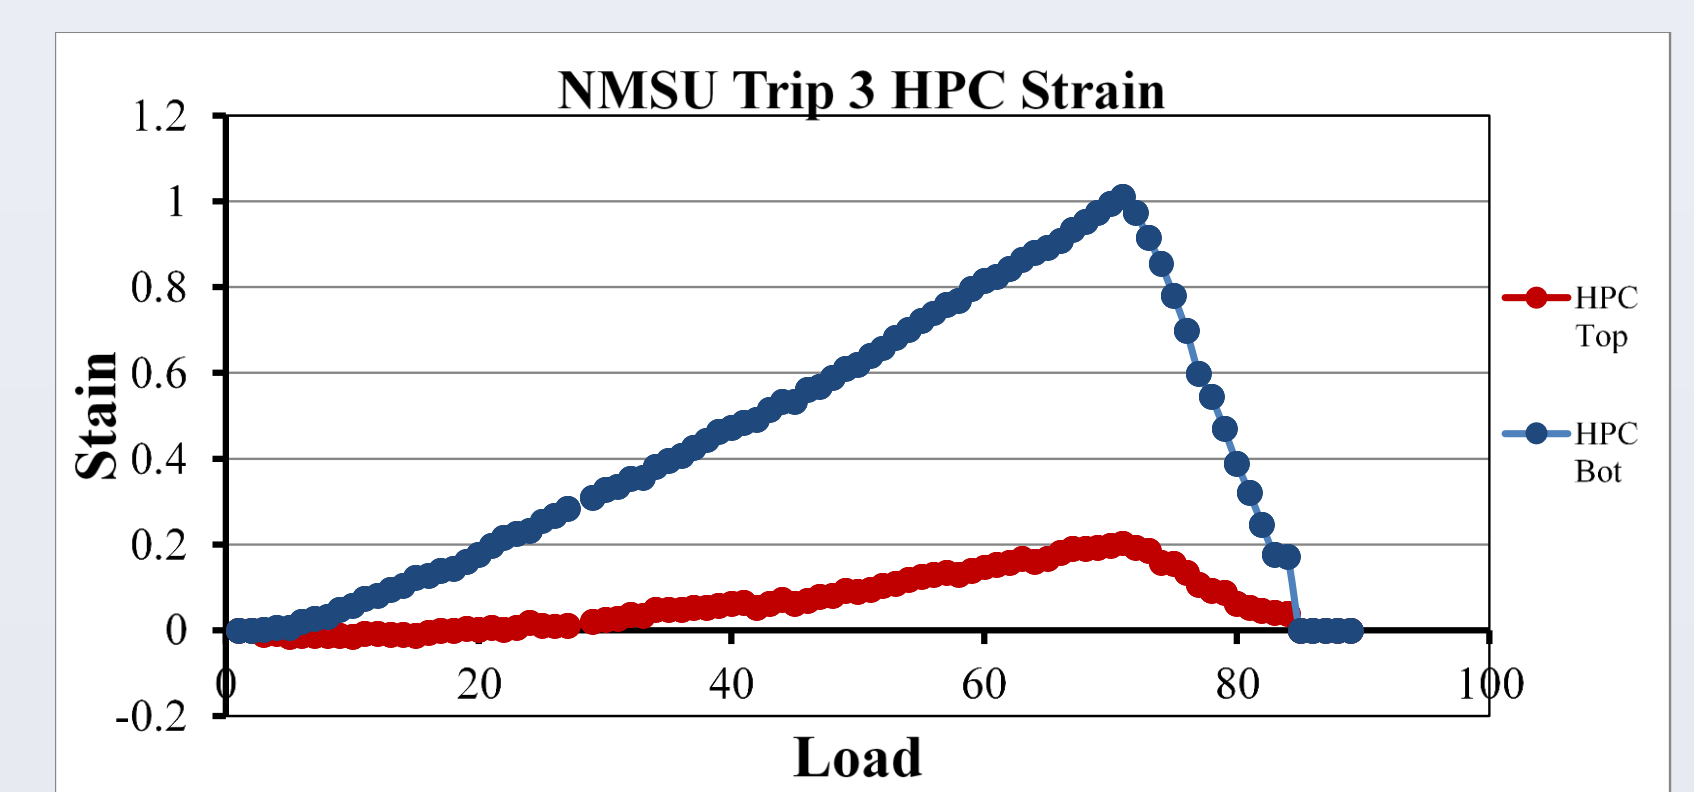
Figure 4 (a)

Figure 4 below shows the graphs of the strain at the bottom and the strain at the top for the UHPC and HPC beams. The first graph, (a), illustrates the strain patterns in the HPC beam. It tells us that the strain at the bottom and the top increases as the load increased until they both reach a peak of 0.99** and 0.2**.

The maximum strain at the bottom and is expected to be greater than the strain at the top because, when load is applied to the center of the beam, the beam is expected to concave curve opposite and perpendicularly to the external force. This causes material near the top of the beam to be placed in compression along the x-direction, with the lower region in tension. So because concrete naturally has high compressive strength with low tensile strength, the strains at the top where compression is occurring is significantly smaller than that of the bottom where tension is occurring.

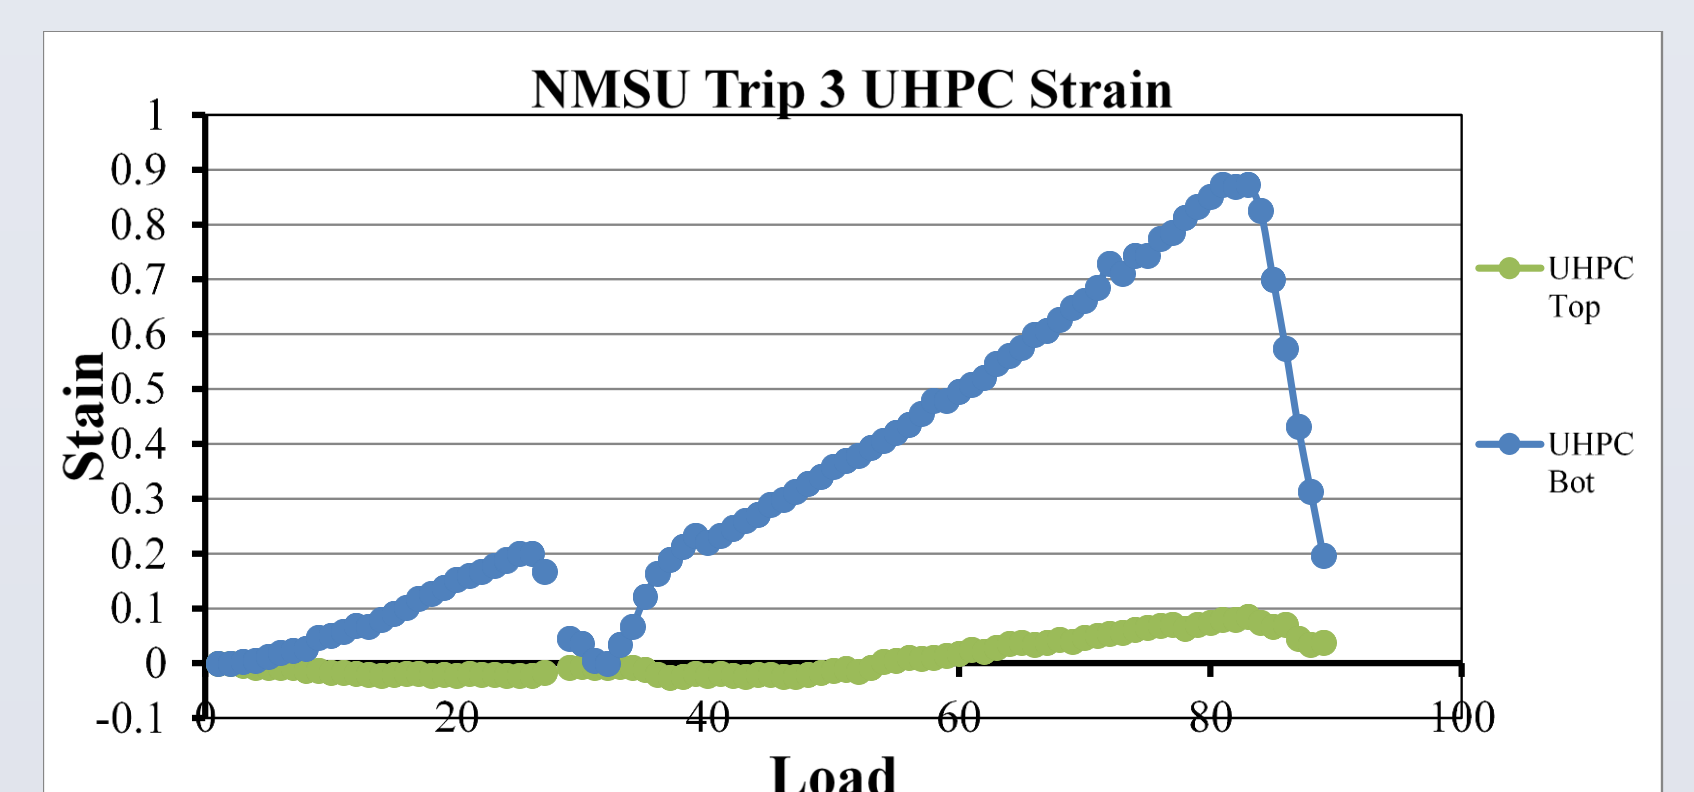
Figure 4(b)

The UHPC beam acted the same way as illustrated in **Figure 4 (b)** below, but in this beam the maximum strained attained was 0.86** at the bottom and 0.08** at the top.

When we compiled the two strain results for the HPC and UHPC beams below in **Figure 3 (c)**, we observed that the HPC beam's strain at the top and bottom was greater than that of the UHPC. This is expected, and it is because the UHPC contains steel fibers which increases its tensile capacity and that makes it more resistant to strain than the HPC beam is.

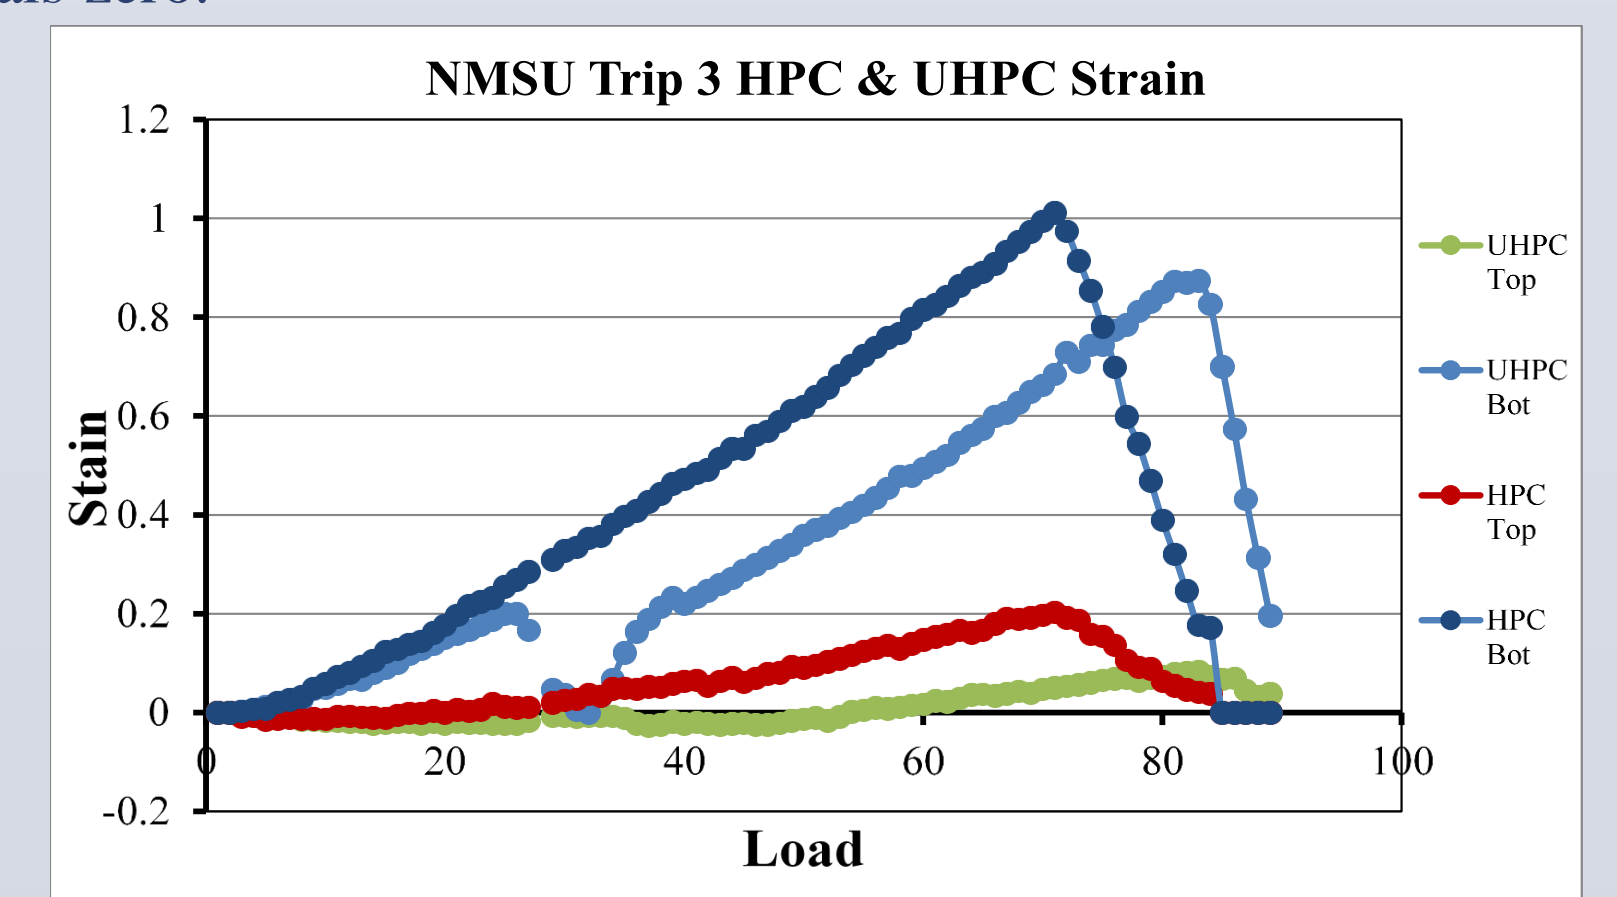
Figure 4 (d)

As the load on the beams increase, and simultaneously, the compressive region reduce while the tensile region increases, the compressive region becomes significantly small in size which causes the beam to fail. For failure to occur, the neutral axis displaces up in the y-direction until it reaches the top of the beam. At this moment, the beam fails. i.e. neutral axis is the point where compression changes to strain in the beam, at this exact point, stress equals zero.
