A Study on Landslide at Malin in Pune

Aswin Anil Kumar,
AM.EN.U4EEE18110

Amrita School of Engineering
September 23, 2020

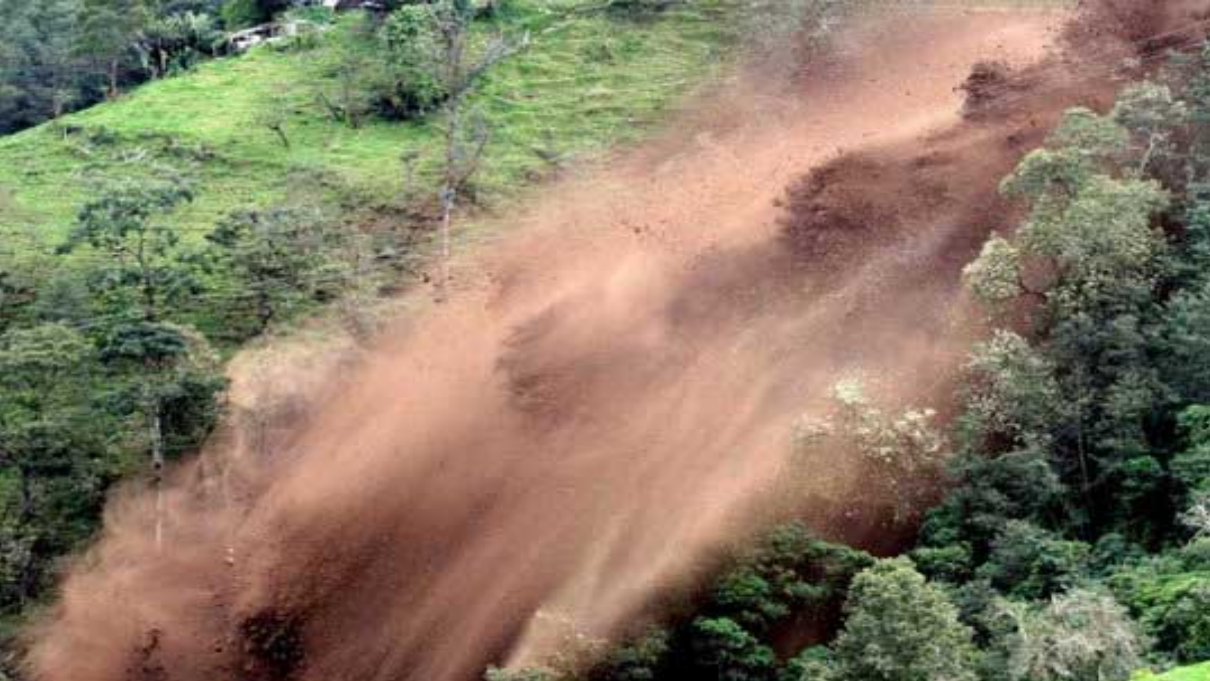
- In July 30, 2014 a major landslide occurred at Malin located at 110 km from Pune city, in the Western Ghats.
- Bundle of mud and debris that came down from a nearby hillock, swallowed up almost the entire tribal village.
- The landslide, which hit early in the morning while residents were asleep, was believed to have been caused by a burst of heavy rainfall, and killed nearly 151 people.
- Due to the remoteness of the village, the tragedy came to light only when the driver of the first state transport bus reached the village a little after 7.30 am to find it uprooted

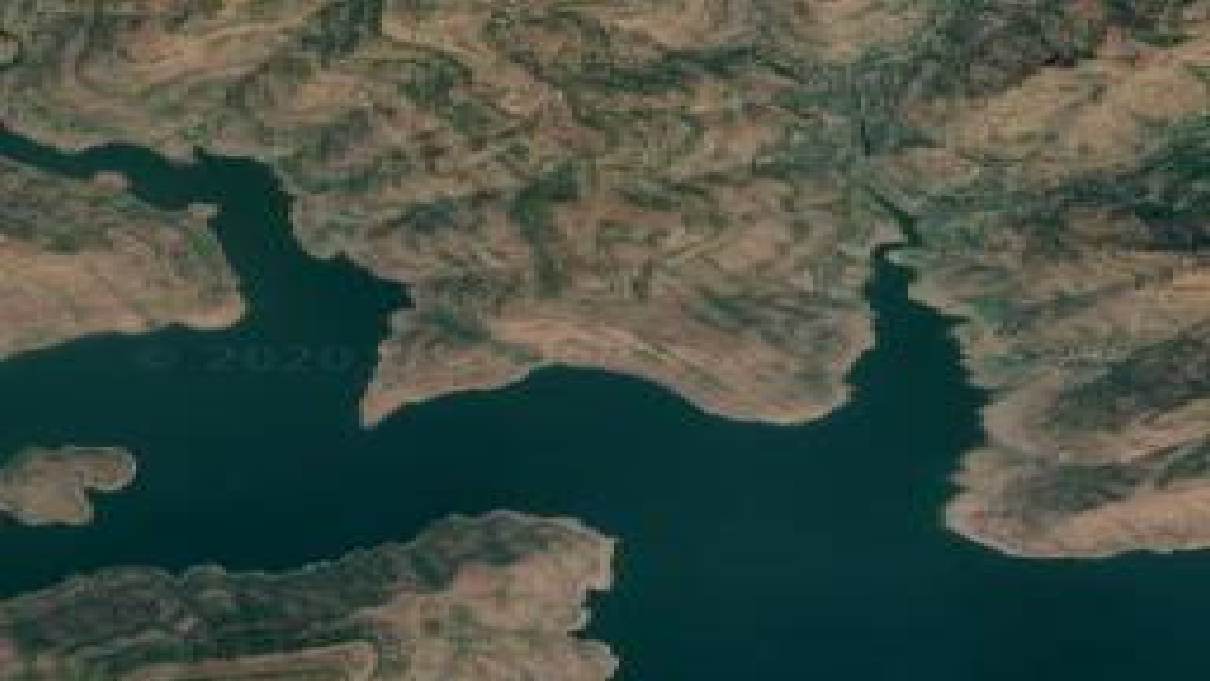
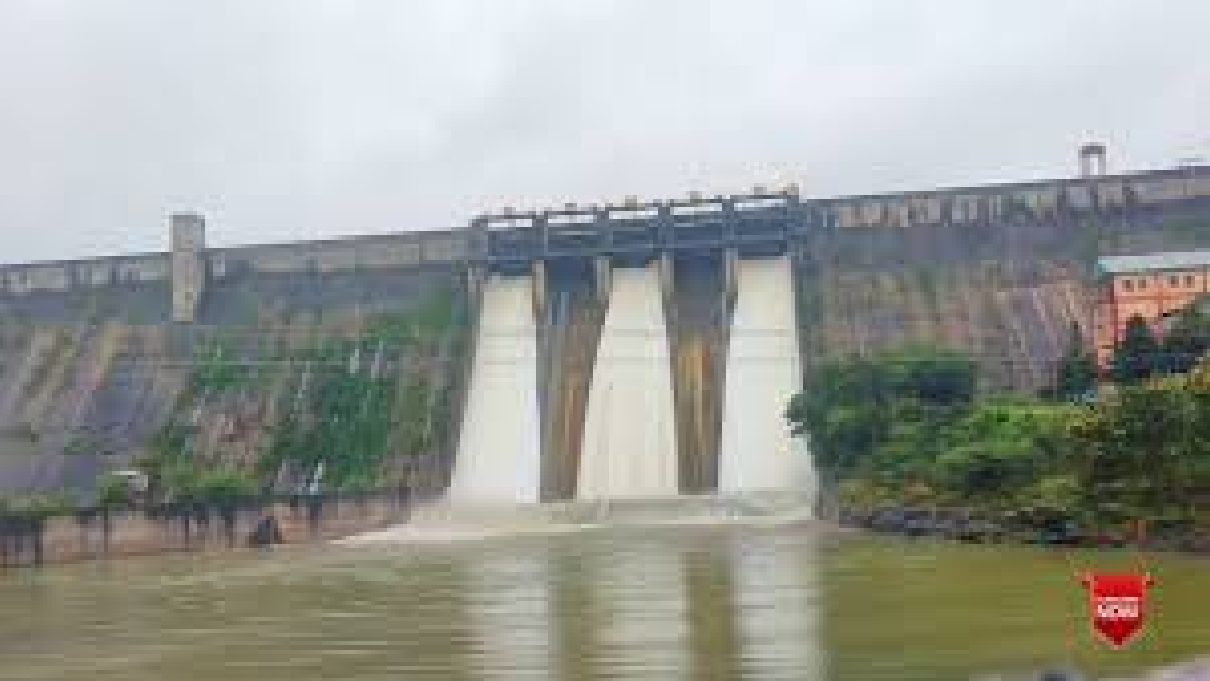
4. Backwater of Dimbhe Dam

Construction of Dimbhe Dam ten years ago may be one of the reasons of landslide. The Malin village falls in a backwater zone of Dimbhe Dam.

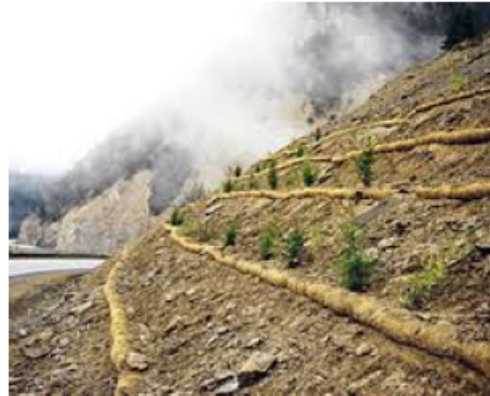
Stabilization using vegetation

Vegetation helps in stabilizing the slopes in numerous ways.
