Diagnostic Study on Clean Technology Implementation in Tiruppur Textile Cluster

@ M/s Sky Apparels

Location <http://www.google.com/maps/place/11.040783833617612,77.3131432087771>
25/11/2023

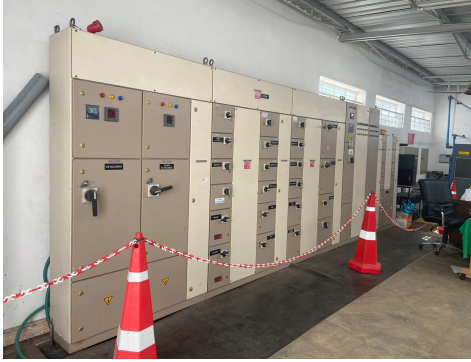
There are no energy measuring and monitoring systems; it is suggested to install energy meters for major electrical loads such as compressors, air conditioners, office blocks, and ironing tables.

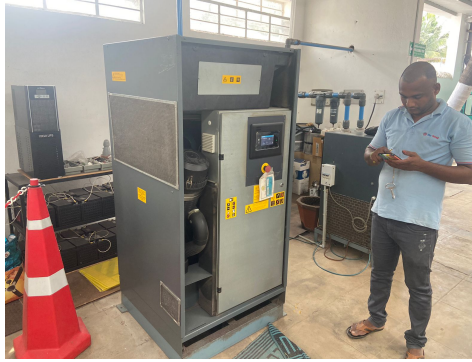
Compressor is Screw compressor of 22kw, 150 CFM capacity. The present pressure setting is 7.0–7.5 bar; this can be reduced to the tune of 0.5–1 bar. Leakage was assessed as 35–40%. Compressed air systems optimization alone will results to energy savings of 12,372 Units per annum. which is 5% of the annual power consumption.

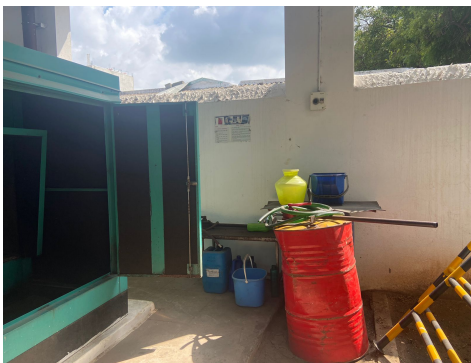
Genset power generation needs to be recorded. Presently the hour and diesel consumption are measured and monitored. The unit generation needs to be logged. (UPL)

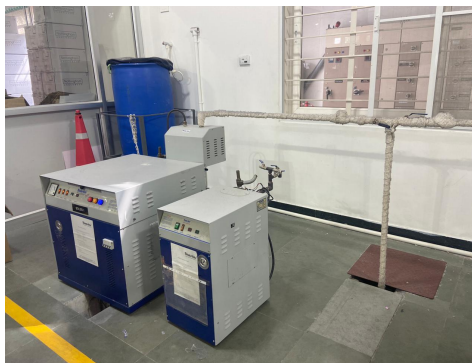
The facility has electrical boiler of 27 kW for ironing purposes. Fresh water with temperature of 30 Deg C is being supplied to boiler to generate steam. The condensate return is being discharged to the open drain. suggested to adopt waste heat recovery and pre-heat the water.

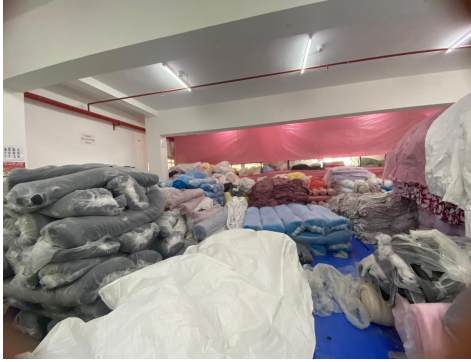
It is suggested to adopt rack systems and bin cards to store the material properly, with the objective of using the floor space effectively.

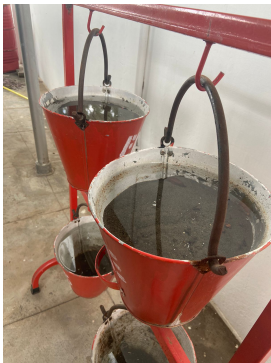
Power house Sand bucket is filled with water. Need to be covered properly and periodical refilling of sand is suggested.

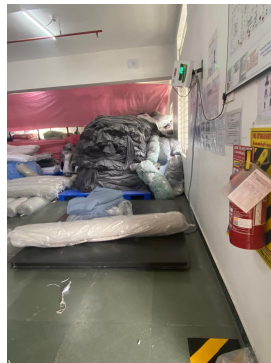
Weighing scale needed to get installed with wood slope to avoid accidents.
