Explosive COVID-19 outbreak in a German nursing home and the possible role of the air ventilation system

In this report we describe an explosive outbreak of COVID-19 in a nursing home and the possible relevance of the air ventilation system for transmission.

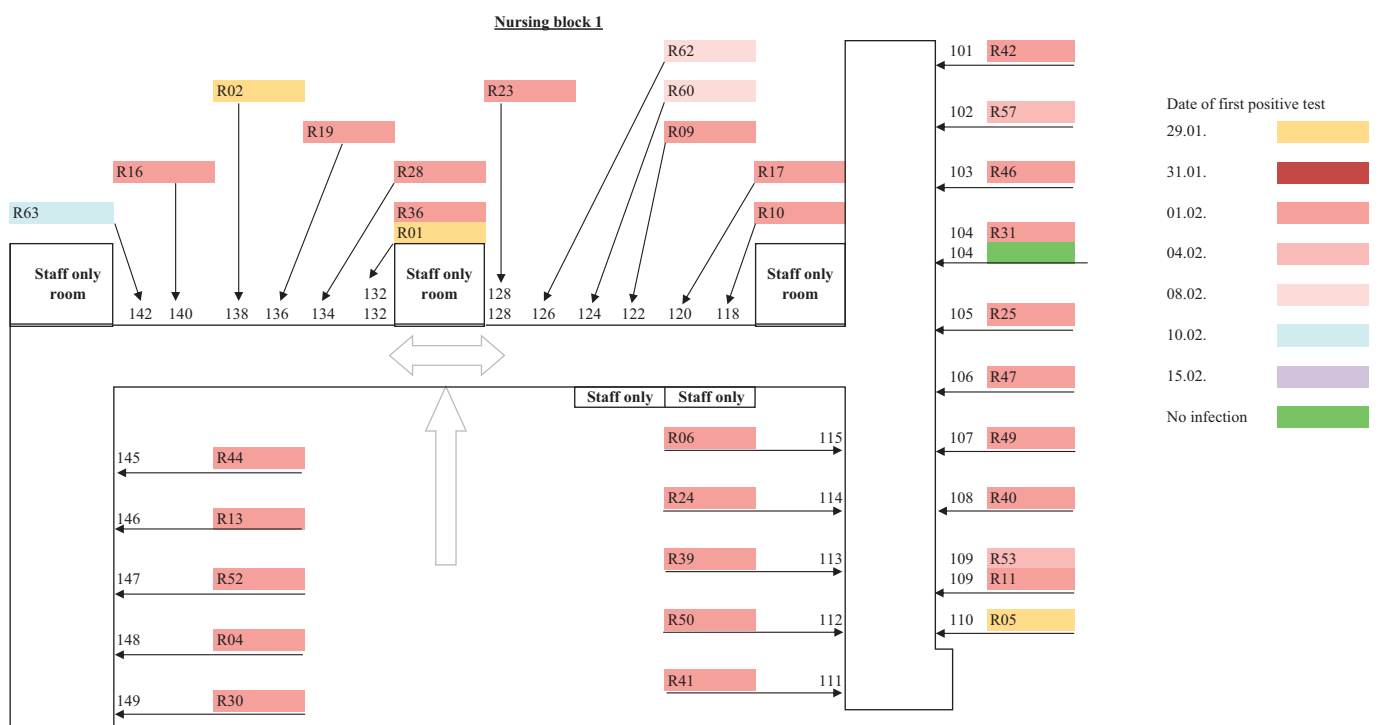
Figure 1. Floor plan of nursing block 1 with rooms 101–149; dates of COVID-19 detection are provided for each resident. R, resident.

areas (nursing block 1 with 35 residents and nursing block 2 with 32 residents) including separate nursing teams for each residential area. The floor plans for the nursing blocks are shown in Figures 1 and 2.

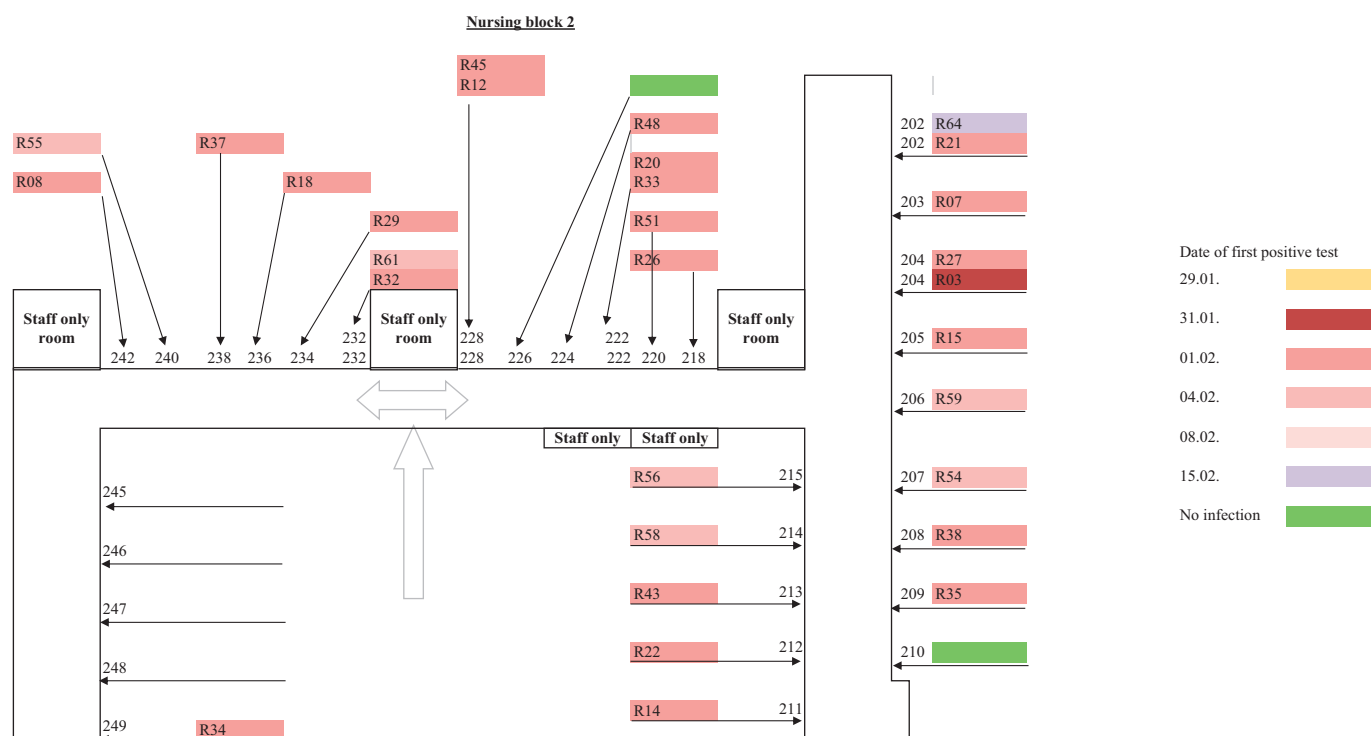
Figure 2. Floor plan of nursing block 2 with rooms 202–249; dates of COVID-19 detection are provided for each resident. R, resident.

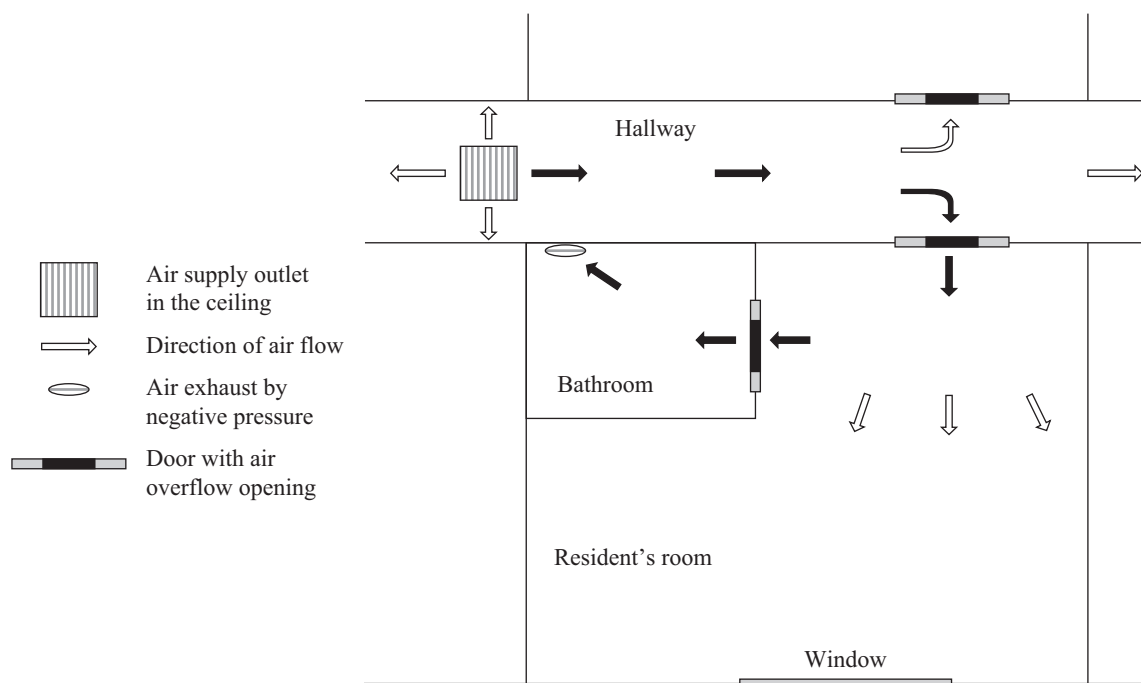
The fresh air is introduced exclusively into the corridors of the building via supply air openings (Figure 3). From the corridors, the air then flows into the residents' rooms, therapy rooms, group rooms and dining rooms. The fresh air introduced from the supply air openings overflows from the corridors into these rooms. The incoming air is extracted from the residents'

Figure 3. Schematic drawing of the air flow in the residential home; black arrows indicate the shortest possible air circulation from the air supply outlet in the ceiling of the corridor to the air exhaust in the bathroom of the resident's room (negative pressure); white arrows indicate additional directions of air flow.

rooms via the sanitary wet rooms (room for toilet, washbasin and showers). The air flow tests indicated that the air from the outlets in the hallway, as indicated in the plans, overflows into the functional rooms and the residents' rooms.

Each resident's room had an air exhaust in the bathroom working with negative air pressure. Fresh air was only supplied from the air outlets in the corridors. The air from the corridor could enter the resident's room via an air overflow opening in the door (Figure 3).

The following risk points were identified after the inspection and characterization of the indoor air supply system: (1) the close spatial relationship between central exhaust air and central supply air, whereby a short circuit between exhaust and supply air can occur in unfavourable weather conditions; (2) the intended overflow of air from the corridors into the rooms and functional spaces, whereby air possibly contaminated with micro-organisms by people in the corridors can reach all other rooms.

air. A fourth factor is air supply to the residents' rooms which came exclusively via the corridors. The exhaust air was removed via the sanitary rooms of the residents' rooms into a central exhaust air duct opening next to the roof tower resulting in an insufficient distance between exhaust air and supply air. Finally, a similar outbreak has been described previously in a residential home with SARS-CoV-1 suggesting that aerosol spread of coronavirus is possible from a common source [18].

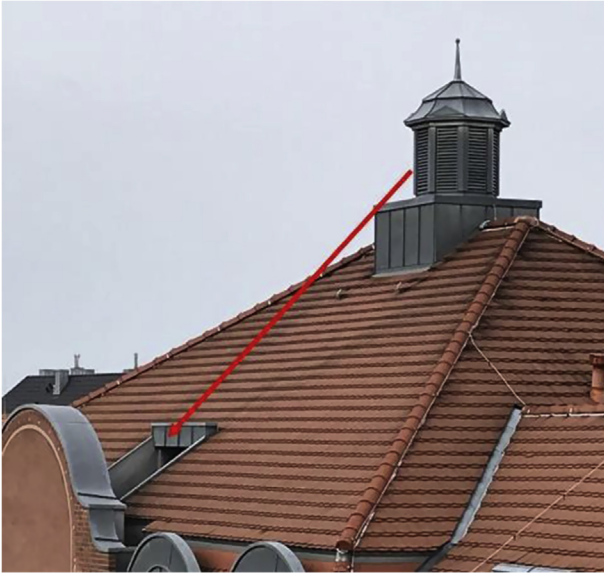
Figure 4. Exhaust air opening in the tower at the highest point of the roof building of the nursing home as well as the location of the supply air opening (red arrow).

In the dining rooms, the exhaust air is not directed, but exits only through the window opening. The exhaust air for the entire building is discharged centrally via the roof. All of the exhaust air or outgoing air is discharged through a small tower at the highest point on the roof of the building. The supply air is fed into the building through a supply air opening integrated into the gable. This supply air opening is located at a distance of approx. 5–6 m from the central exhaust air opening (Figure 4).

In unfavourable weather conditions, it cannot be ruled out that short-circuit flows occur between the exhaust air opening and the supply air opening. Unfavourable weather conditions can be, for example, inversion weather conditions which, in the case of the building under consideration, can lead to the exhaust air not being discharged upwards but being sucked directly back into the supply air opening. Another possibility of a short circuit between the exhaust air and supply air on the roof would be a north-north-east wind situation before the outbreak as described for 25th January 2021. With this wind direction, the air from the exhaust air opening could move directly towards the air supply opening, whereby turbulence in the leeward area could result in exhaust air components getting back into the supply air.

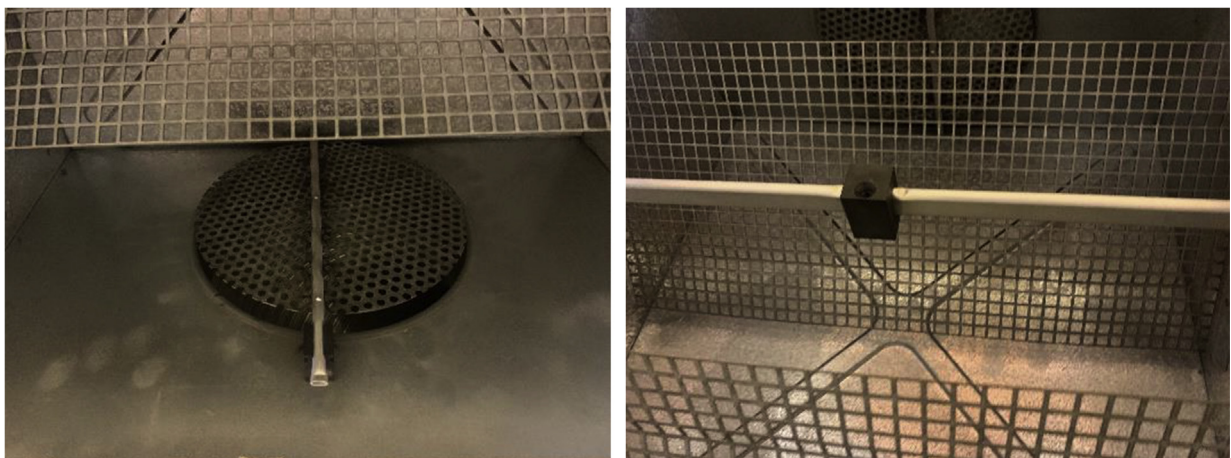
After carrying out the site inspection and characterization of the air conditioning system, a hygienic-microbiological inspection of the supply air and exhaust air openings of the room air conditioning system was carried out on 29th April and 6th May 2021. For this purpose, collective samples were taken from the surfaces. The sterile swabs were moistened with virus transport medium (BD Universal Viral Transport, Becton Dickinson, Sparks, USA) and selected surfaces of the ventilation installations were swabbed. At the supply air openings, the backs of the air outlet and the grids between the air ducts and the air outlet were sampled (Figure 5). In addition, the

Figure 5. Grids between the air ducts and the air outlets.

On the 29th April 2021 and 6th May 2021, a total of 39 environmental samples were taken from the air ventilation system of the nursing home. SARS-CoV-2 sequences were detected by PCR at several locations in the supply air outlets in the ceiling of the corridor at both testing times. During the first series with 23 samples, eight of them were positive, and six were positive during the second series of 16 samples. Most of the positive samples were from the air duct side components behind the grids of the supply air outlets. On one occasion, SARS-CoV-2 RNA was detected at the overflow opening from the hallway to the resident's room. No SARS-CoV-2 RNA was detected at the resident's room air exhaust vents in the bathrooms. The median Ct values were 40.2 (29th April 2021) and 37.5 (6th May 2021) (Table I).

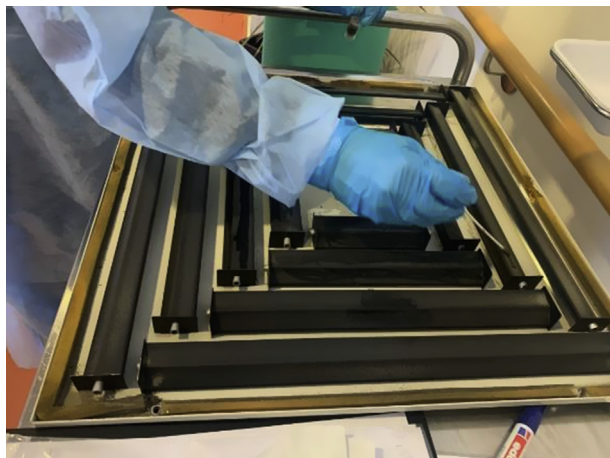
Figure 6. Sampling of the back of the air outlet.

overflow openings between the hallway and the residents' rooms and the exhaust openings in the wet rooms of the residents' rooms were examined (Figure 6). Samples were taken on both floors and on both wings.

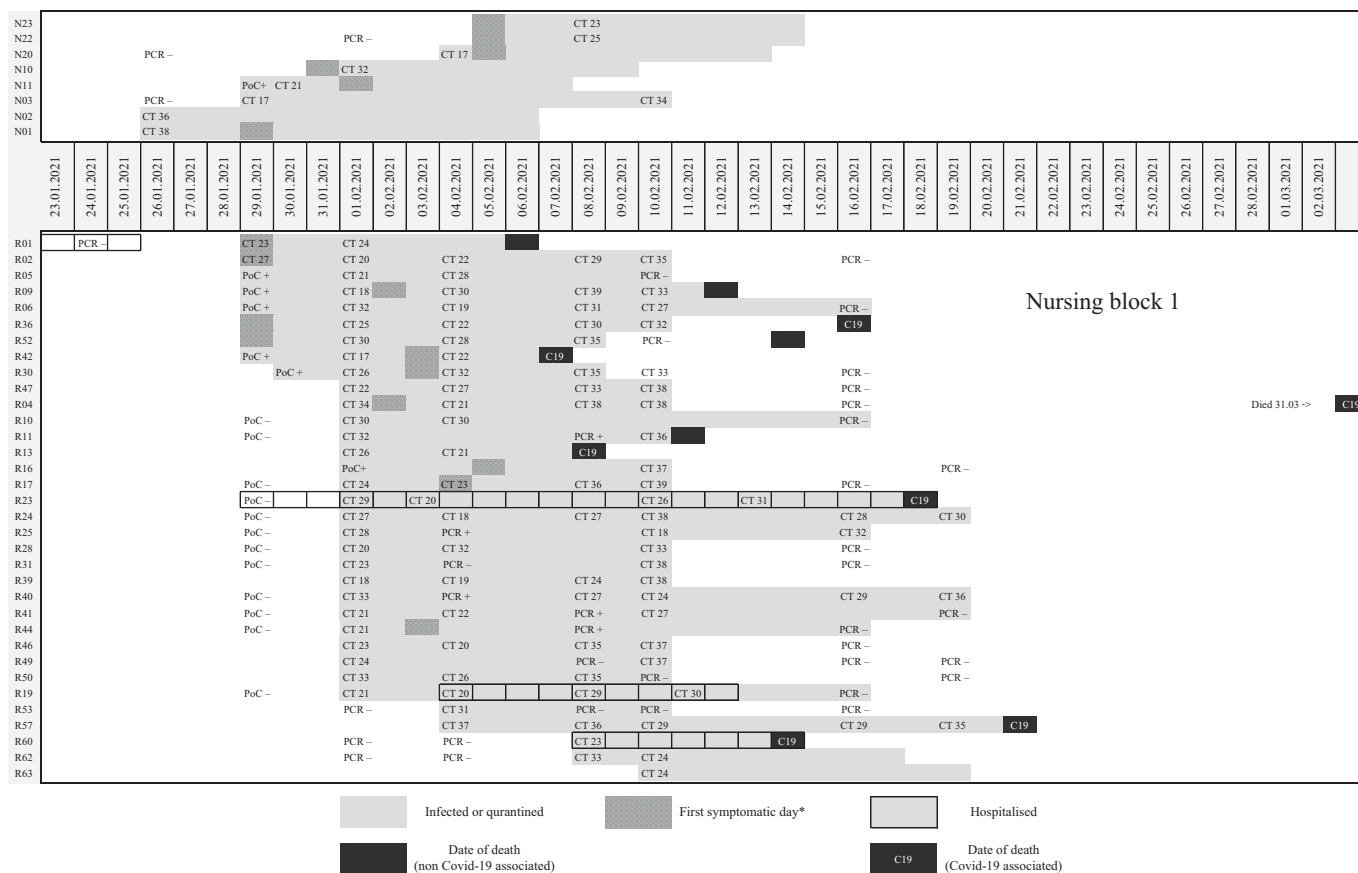
Figure 7. Description of the COVID-19 outbreak among nursing home residents and staff in nursing block 1. CT, PCR cycle threshold; N, staff; PCR –, negative COVID-19 PCR; PoC +, rapid antigen test positive; PoC –, rapid antigen test negative; R, resident.

The nursing home had 67 residents during the outbreak. The first two confirmed cases were nurses from nursing block 1 who were identified on 26th January 2021 (Ct values: 36 and 38). They were initially asymptomatic and therefore continued to work until the positive test results were available on 28th January 2021 (Figure 7). On the same day, another nurse who only worked in an onsite COVID-19 test centre developed symptoms of a respiratory tract infection; she tested positive on 29th January 2021 (Figure 9). On 29th January 2021, four residents and one more member of staff demonstrated symptoms (Figure 9). This staff member had a positive rapid antigen test that was refuted by a negative PCR test the next day. Two of the residents tested positive on the same day by PCR, and additional six residents had positive rapid antigen tests. On 1st February 2021 a total of 38 new cases were found among residents (20 in nursing block 1; 18 in nursing block 2) and seven among members of staff with two of them confirmed by PCR one day later (Figures 7–9).

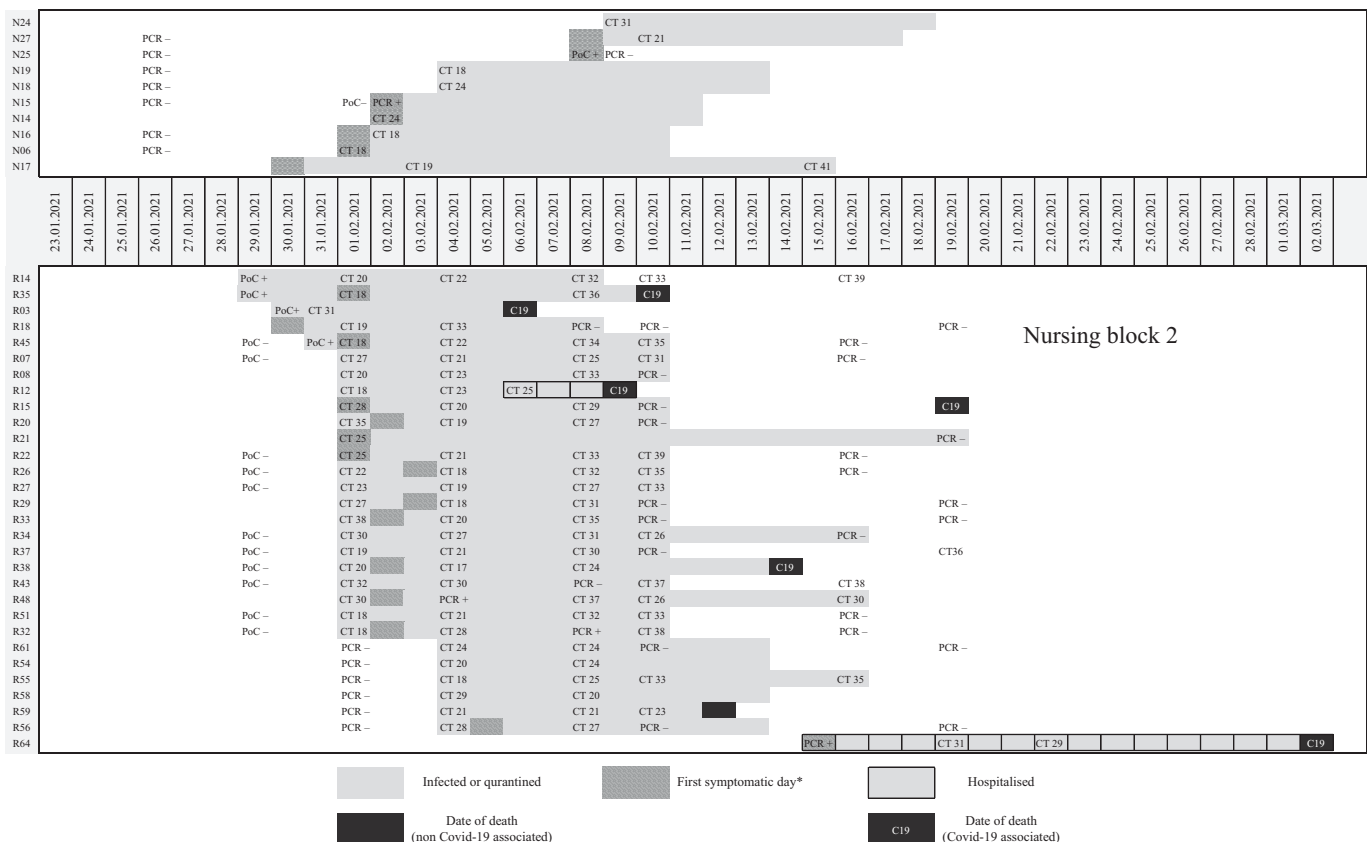
*The first symptomatic day was not recorded for all residents

Figure 8. Description of the COVID-19 outbreak among nursing home residents and staff in nursing block 2. CT, PCR cycle threshold; N, staff; PCR –, negative COVID-19 PCR; PoC +, rapid antigen test positive; PoC –, rapid antigen test negative; R, resident.

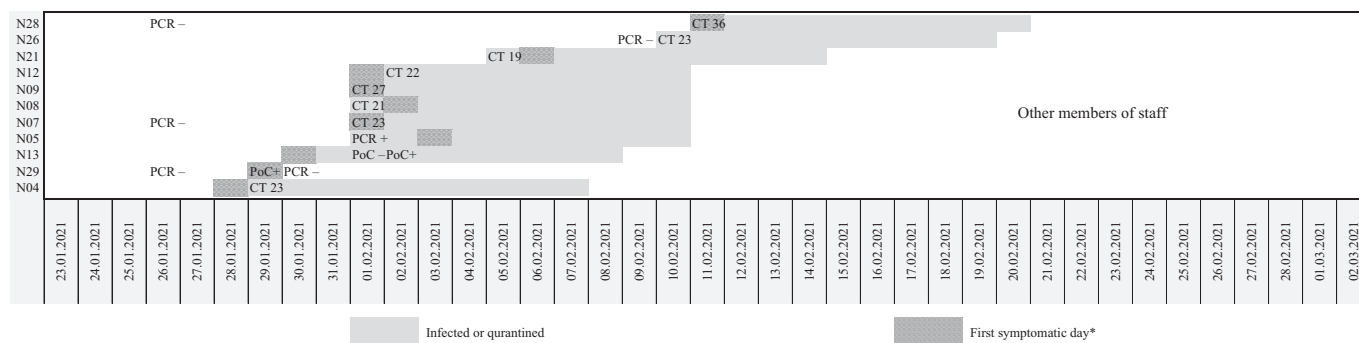
Figure 9. Description of the COVID-19 outbreak among other members of staff; N04, N09 and N21 never entered the nursing blocks 1 or 2; N29, N07, N26 and N28 occasionally entered the corridor of nursing blocks 1 or 2 but never the residents' rooms; N13, N08 and N12 worked in one of the nursing blocks but it was not possible to find out further detail about which of the two; N05 occasionally entered the resident's room but only in the absence of the resident. CT, PCR cycle threshold; N, staff; PCR –, negative COVID-19 PCR; PoC +, rapid antigen test positive; PoC –, rapid antigen test negative.

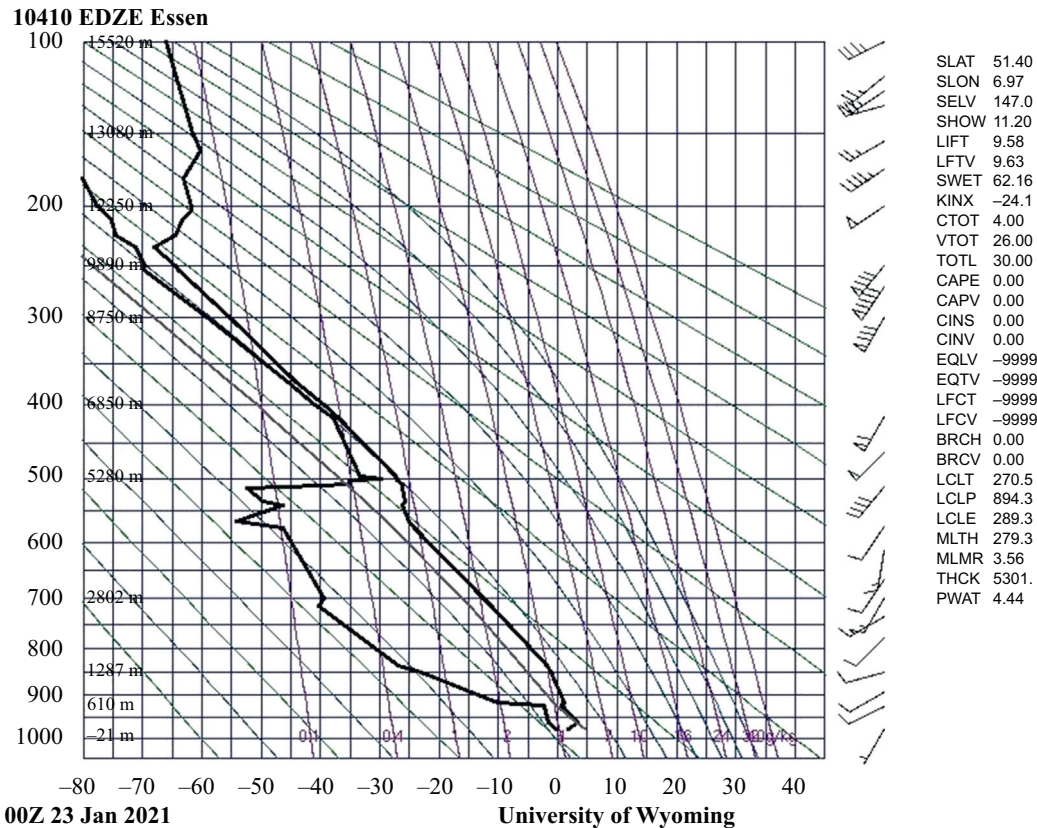
Figure 10. Description of the sounding indices for Essen, Germany, for 23rd January 2021; data obtained from the University of Wyoming, USA (<https://www.uwyo.edu/atsc/>).

Based on the sounding (Stüve diagrams) of the Essen meteorological station, a slight inversion can be recognized retrospectively for 23rd January 2021 from 5000 m altitude (Figure 10). It can be assumed that this stratification was similar in the Cologne area, because such weather conditions generally occur over a larger area [12]. The ground analysis also showed an intermediate high-pressure area for this day, which is consistent with the subsidence inversion evident in the sounding.

On the other days of the period around the outbreak, the stratification was unstable. The pronounced low-pressure area that was located over the North Atlantic before the formation of the intermediate high-pressure area, as well as the occluded front, which formed over Germany afterwards, indicate the strong vertical mixing of the air layers on the days before and after 23rd January 2021.
