Earth Fissure Map of the Picacho and Friendly Corners Study Areas: Pinal County, Arizona

December 2012
Arizona Geological Survey

Digital Map Series - Earth Fissure Map 3 (DM-EF-3)
version 2.0

Sheet 3 of 3

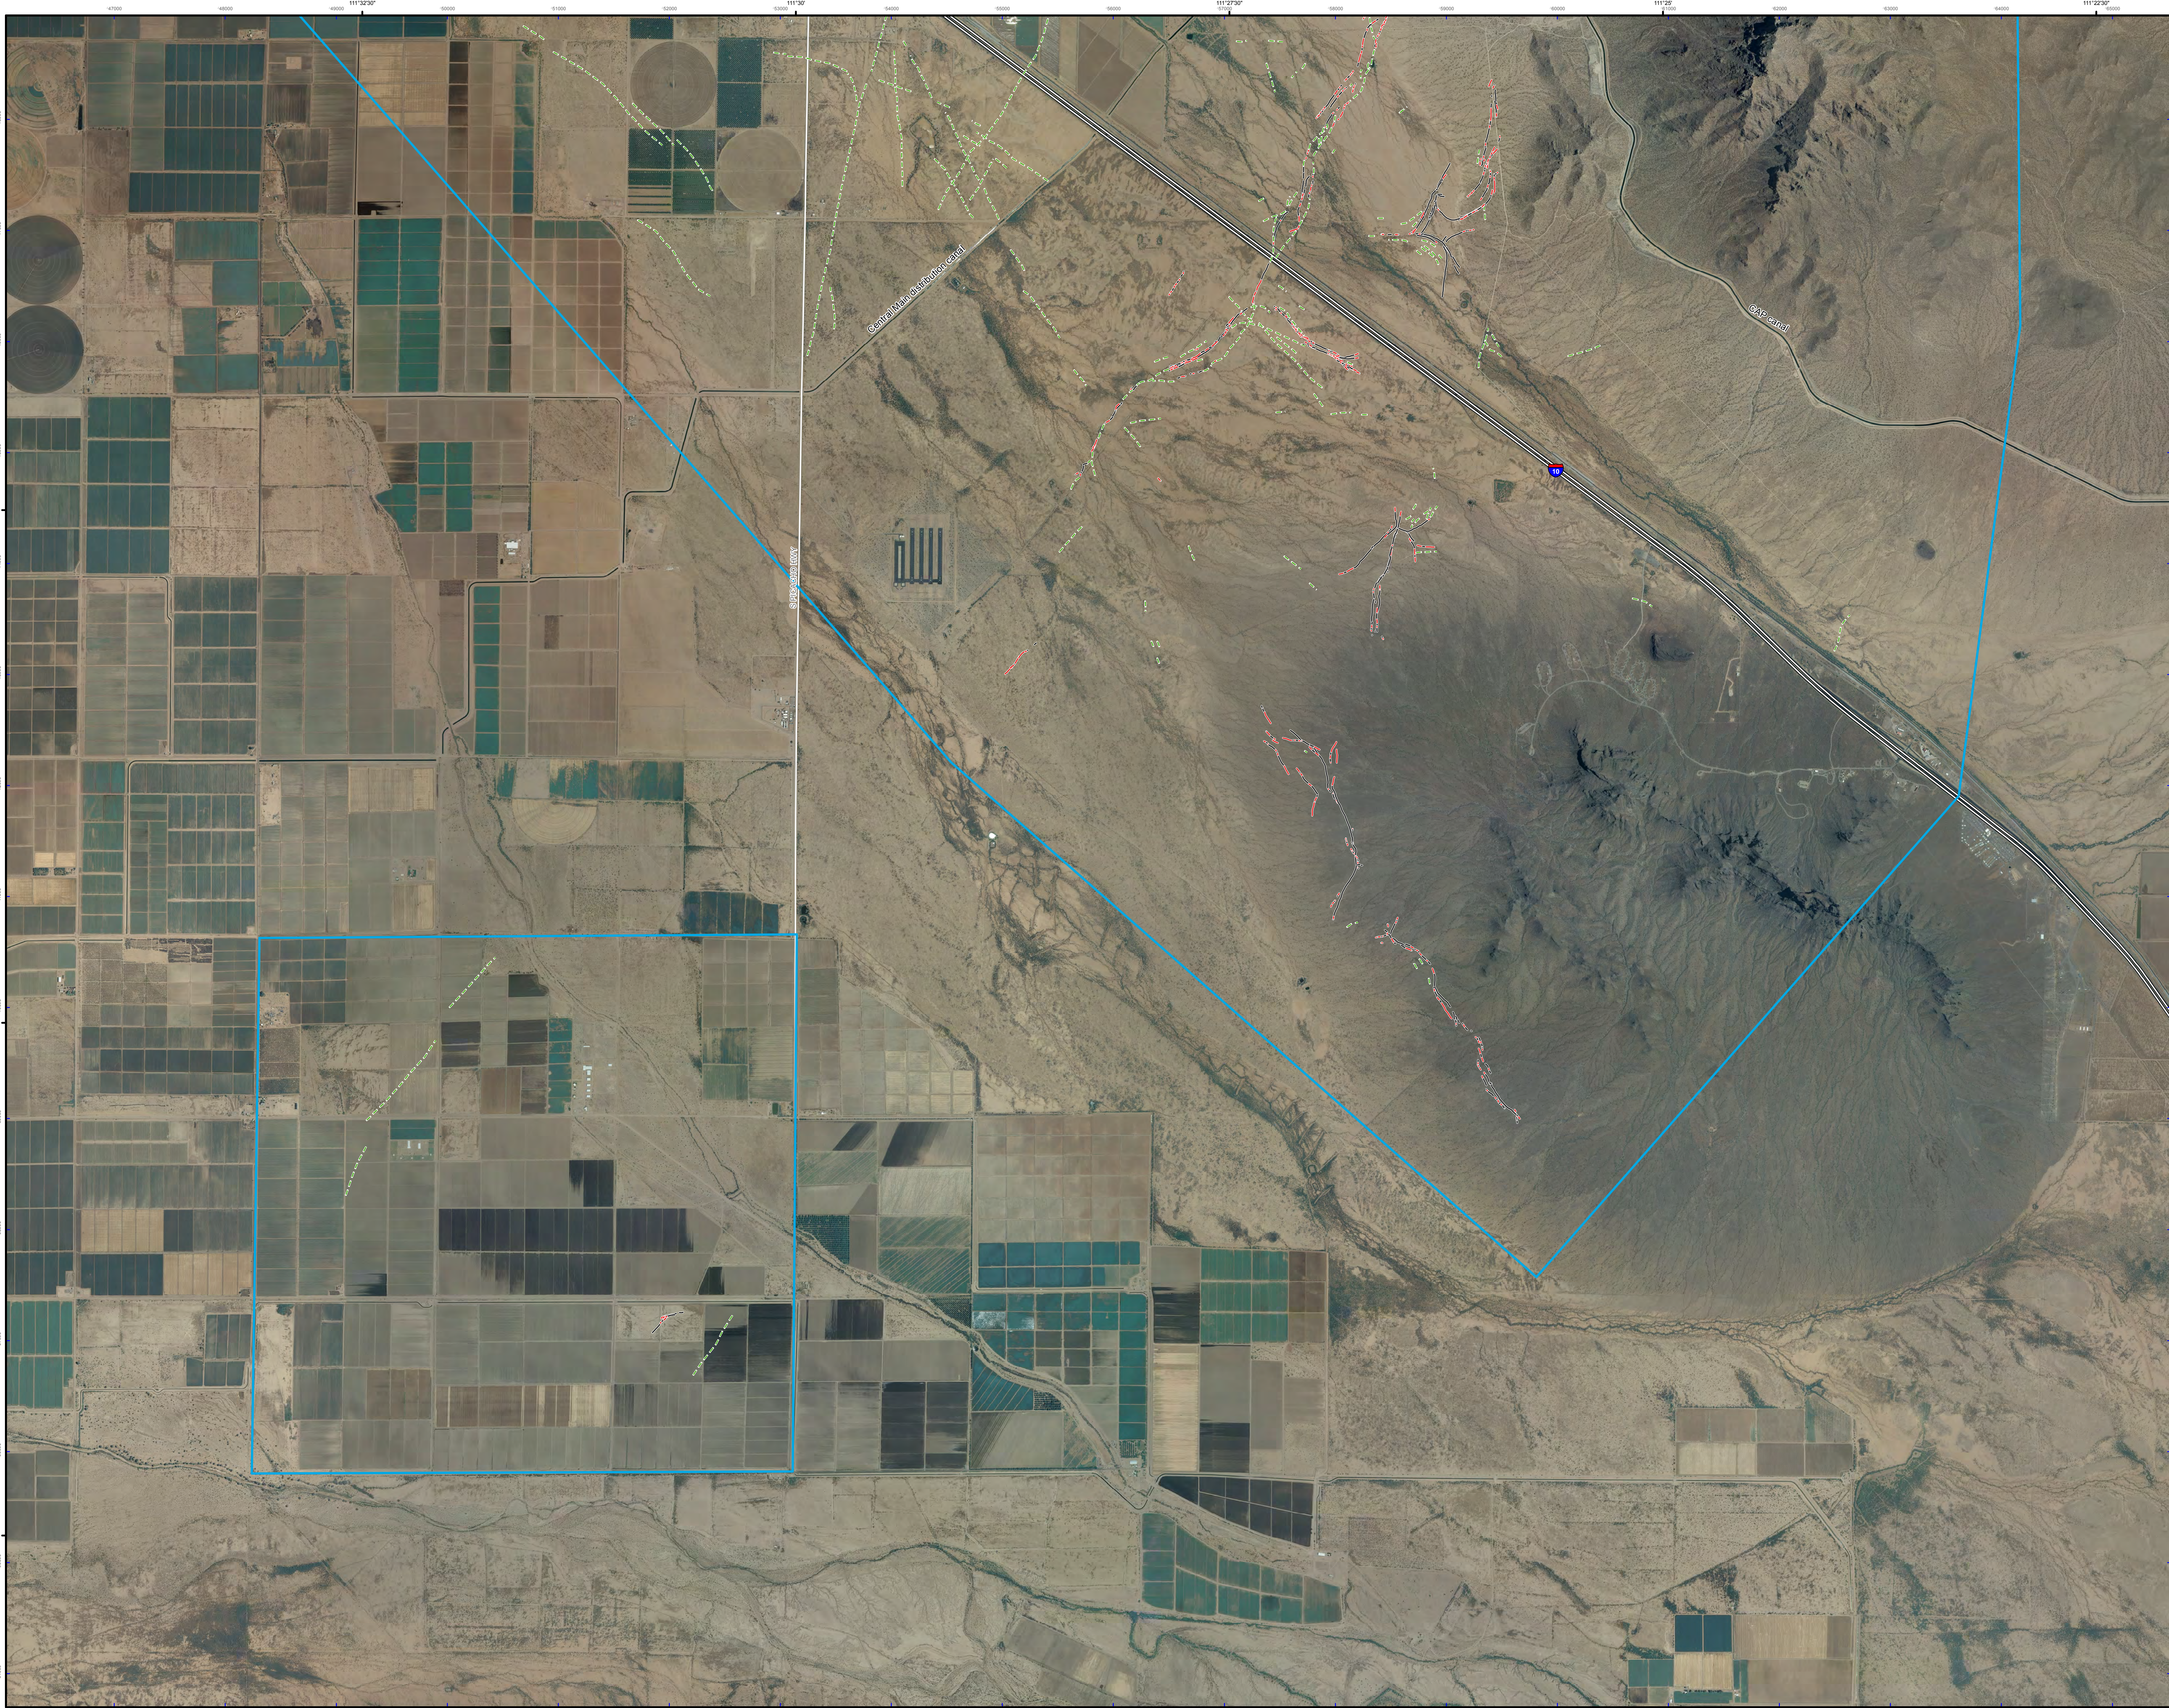
MAP EXPLANATION

- Solid black lines represent the location of continuous earth fissures manifested as open cracks or gullies.
- Solid red lines represent the location of discontinuous earth fissures manifested as elongated to circular depressions or as abbreviated or irregular linear depressions. These discontinuous surface features frequently represent an incipient surface expression of an earth fissure.

- Dashed green lines represent the approximate locations of unconfirmed earth fissures, defined as fissures which could not be confirmed by surface investigations by AZGS geologists, but which have been previously reported by Professional Geologists in published documents or maps.

- The outline of the Study Area is shown in blue. Historical and modern aerial photos taken within this area were searched for anomalous lineaments. These lineaments were then investigated in the field to determine if there was any evidence of earth fissures.
