**GENESIS COUPE(BK) >2010 > G 2.0 DOHC > Body (Interior and Exterior) > General Information > Specifications**

**Special Service Tools**

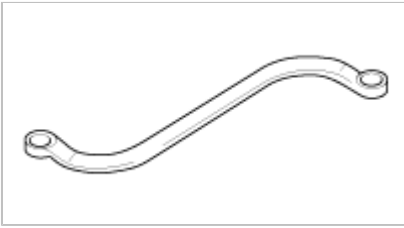
Tool (Number and name)	Illustration	Use
09793-21000 Door hinge adjusting wrench

Adjustment, removal and installation of the door hinge
09800-21000 Ornament remover

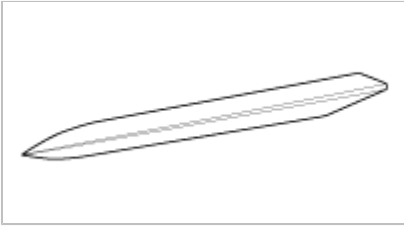
Trim removal
09853-31000 Headliner clip remover

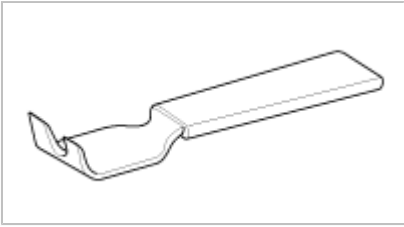
Headliner clip removal
09861-31100 Sealant cut-out tool

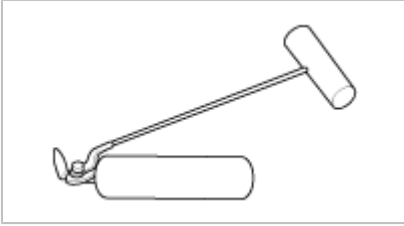
Cutting windshield sealant (use with 09861-31200)
09861-31200 Sealant cutting blade

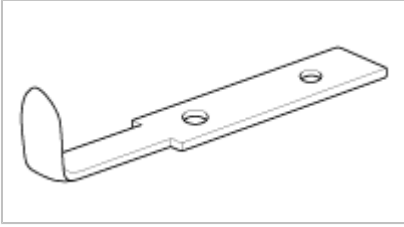
Cutting windshield sealant (use with 09861-31100)
09861-31000 Windshield molding remover

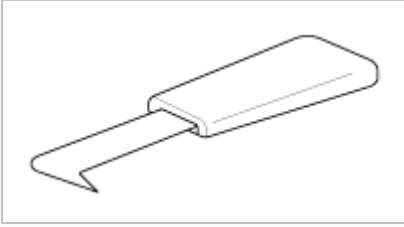
Windshield molding removal
09880-4F000 Hog ring clip installer		Hog ring clip installation
