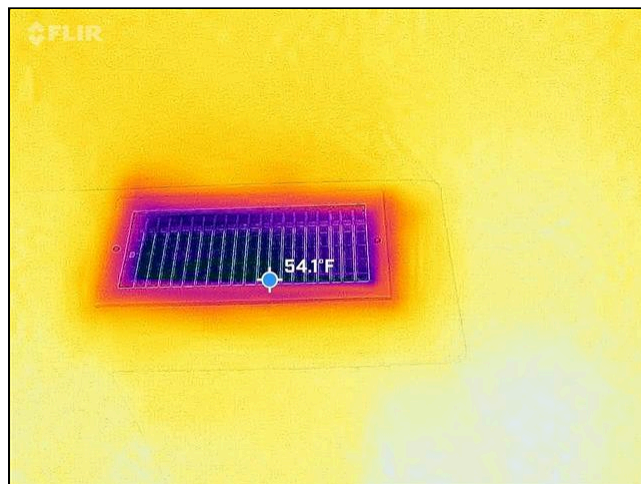
5.2 Item 1(Picture)

(1) The air conditioning system was evaluated using provided controls. The difference between the return air vent and service registers was between 15 to 20 degrees Fahrenheit. The system appears to be in operational condition. Therefore, changing the air filters, servicing system and implementing a regular maintenance schedule for the components is recommended to prolong the system's service life.

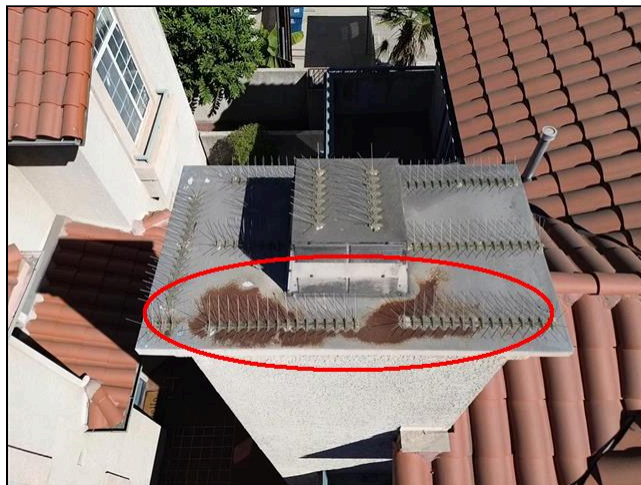
6.1 Item 1(Picture)

The chase cover is rusted. This is an indication of inadequate drainage at chase cover. This could lead to water intrusion at the chimney chase. Recommend correcting.

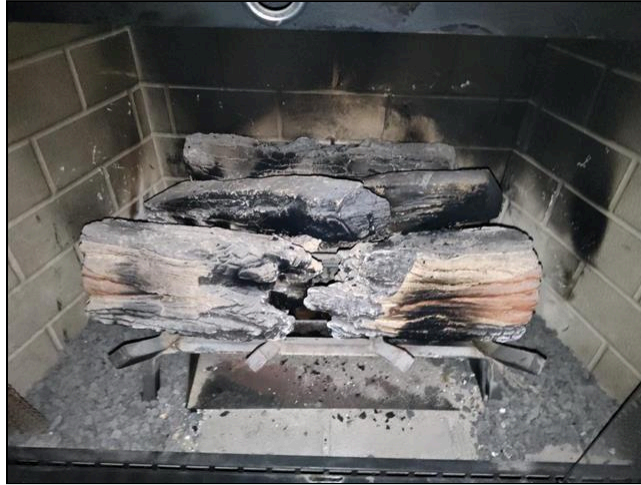
6.3 Item 1(Picture)

(1) A protective screen surround is not installed in front of the glass doors at living room - safety concern. Recommend installing.

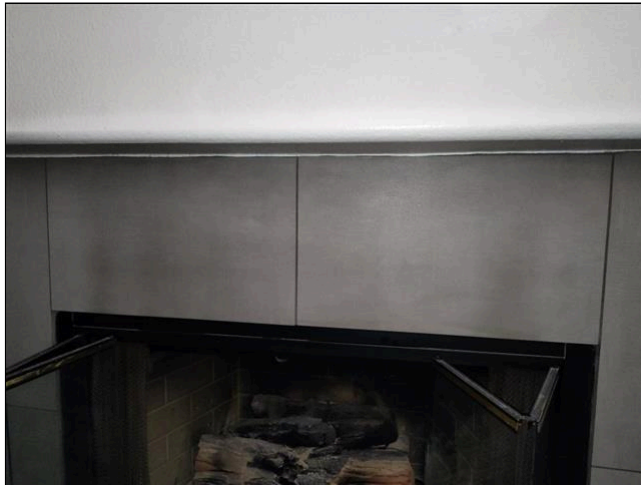
6.3 Item 2(Picture)

(2) Soot observed on log set at living room. This is a possible indication of flame impingement. We recommend further review by a qualified fireplace specialist.

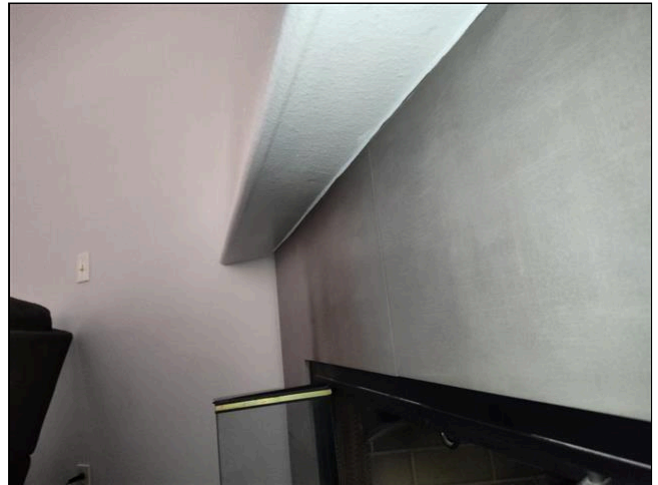
6.3 Item 3(Picture)

(3) Dark staining observed at fireplace facing and under mantel - safety concern. We recommend further review by a qualified fireplace specialist.

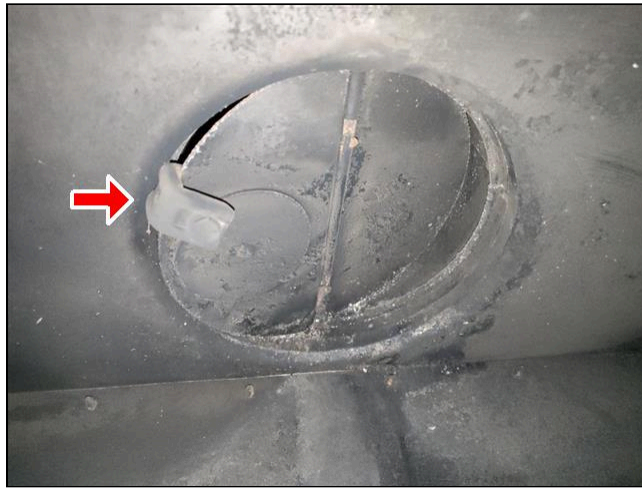
6.4 Item 1(Picture)

Locking device is not installed at damper in a way that locks the damper in the 100% open position - safety concern. Recommend correcting.

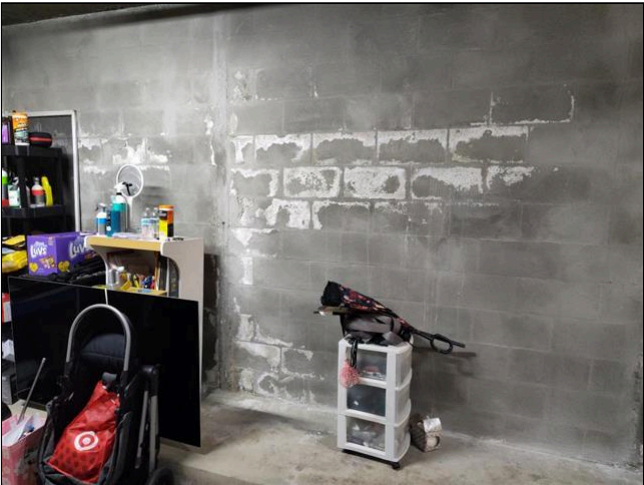
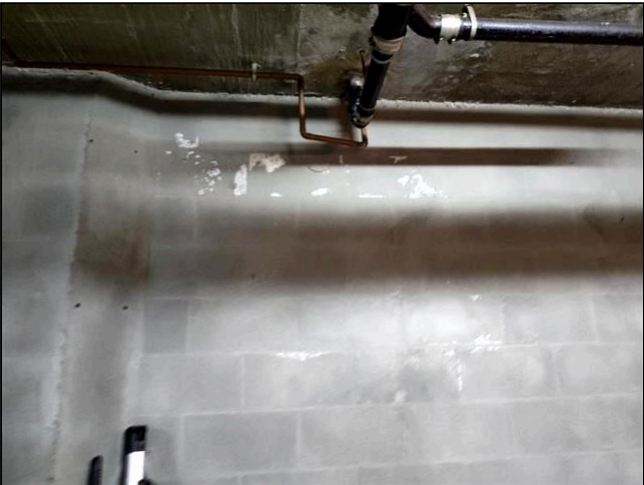
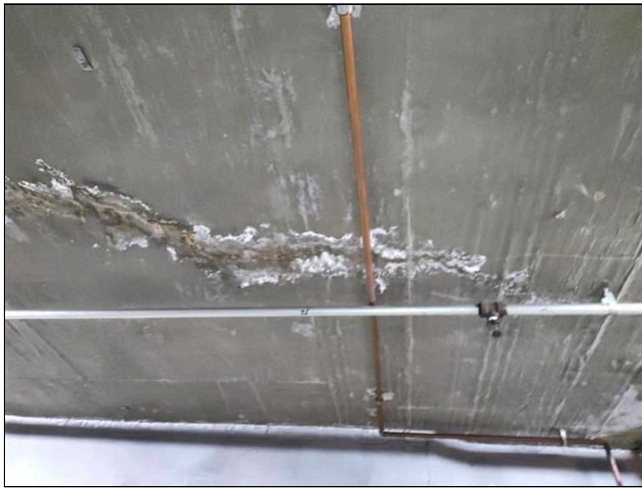
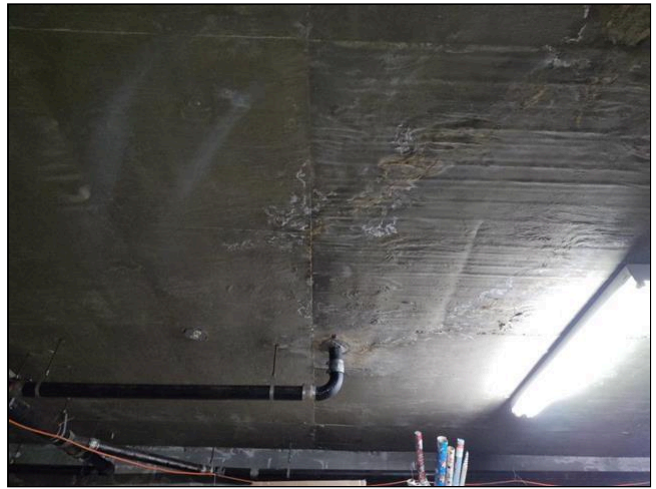
(1) Efflorescence and evidence of water intrusion observed at garage walls and ceiling. This is an indication of inadequate drainage and water proofing above and around garage. We recommend further review by a qualified contractor.

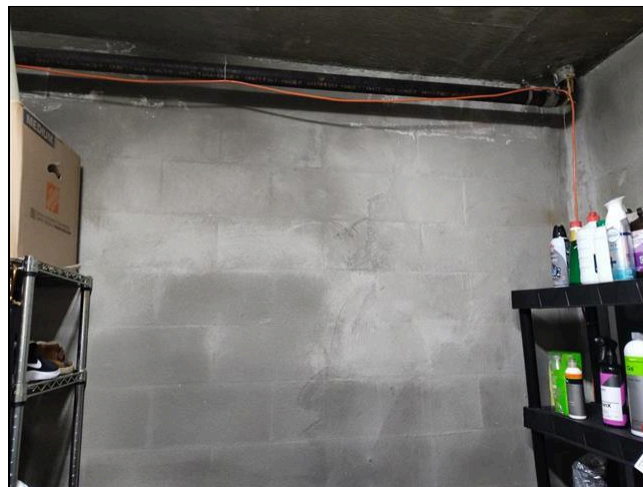
7.0 Item 5(Picture)

(2) Evidence of repairs observed. Unable to determine the cause and or effectiveness of these repairs.

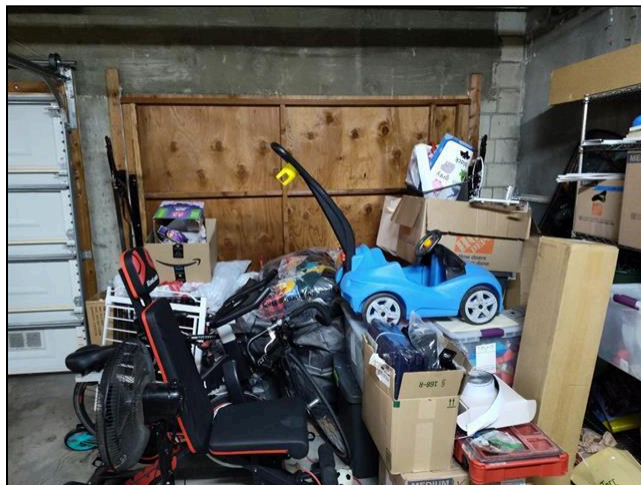
7.3 Item 1(Picture)

Limited review due to personal items.

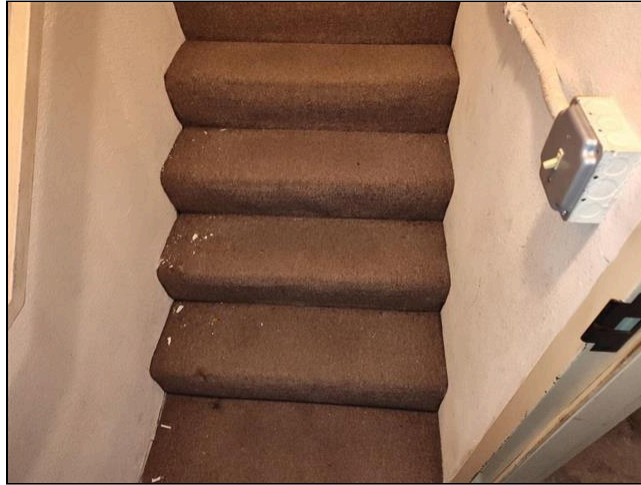
7.7 Item 1(Picture)

(2) Loose carpet observed at garage stairs - tripping hazard. Recommend correcting.

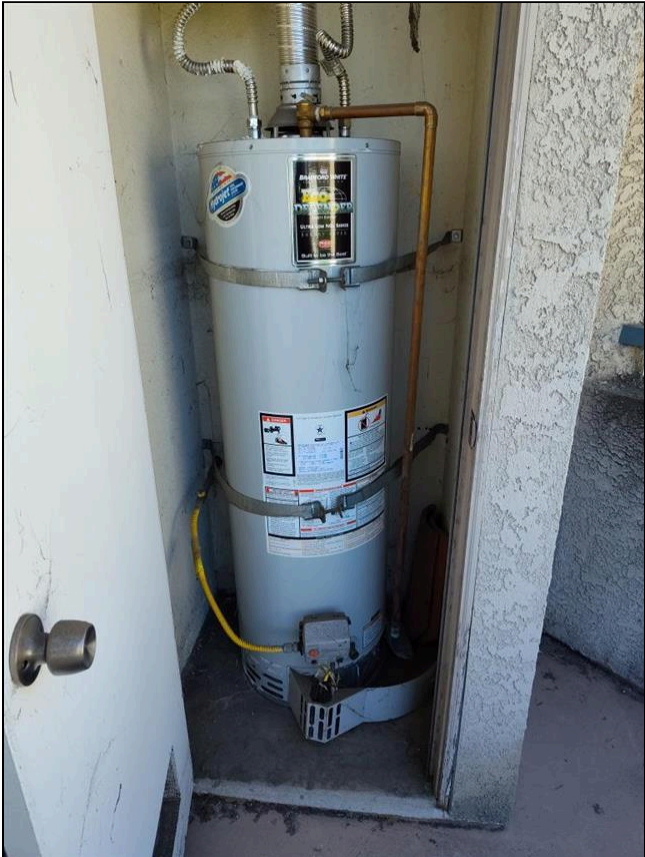
Location: Exterior closet	Manufacturer: Bradford White	Power Source: Natural gas (quick recovery)
Capacity: 40 Gal.	Earthquake Straps: Correct	Connections: Flexible Pipe
Date Manufactured: 2018	Water Heater Operation: Operational

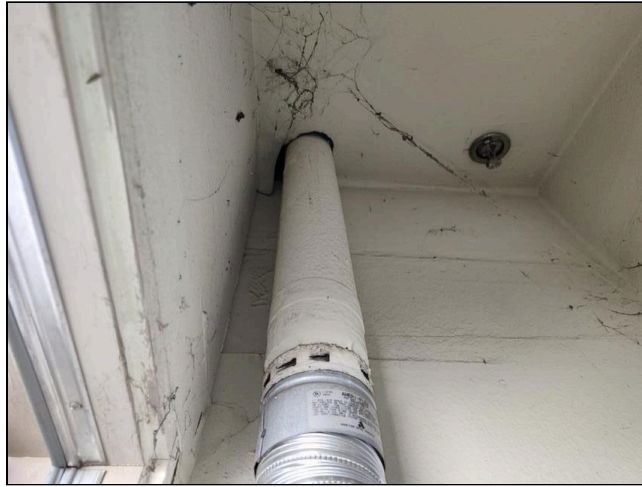
8.0 Item 1(Picture)

(1) Exhaust vent pipe has been painted. Suggest correcting

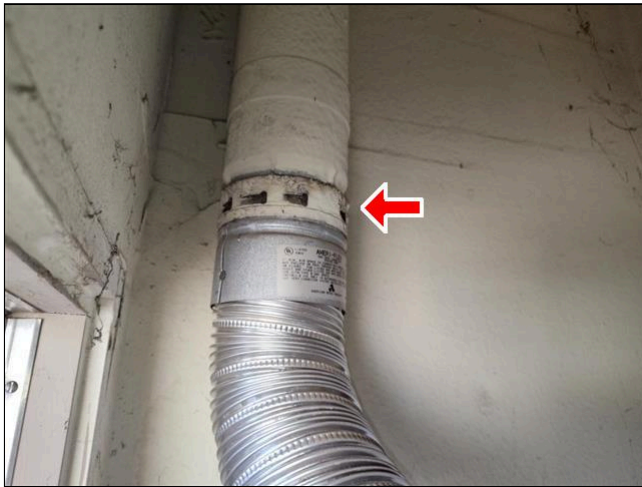
8.0 Item 2(Picture)

(2) Vent pipe is not secured at fitting(s) using screws. Suggest correcting.

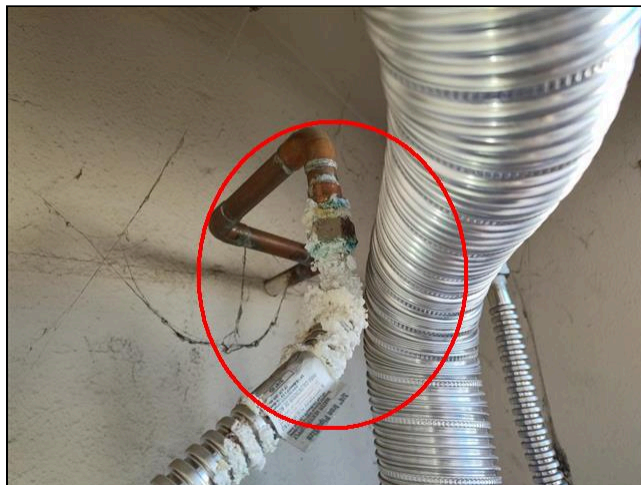
8.2 Item 1(Picture)

Corrosion observed at supply piping. This condition could lead to leaking and water damage. Recommend correcting.

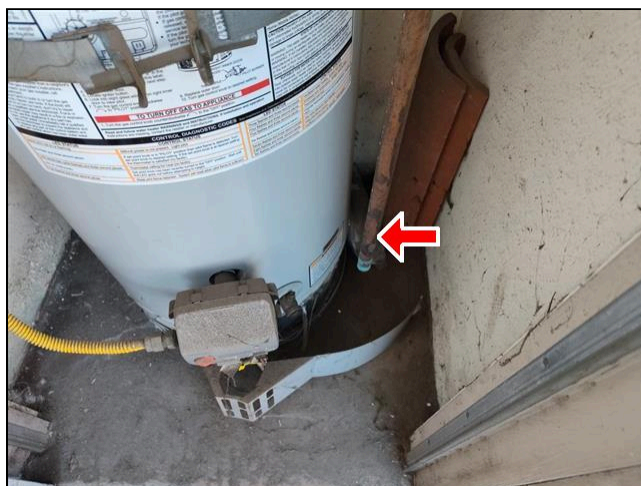
8.3 Item 1(Picture)

Discharge line termination point is incorrect. Recommend correcting.

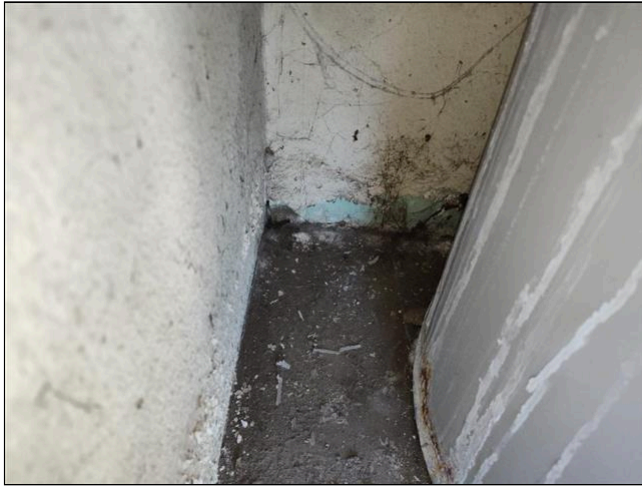
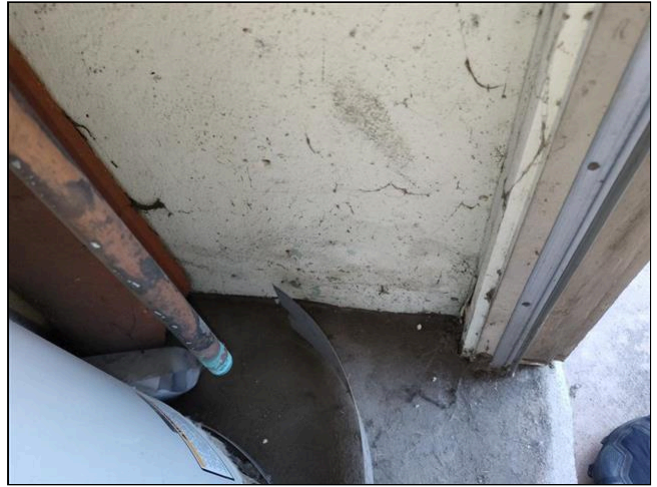
(1) Water staining/damage observed at water heater closet. Hidden damage may not be observable. Recommend further review by a qualified professional.

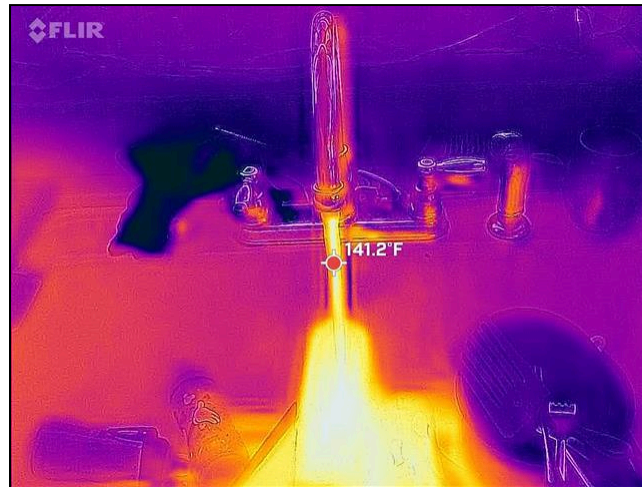
8.6 Item 1(Picture)

(2) Hot water temperature is over 135 - safety concern. Recommend correcting.

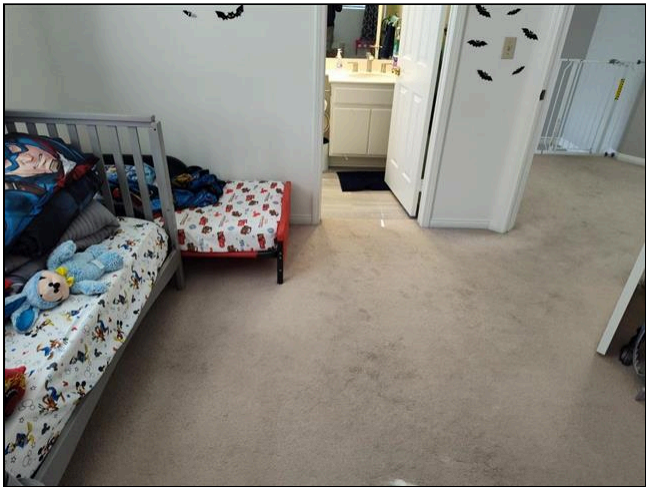
10.0 Item 1(Picture)

(1) Creaking sounds observed at the bedroom floor above water stained ceiling. this may be an indication of water damaged sub floor framing. We recommend further review by a qualified contractor.

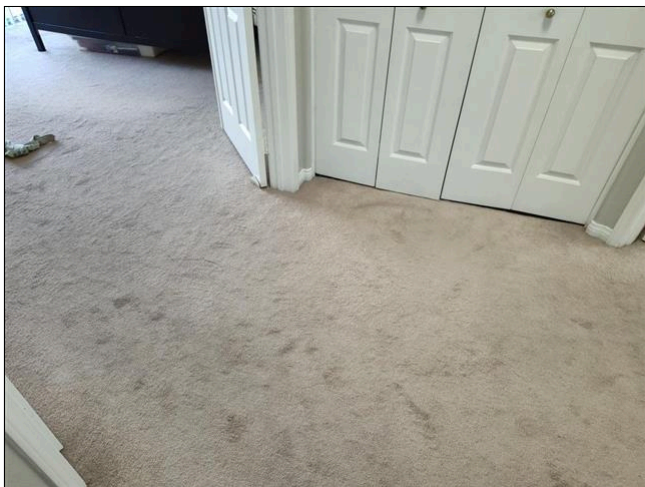
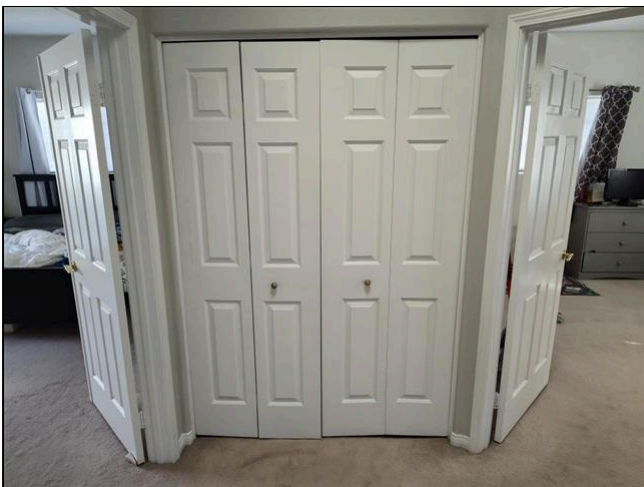
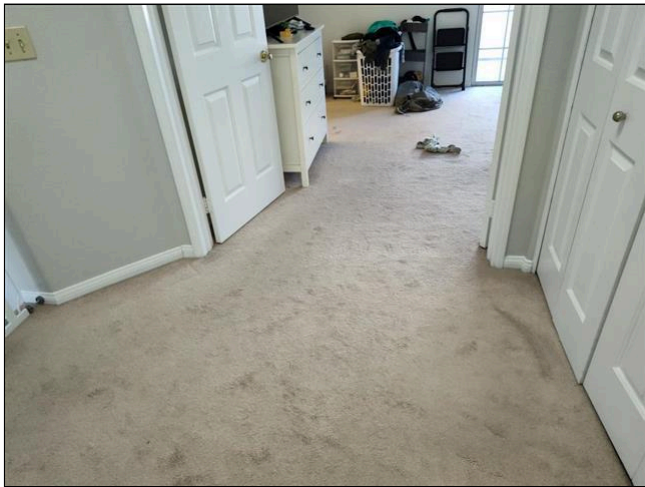
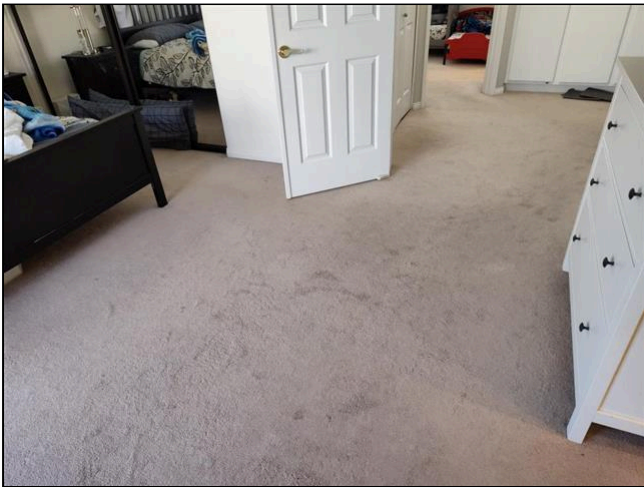
(2) Sloping floor and racked door frame observed at 2nd level hallway and master bedroom; sloping observed at slab below hallway area. We recommend further review by a structural engineer.

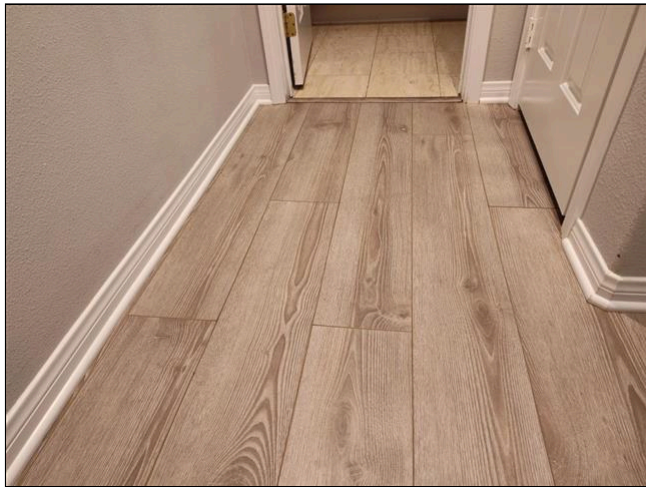
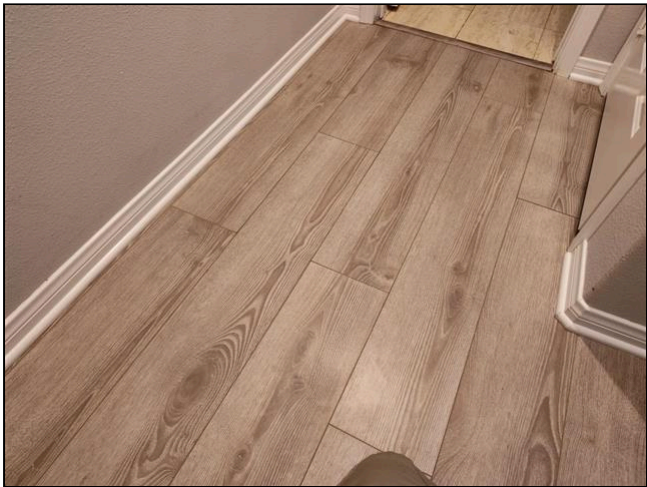
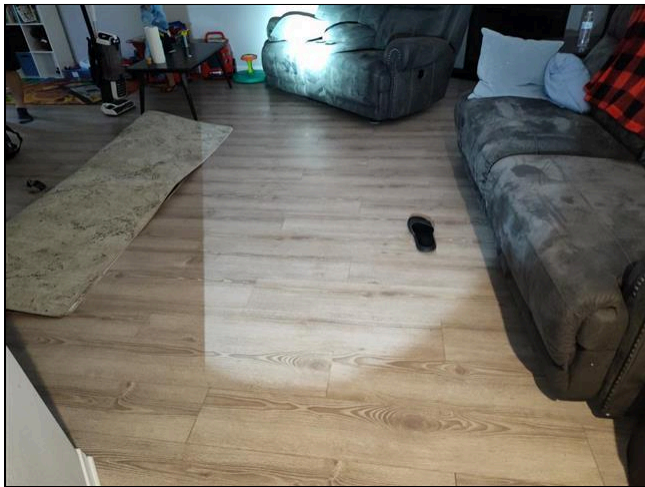
(3) Cupping and soft flooring observed at 1st level entry hallway laminate. Hidden damage may not be observable. This area is next to the exterior wall with inadequate drainage and incorrectly covered weep screed. This is an indication of water intrusion. We recommend further review by a mold specialist.

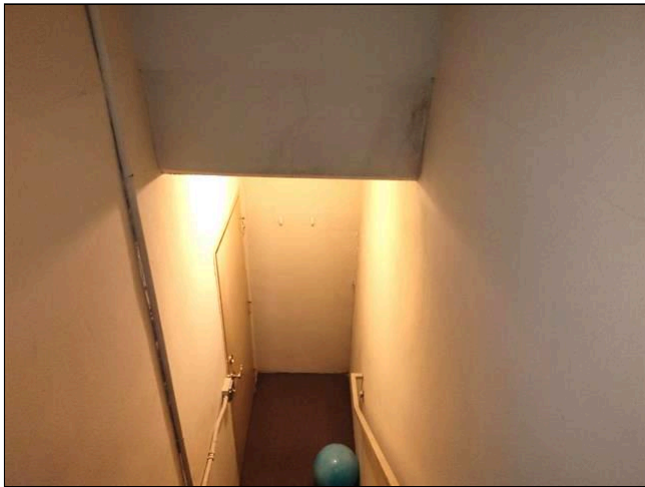
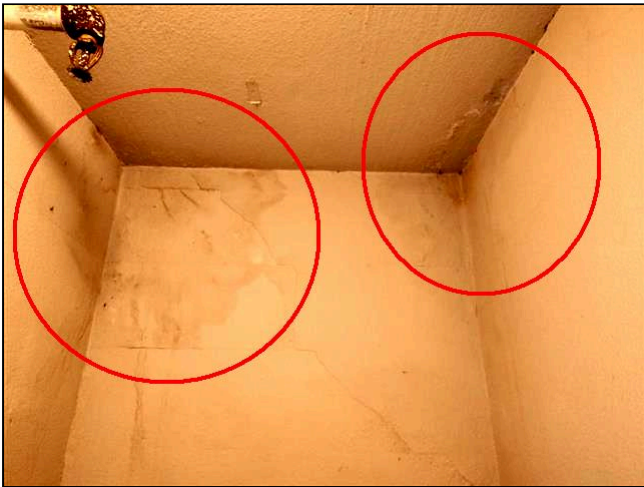
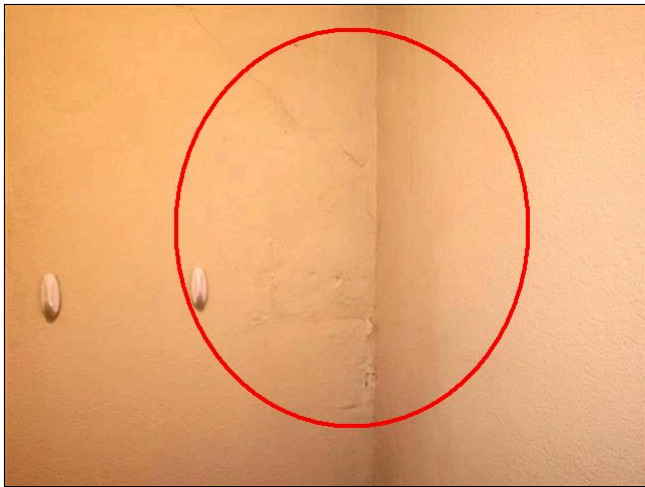
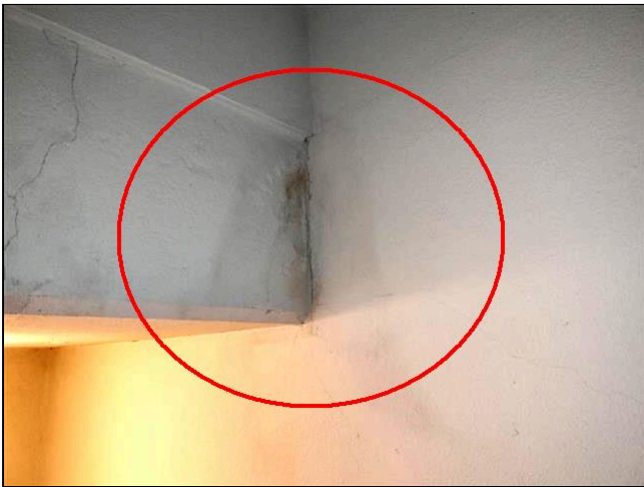
(1) Water damage and staining observed at garage stairwell wall(s) and ceiling. Hidden damage may not be observable. Recommend further review by a qualified professional.

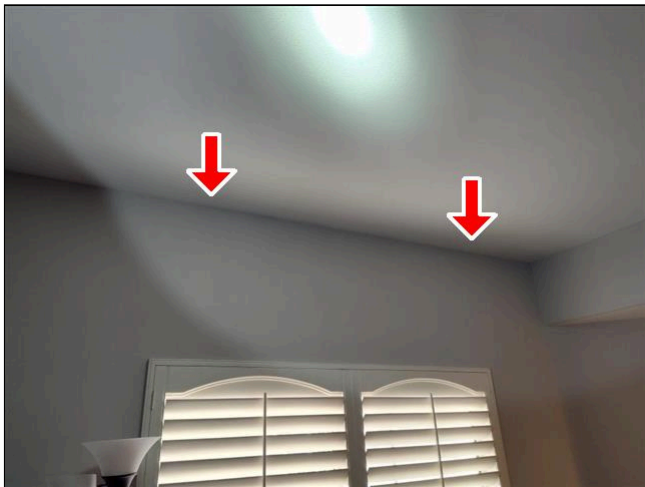
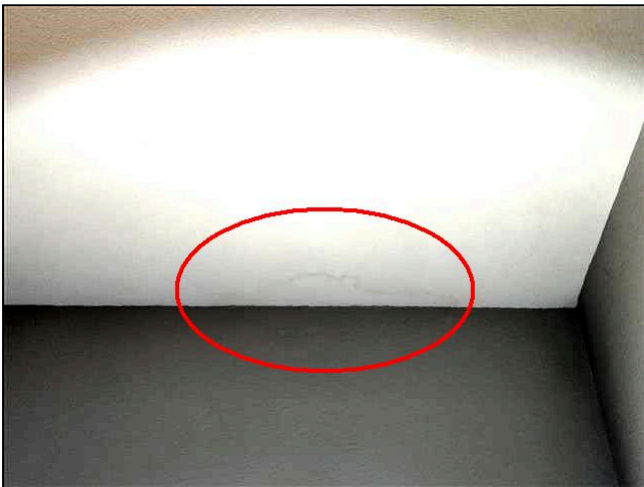
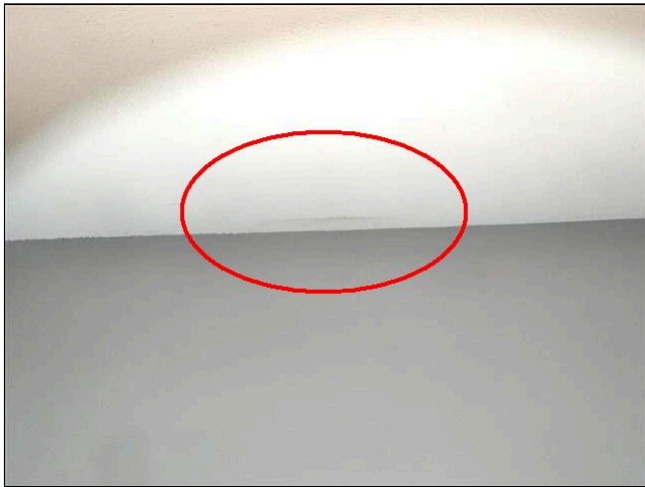
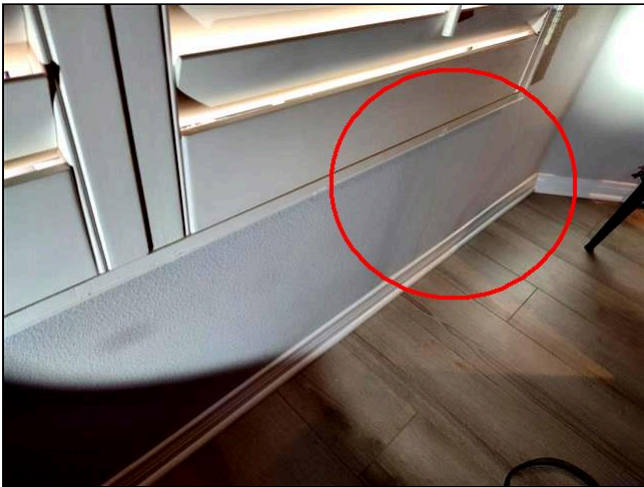
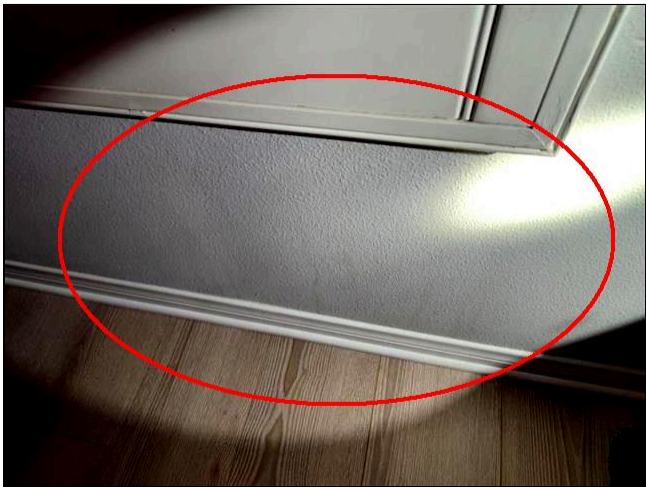
(2) Water staining observed at 1st level living room wall(s) and ceiling. Hidden damage may not be observable. We recommend further review by a qualified mold specialist.

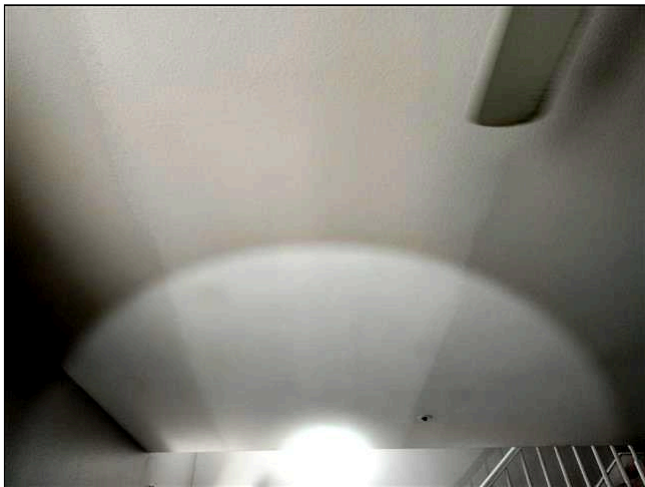
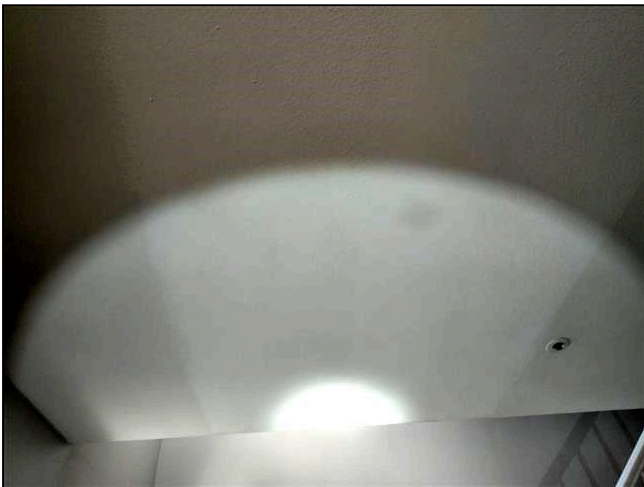
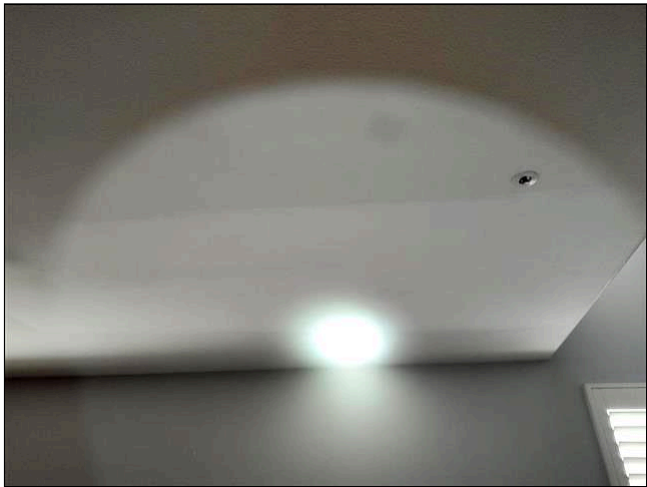
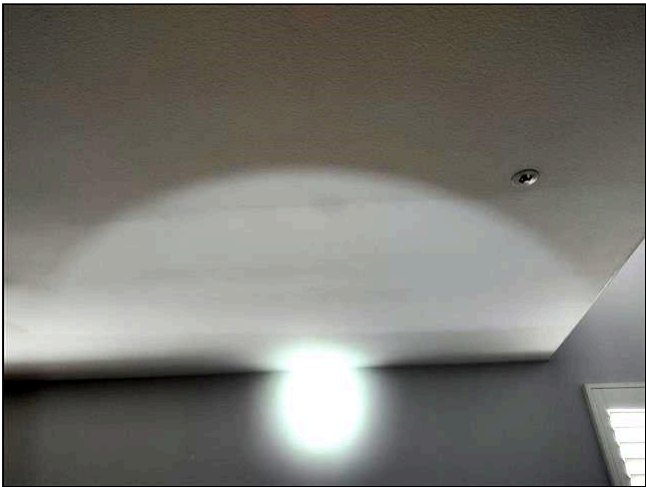
(3) We observed evidence of repairs and water staining observed at the ceiling in the dinning room area below the ensuite bathroom. We recommend further review by a qualified mold specialist.

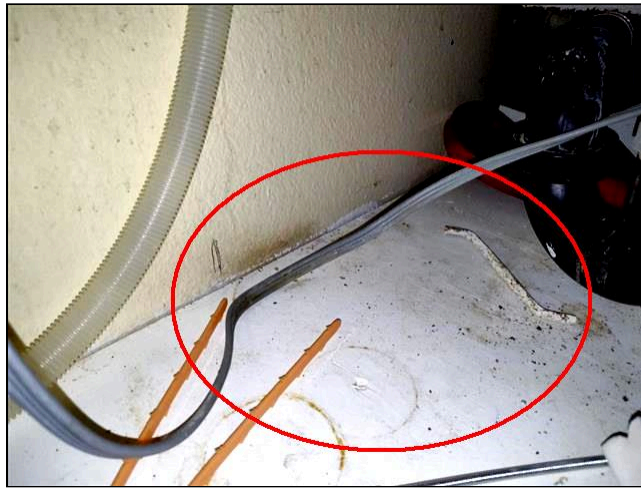
10.4 Item 1(Picture)

(1) Water staining and black staining observed at kitchen cabinetry. Hidden damage may not be observable. We recommend further review by a qualified mold specialist.

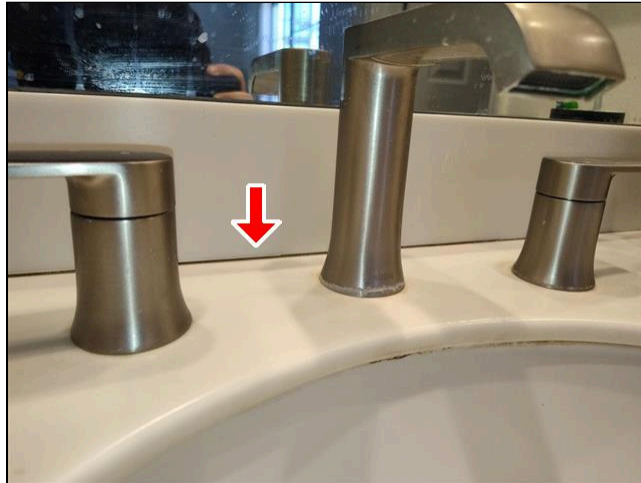
10.4 Item 2(Picture)

(2) Deteriorated grout/sealant observed at the master bathroom sink backsplash. Recommend repair.
