A preliminary hydrogeological characterization of landslides at Selsstaðir, East Iceland

SIT ICELAND: CLIMATE CHANGE AND THE ARCTIC

BRONTE STAHL

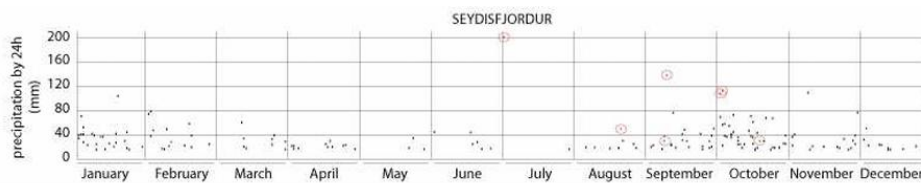
Figure 2. Monthly high rainfall distribution and related debris-flow releases in eastern Iceland. The debris-flow events are circled in red (Saemundsson & Decaulne 2008).

The steep, glacially carved slopes of the East Fjords make the region highly susceptible to mass movements, particularly debris flows, landslides, and avalanches. These processes are primarily driven by gravity but often triggered by meteorological events (Decaulne & Sæmundsson, 2007; Portier et al., 2023). Long lasting rainfall controls almost 50% of debris-flow events and intense rainfall represents more than 30% of debris flow causes in East Iceland (Decaulne & Sæmundsson, 2007) (Figure 2).

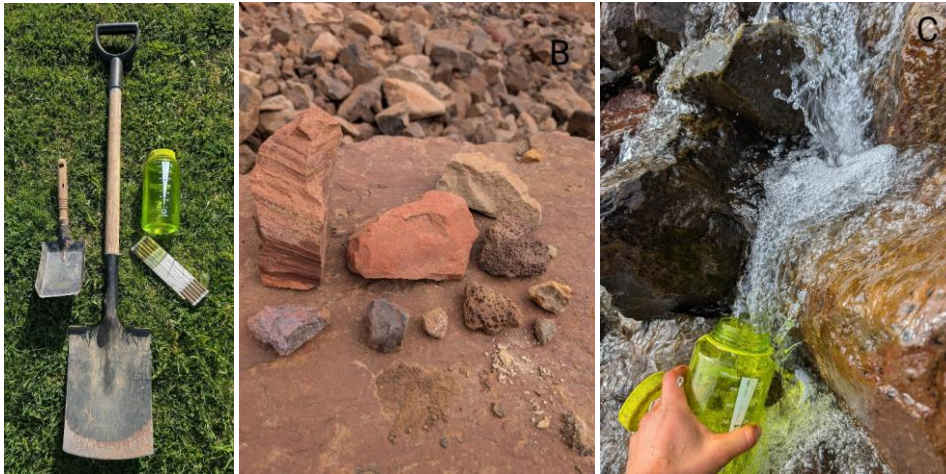
Figure 6. A) Materials used. B) Rock types throughout landslide scar C) Flow rate collection.

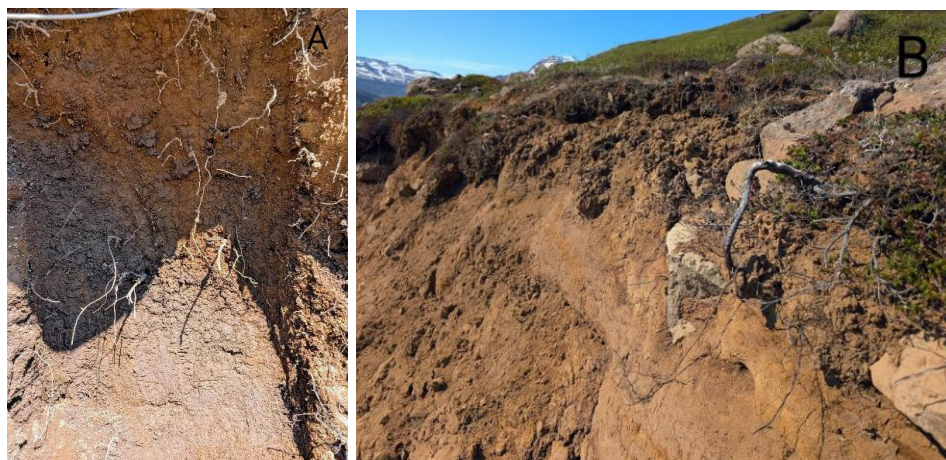
Figure 8. A) Soil pit 1 B) View of source area scar and reddish horizon about 20 cm deep.

The source of the landslide is connected to Skógarhjallar which is vegetated with grasses, shrubs and mosses. The slope was dusty, blowing the fine sediment away in a light breeze due to the dry conditions this April and May. The soil pit was dug 50 cm deep and 20 cm long, next to quadrat 3. There was a reddish oxidized upper layer and a brown/grey bottom layer in the horizon. Fine roots exuded out of the soil throughout the pit (Figure 8).

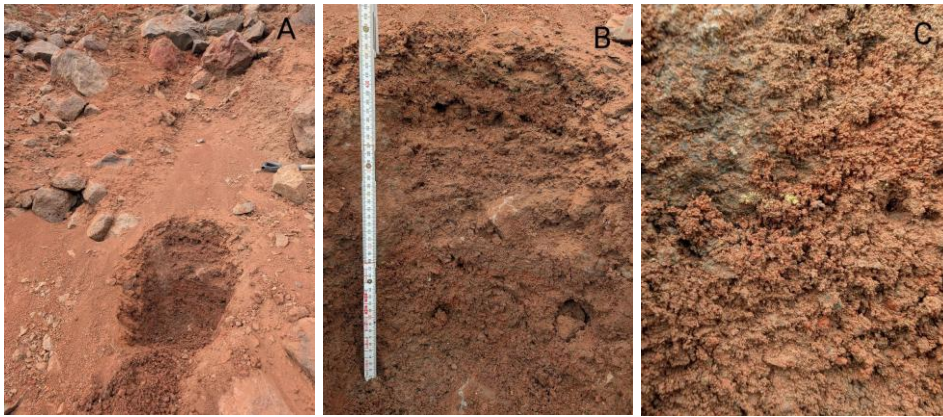
Figure 9. Soil pit 4 below source area. A) Surroundings of the pit. B) Pit wall C) Close up of the yellow spots in the middle and grey boulder embedded in the top left.

A second soil pit (soil pit 4) was dug on the west side of the scar, 267 m a.s.l. There were large patches of red colored sediment spread throughout the orange-colored slope. The pit was 43 cm deep and 20 cm wide. There were faint horizons present, and the soil texture is sandy clay loam; when rolled into a ball, it was sticky to the touch. There were sand and gravel sized rocks mixed with the red-colored fine particles, making it very gritty (Figure 9).

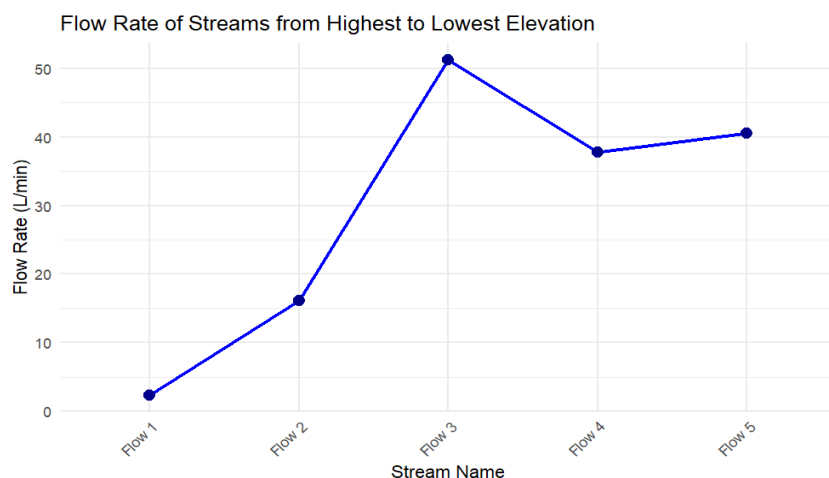
Figure 13. The flow rate in liters per minute of each spring fed stream. The flow number increases with a decrease in elevation.

Flow rate measurements reinforce this hydrological interpretation. The two primary springs (Flow 1 and Flow 2) had distinct textures and flow characteristics, with Flow 2 exhibiting higher discharge (16.13 L/min) and coarser clasts (including boulders), while Flow 1 had finer, looser sediment that behaved fluidly when disturbed. These differences in flow rates suggest variability in flow resistance and sediment mobilization, which are key parameters in modeling debris flow behavior and volume estimation (Iverson, 1997). There have been similar observations of springs across a single elevation, and saturated sediments moving fluidly on the south mountain as well (Helgason, 2025). The flow of saturated material, pictured in Figure 12, mimicked the behavior of a density-driven flow, in which interstitial water significantly reduces friction and increases mobility (Iverson, 1997; Major & Iverson, 1999).

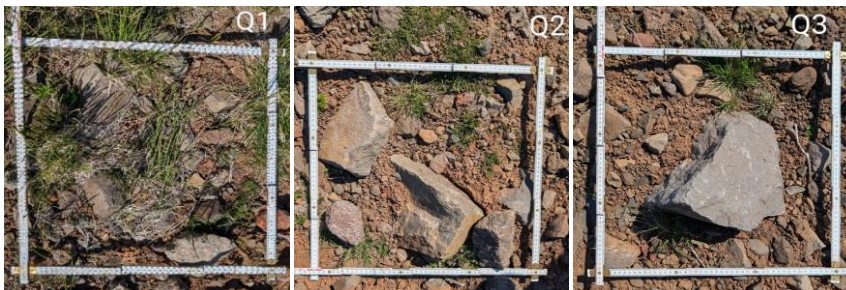
Figure 17. Quadrats at the deposition zone.

Surface conditions greatly varied. The quadrats were on mostly level ground. The narrow stream channel that the debris flow followed has many person sized boulders in its banks (Figure 17, 18, 19).
