Twingo Phase II  
Mégane  
Laguna Phase II

Type		S/Section
X06	X	75
XA0	X	75
X56	X	75

**SAFETY OPERATION TO BE CARRIED OUT PRIOR TO REMOVING A FRONT SEAT EQUIPPED WITH A SIDE AIR BAG AND/OR SECTIONS OF PANELLING IN THE AREA OF THE SIDE IMPACT SENSOR**

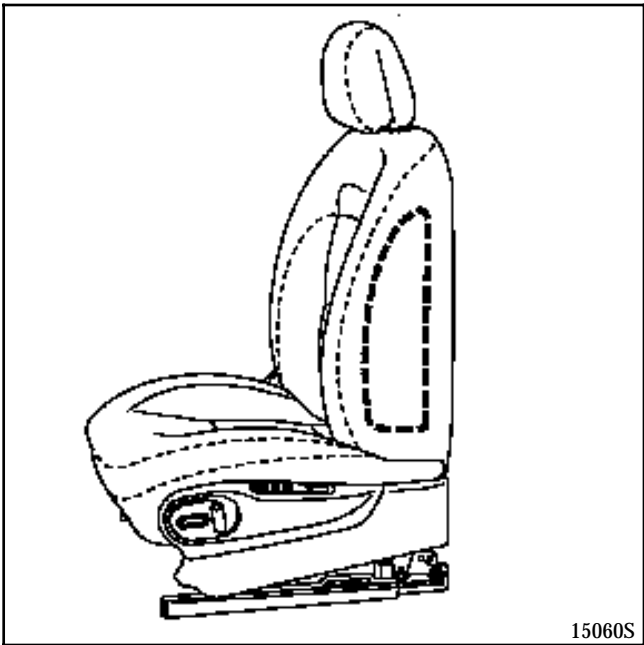
- removal of front seats fitted with a side air bag,

It is **PROHIBITED** to carry out an operation on a vehicle equipped with side air bags without first disconnecting the vehicle's battery.

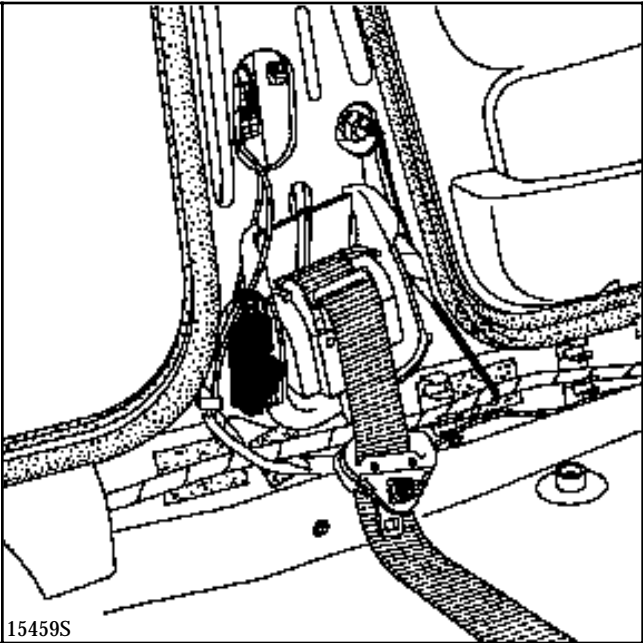
- operations relating to the repair or complete or partial replacement of any upper side structural section (for example, sill panel, centre pillar) and lower structural section (for example, floor panel).
