Mitigating Soil-Side Corrosion on Crude Oil Tank Bottoms Using Volatile Corrosion Inhibitors

ABSTRACT

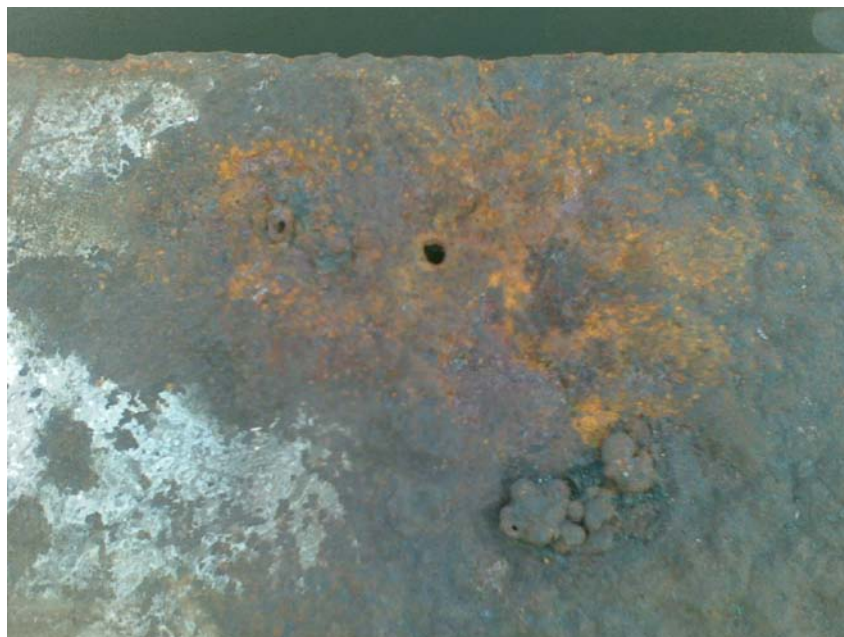
Figure 2: Soil-side corrosion on pilot project floor plate.

Unlike some of the past floor inspection reports at this facility, the report from the floor inspection identified corrosion in the 6 meter area but also significant random corrosion under many plates throughout the entire floor. Figure 2 provides an example of severe soil-side corrosion on this tank. Figure 3 identifies the different degrees of corrosion from the tank floor inspection report. The inspection results coupled with the existence of the grout under the floor plates caused the project to be revised. The scope of work was modified to include application of VCI chemistry under all plates that had experienced corrosion – not just the plates in the 6 meter perimeter area.

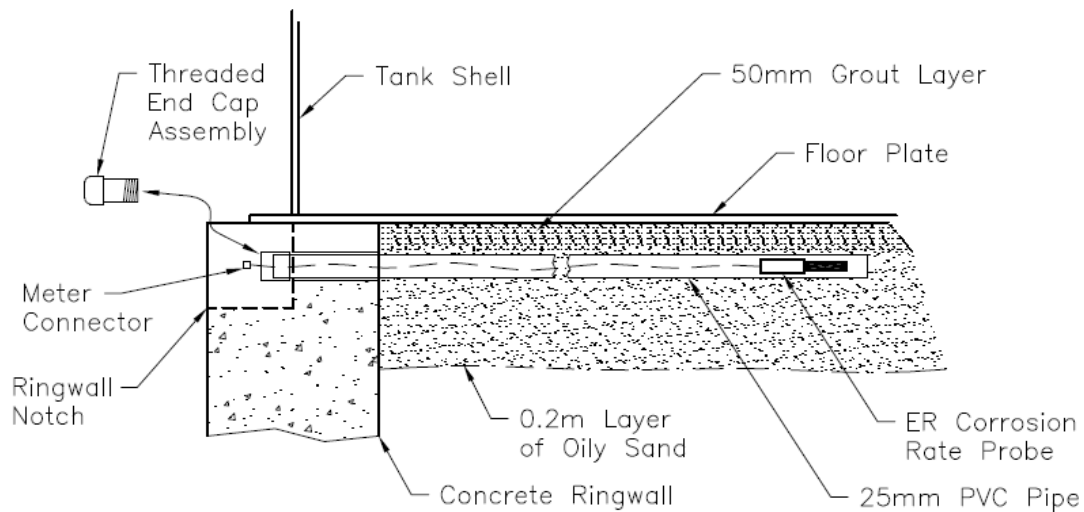
Figure 5: Typical ER probe installation without grout removed above probe location.

The floor plate was cut-out above the end of four PVC pipes and the cement grout was removed. Sweet sand was backfilled over the PVC pipe in the ER probe locations, Figure 4. Two of the probes were installed inside slotted PVC pipe located beneath the grout. The floor plate was not removed above these installations, Figure 5.

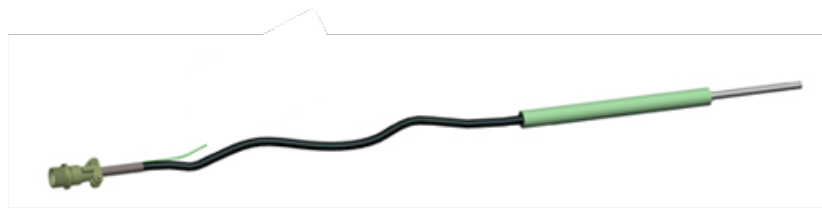
Figure 6: ER corrosion probe used for pilot project.

The ER probe chosen for the project is depicted in Figure 6. This probe configuration was chosen for compatibility with the PVC access pipes installed immediately under the floor plates. Data from the probes was obtained by connecting to a meter supplied by the probe manufacturer.

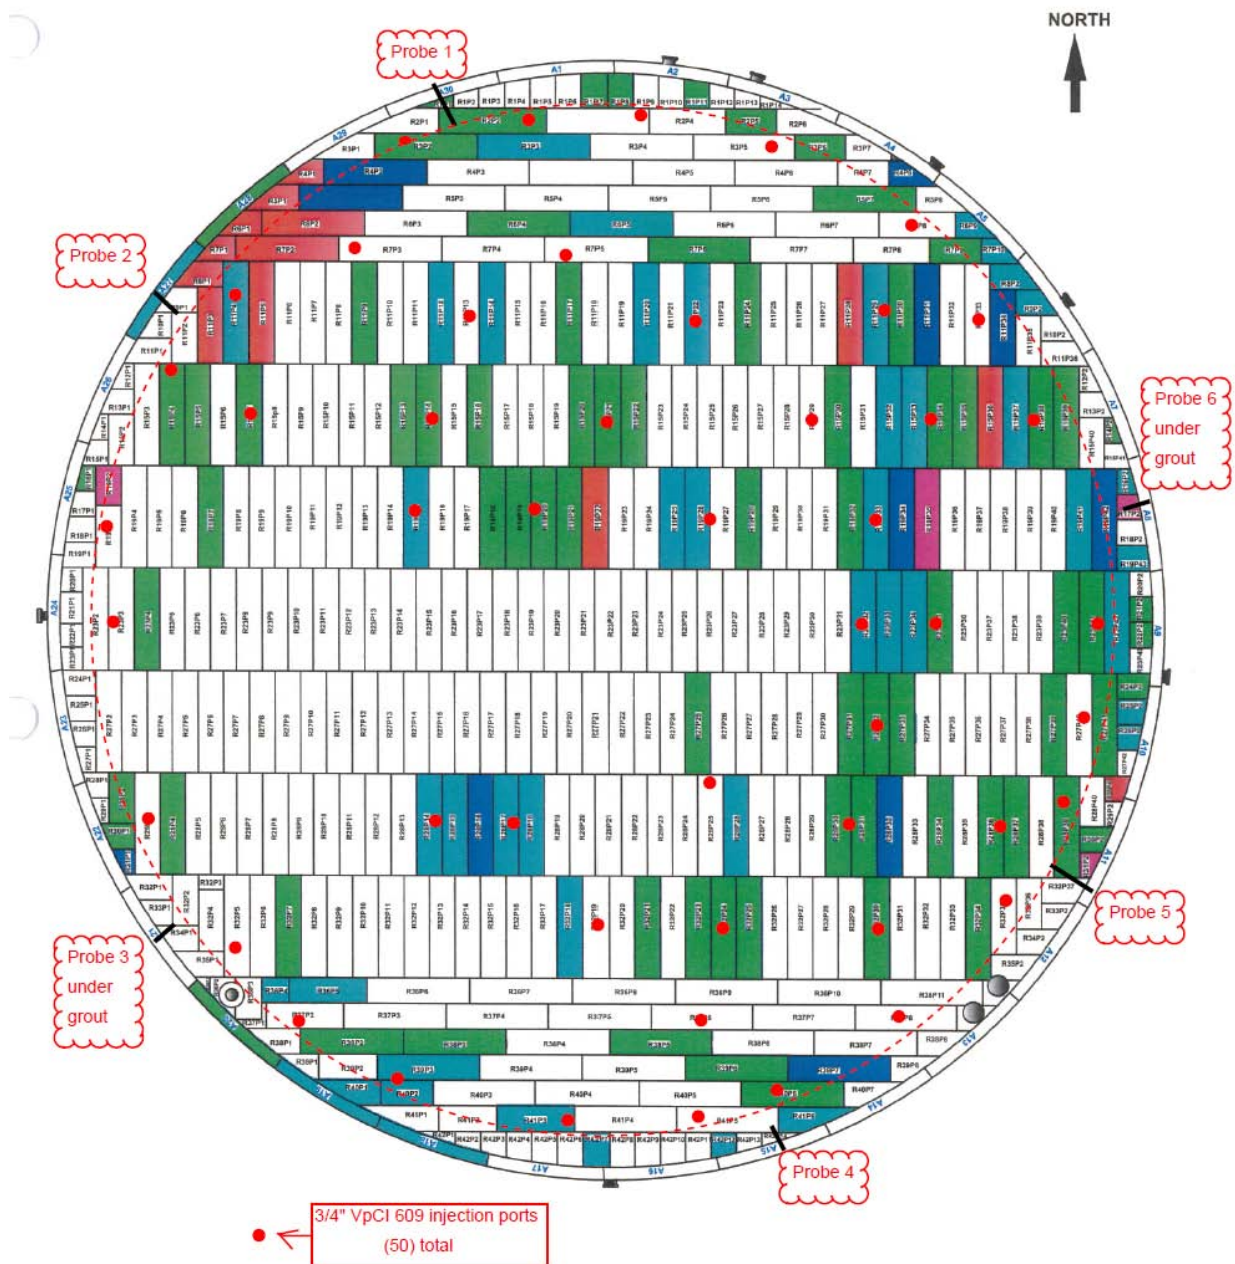
Figure 7: Plan view with ER probe and VCI injection port locations.

The corrosion rate monitoring system was installed per the original design. The system was installed 2 months prior to the application of the VCI. The locations of the ER probes were chosen by using the MFL scan drawing to identify the area where severe corrosion was noted and the floor plates were not going to be replaced, Figure 7.

A combination of two methods for delivery of both a liquid and a powder VCI were originally specified. The revised plan included injection of VCI powder only through (50) x 20 mm threaded temporary injection ports in the floor plates. The design addressed the 6 meter perimeter floor plate area; and also includes the interior floor plates where corrosion was identified on the MFL Report, Figure 7. Pneumatic equipment was used to effectively distribute 9.5 kilograms of VCI powder through the temporary injection ports under the floor plates a minimum 10 meters in all directions. Steel plate patches were welded over each port after the VCI applications were completed.

The ER probes were located (2 to 4) meters inside the tank perimeter because that was the historical location of the most severe corrosion on ASTs at this facility. Note the proximity of the VCI injection ports to the ER probe locations in Figure 6. The VCI injection ports were not close to the probes. The ports were 6 to 10 meters away from the probes and outside of the concrete grout layer. This design enabled the project team to evaluate the VCI overall effectiveness and molecular distribution through the very dense oily sand and the cement grout applied under the perimeter floor plates, Figure 9.

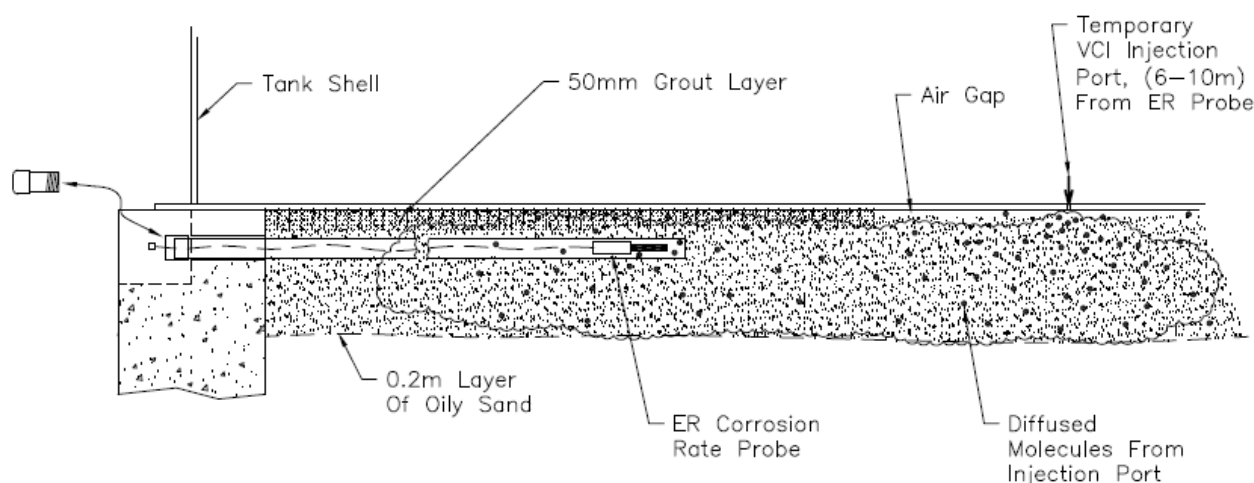
Figure 9: Molecular distribution of the VCI through the undertank environment.

This data clearly defines the effectiveness of VCI chemistry in mitigating corrosion within the very difficult environment under aboveground storage tanks. It is significant to observe Figure 9 and note the challenges for effective molecular distribution through the oily sand and cement grout. The project team considers the project a success based upon the initial data.
