**Clinical use of optical coherence tomography to evaluate the integrity
of dental restorations**

We have applied Optical Coherence Tomography (OCT) clinically to assess dental restorations in humans. Twenty patients with resin composite restorations in anterior teeth were selected and evaluated using a conventional radiographic examination, visual inspection and OCT. Images were obtained using a home built OCT system operating in the spectral domain, with an 850 nm superluminescent diode light source. The results were analyzed with respect to the integrity and marginal adaptation of the restoration. Using appropriate software failed and failing restorations, including those with lesioned regions, could be located prior to the placement of a new restoration. Lesions and failed restorations were identified with the OCT system that could not be seen by conventional visual and X-ray examinations and these were found to be present on surgical intervention. This *in vivo* study demonstrates that the OCT technique has a great potential to be used in clinical practice to assess dental restorations and prevent recurrent caries.

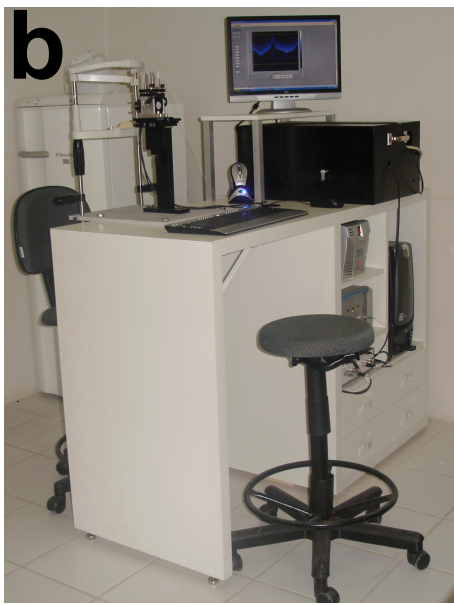
Figure 1. OCT setup. 1(a) schematic diagram of SD-OCT, operating at 850nm; 1(b) dental SD-OCT adapted for *in vivo* study; 1(c) positioning of patient.

The schematic diagram of the home-built OCT operating in the spectral domain, which was used in this study is shown in figure 1(a), and is the same as reported previously [19] where the full experimental details are described. The centre wavelength of the system was selected to be around 850 nm. Although longer wavelengths penetrate more deeply into the sample due to a lower scattering coefficient, this lower scattering coefficient also means a loss of sensitivity to slight changes in refractive indices. In order to maximize the sensitivity to changes we therefore opted for a shorter wavelength compared to the 1300 nm that reported previously [24, 25].

In summary, the output emission from a superluminescent diode (Broadband SLD Lightsource S840, SUPERLUM, Moscow, Russia) operating at 850 nm, with a spectral width of 49.9 nm and a fiber output power 25 mW was sent to a Michelson interferometer setup providing an axial resolution of 6 μm . In the reference arm a mirror was mounted on a piezoelectric base, whilst in the sample arm, a mirror controlled by a Galvanometer motor was used to scan the light on the sample. The reflected and back-scattered light coming from both arms was then recombined at the beam splitter and collected by a spectrometer.

This optical delivery system was mounted on a 2D translation stage, though as the beam passes off a scanning galvo, this is used to scan either in the X or Y direction for data acquisition and only one axis of the translation stage was used for lateral movement of the imaging system. The control of the scanning systems was undertaken by a personal computer with a LabView based imaging program. A photograph of the entire system is shown in figure 1(b).

To perform the OCT examination, a lip retractor was used on the patients, and their heads were positioned in an appropriate support, in front of the sample arm, seen in figures 1(b) and 1(c). The image acquisition time is less than one second (for each image, there was 0.1 second of pre-scan settling time and 80 μ s of integration time) though the support was used to minimize movement which would otherwise blur the high optical resolution images. The authors analyzed the results with respect to the integrity and marginal adaptation of the restoration by visual inspection of the images in real time as well as on the images produced from the subsequent image processing.

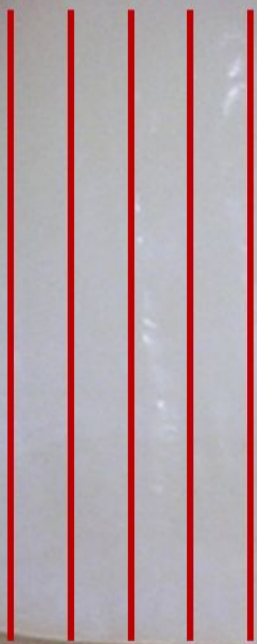
Figure 2. Sequence indicating the scan positioning in the patient's teeth, identifying the tomographic slices.

OCT images were obtained from vertical slices of the tooth, as indicated in figure 2. The scan was always mapped from left to right. The lateral distance between each image was 0.2 mm. For didactic reasons, we have only shown some tomograms of each tooth. The upper part of image corresponds to the cervical region and the lower part, the incisal region.

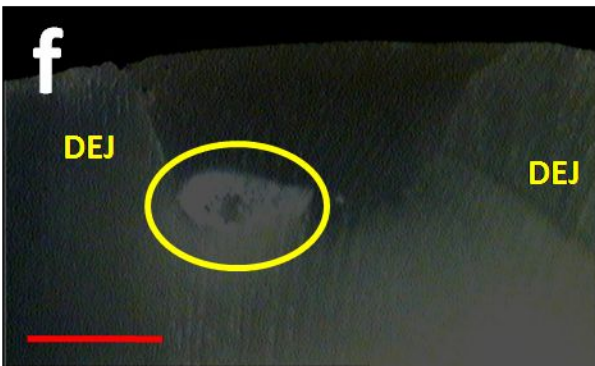
Figure 3. OCT and their respective optical microscopy images of different samples restored with resin composite. In 3(a) and 3(b), arrows indicate the well suited restoration, whilst in 3(c)/3(d) and 3(e)/3(f) air bubble close to the tooth restoration interface can be seen within the circles; in DEJ, we can observe the dentin-enamel junction; 3(g) and 3(h) show an aesthetic facet, in which is possible to observe the tooth-restoration limits (arrows) and the use of different shades of composite resin (large rectangles). Red bar represents 1 mm.

Features seen in the OCT images were interpreted by reference to the literature and also to previous *ex vivo* studies by the authors, where the teeth were imaged via OCT and subsequently sectioned and histologically studied by light microscopy. It can be shown in figure 3, in which 3(a), 3(c), 3(e) and 3(g) represent OCT images of different samples restored in composite resin, and 3(b), 3(d), 3(f) and 3(h), their respective optical microscopy images. In figures 3(a) and 3(b) we can see an example of a well placed and sound restoration, whilst 3(c)/3(d) and 3(e)/3(f) show the air bubble presence (within the circle) close to the tooth restoration interface, as well as the dentin-enamel junction. The white appearance of the air bubbles in the optical microscopy images is due to the smear layer impregnation during the teeth sectioning with diamond wheel. Figures 3(g) and 3(h) show an aesthetic facet, in which is possible to observe the tooth-restoration limits (arrows), the dentin-enamel junction and, specially, the use of different shades of composite resin (large rectangles).

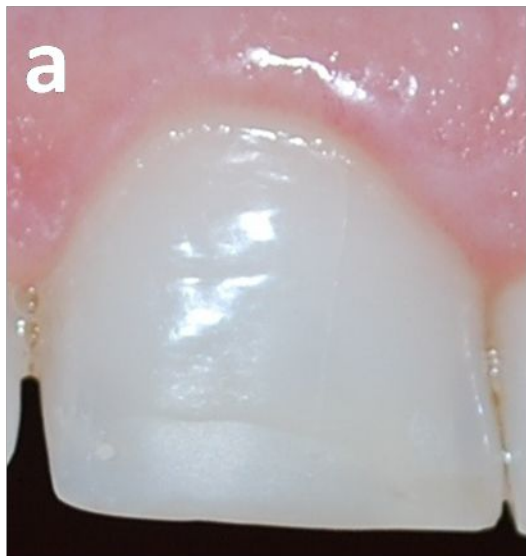
Figure 4 shows a sequence of examinations of a patient with a well placed and sound restoration in a central incisor, placed seven years previously. Figure 4(a) represents the clinical examination; 4(b), the conventional radiograph showing the restoration at the incisal region in the circle. Arrows in 4(c) indicate the interface between the enamel and the restorative material, which can be clearly seen.

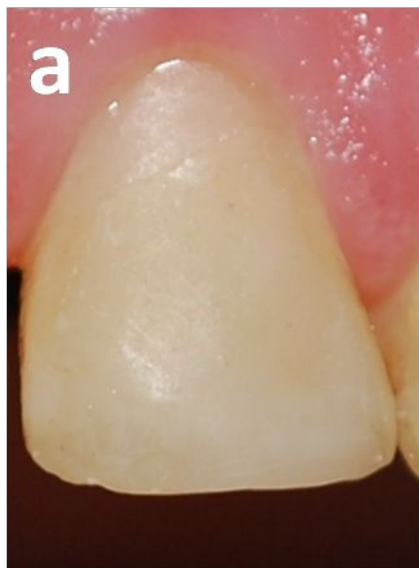
Figure 5(a) shows a lateral incisor with an aesthetic facet (not polished) over an incisal and cervical restorations, confirmed by radiography in figure 5(b), performed

two weeks before the analysis reported here. In the OCT image, figure 5(b), an air bubble in the restoration (within the circle) can be seen and the dots indicate the points of microleakage at the enamel-restoration interface. The small rectangles indicate an extensive space under the restoration, probably due to resin polymerization contraction during the restorative procedure and the triangles indicate crack points between resin increments.

contraction; and the triangles, crack points between resin increments. Red bar represents 1 mm.
