## Water loss reduction in Razgrad demonstrative project through active leakage control, pressure management and the relationship between pressure management and leakage: The case of Kooperativen Pazar DMA

**Abstract:** This demonstrative project comprises four of the 24 districted metered areas (DMA) of the town of Razgrad connected to SCADA system - Kooperativen Pazar, Largo 1, Largo 2 and Parkova zones respectively. The first phase of the project was implemented for three months. This was possible not only because of the high level of completeness of the SCADA system but also due to the realized in the period between September 2006 and September 2007 project under a Dutch governmental initiative managed by Aquapartner Ltd, Bulgaria and Aquanet Ltd, the Netherlands. The aim then was a twinning project between Water Company PWN, the Netherlands and Vodosnabdyavane Dunav, Razgrad for improvement of the water supply management in Water Company Razgrad, Bulgaria. The project was financed under programme LOGO East of the Association of Netherlands Municipalities (VNG) for strengthening of the regional and local government through partnership and by PWN, the Netherlands. The report gi

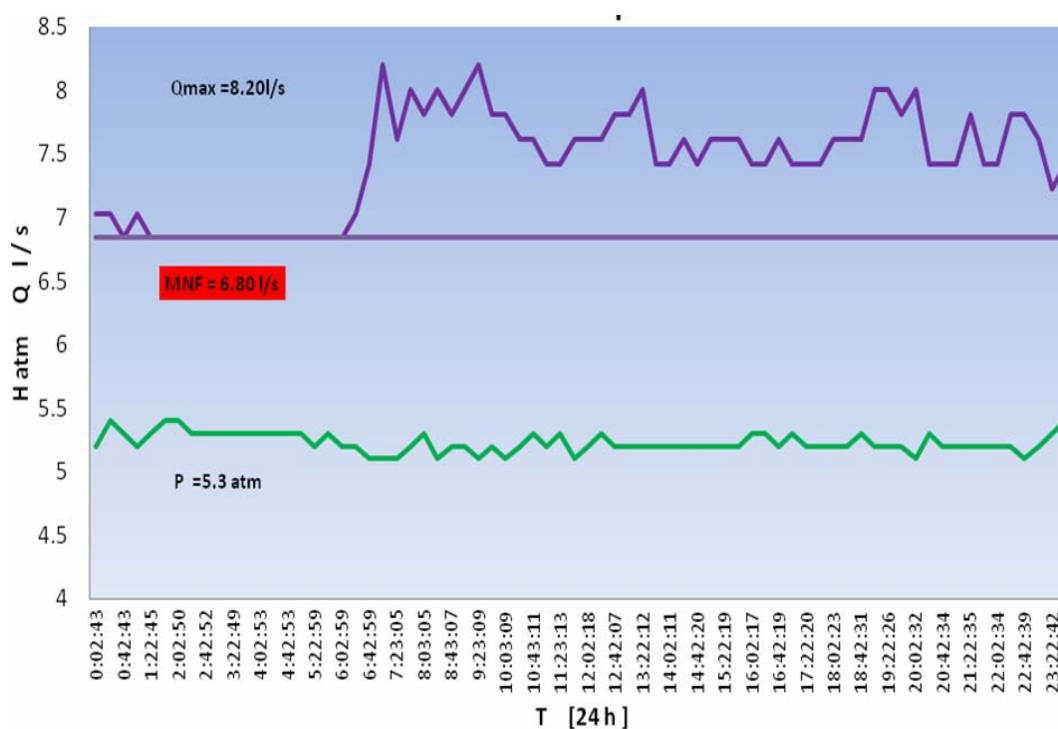
Graph 1. Minimum night flow and pressures in a DMA chamber

supply pipes of around 13 km and serviced population of 5,928 people. A great deal of the required data – 24-hour data on water input volumes, pressures downstream and upstream of the DMA chambers – were obtained through SCADA (Graph 1).

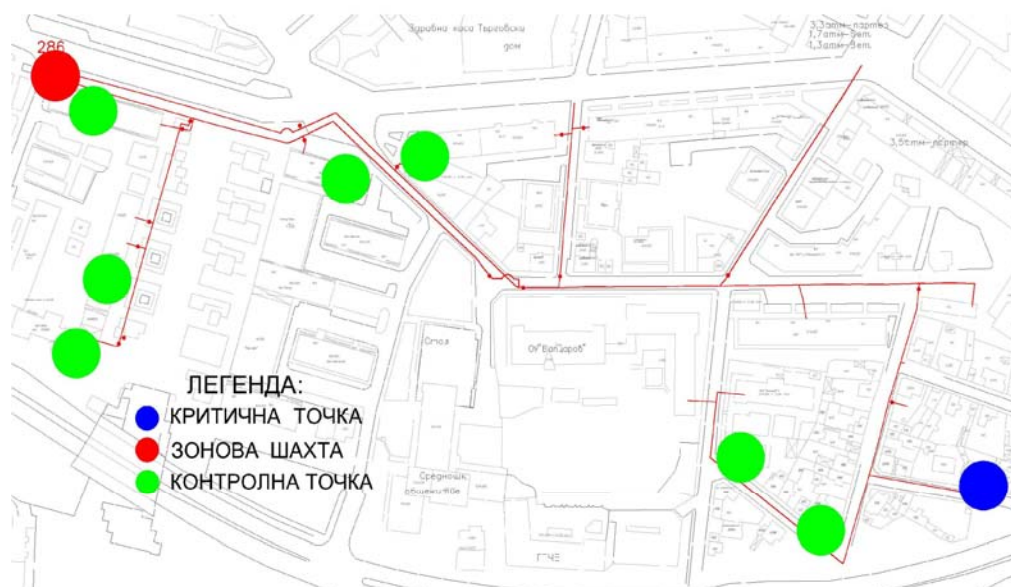
Figure 6. Control points where pressure is measured

Critical points were set for each DMA (Figure 6), where measurements were made (Graph 2) of pressures before and after each significant project step.

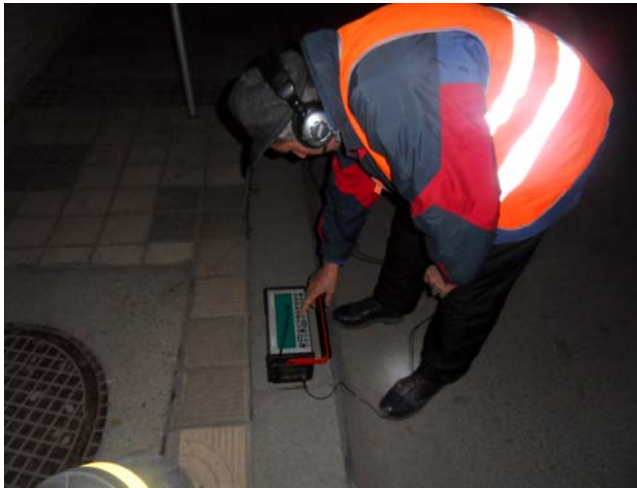
*Picture 1. Hidden leaks detection (a)*

*Picture 2. Picture 1. Hidden leaks detection (b)*

Together with teams trained to search the water supply network for hidden leaks, we localized 6 leaks (Pictures 1 and 2) in four areas, the repair of which led to reduction of the minimum night flow in the areas with a total of 5,9 l/s.

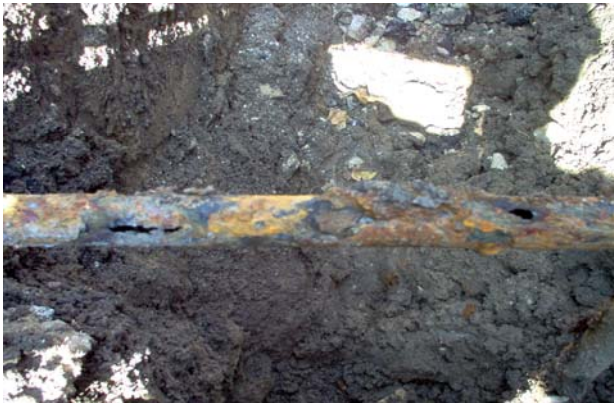
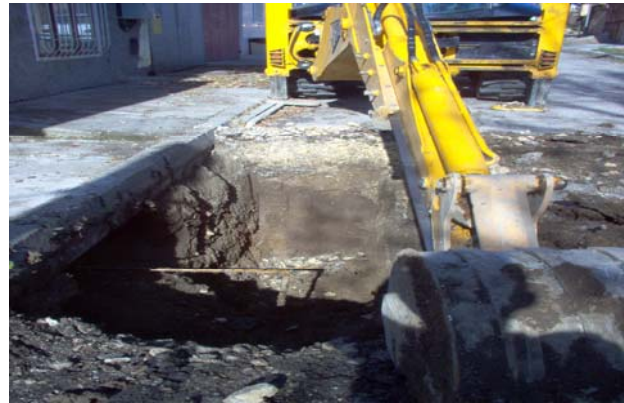
*Picture 3. Repair of leaks (a)*

*Picture 4. Repair of leaks (b)*

The repair of the leaks (Picture 3 and 4) in the DMA's was reflected in the increase of the minimum free pressure in the critical points. Another very common water loss reduction approach was put in place – Pressure Management (Graph 5).

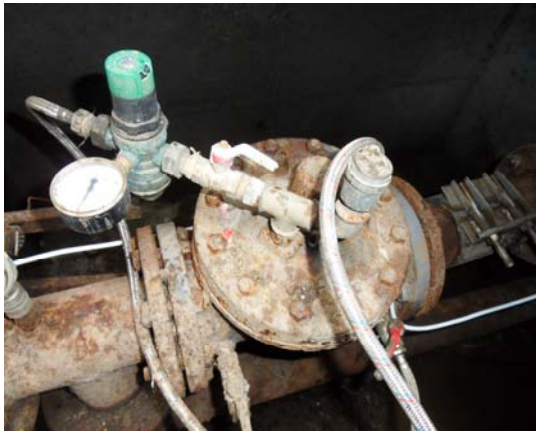
*Picture 5. The Kooperativen Pazar DMA's chamber – Water meter*

The DMA is supplied by a single point from the main branches. A DMA chamber (Picture 5 and 6) houses a downstream pressure regulator regulating pressure to 5,1 atm and a digital night flow

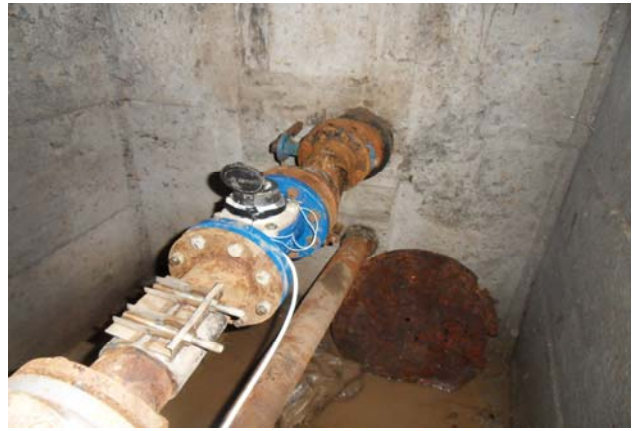
*Picture 6. The Kooperativen Pazar DMA's chamber – PRV*

water meter - MNF = 10,6 l/s, which could be monitored in real time through SCADA. The variation in the DMA levels is small, within 5.0 m, the average buildings height is around 6 floors. The average network pressure was maintained between 3.5 atm and 4,8 atm due to the existence of a 9-floor block of flats (the critical point) in the middle of the DMA, setting the downstream pressure of the pressure regulating valve (PRV).

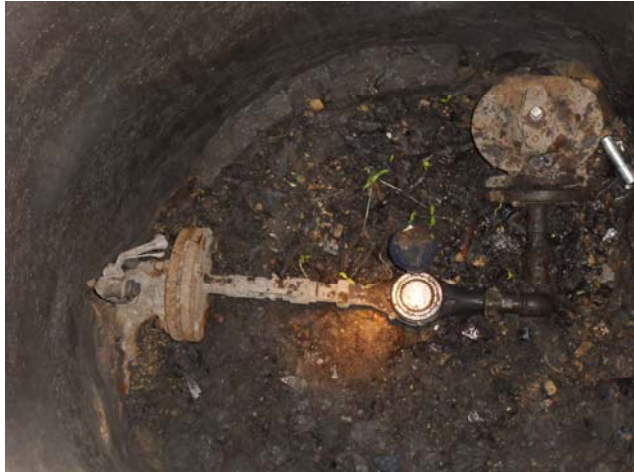
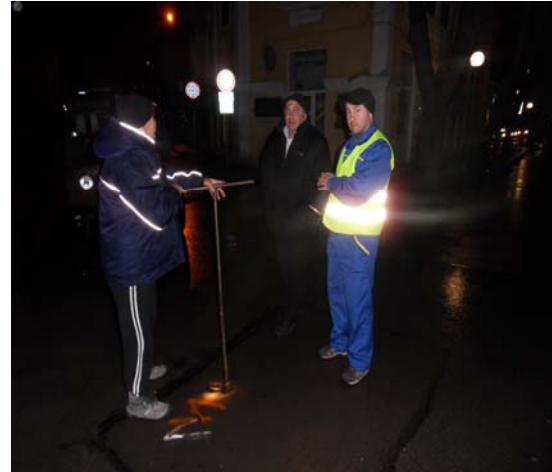
Picture 7 Step test in Kooperativen Pazar DMA

Picture 8 Step test in Kooperativen Pazar DMA

- 2) The conduction of a STEP TEST aimed the localization of possible failures (leaks). Using the existing working stop valves, we subdivided the DMA into 5 sub-DMA's for the purpose of monitoring. We determined in advance for each area the length and the materials, of which the water-supply mains were made. The test revealed, through the step-by-step shutting-off of the sub-DMA's during the small hours of the night 1:00 – 4:00h (Pictures 7 and 8) and SCADA monitoring, how many l/s from the minimum night flow were owing to

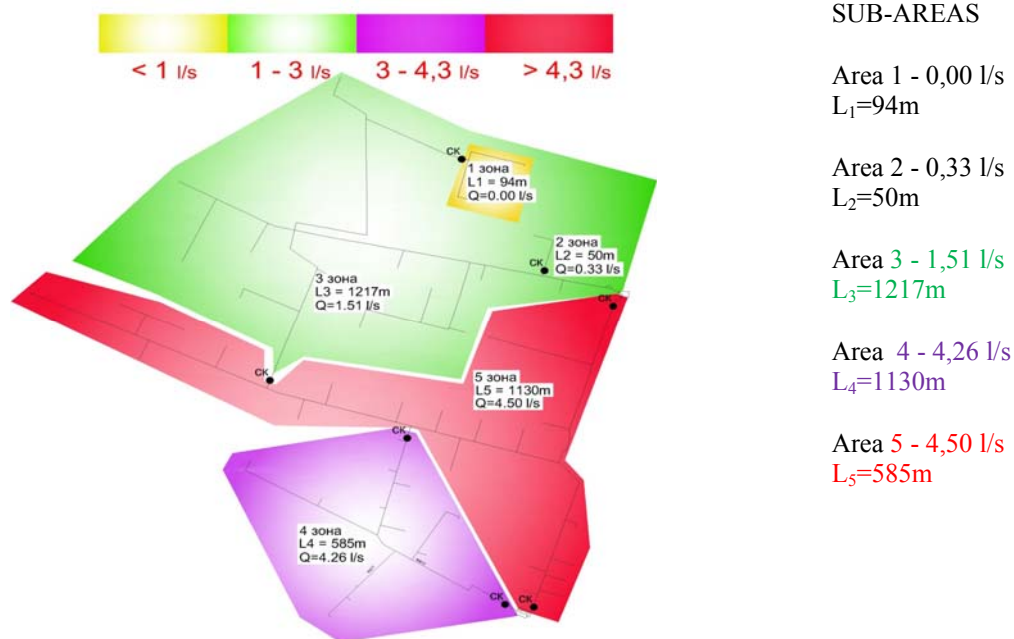
Figure 10. Step test in Kooperativen Pazar DMA

failures in each sub-DMA. (Figure 10; Table 4; Graph 8). The test carried out, it was established that there were 2 sub-areas with high water losses. Table 4 exemplifies the allocation of losses in %. Based on the step test data, it was found out that 4.26 l/s were being lost in sub-area 4, in only 585 m, which indicated there was a huge leak (pipe failure). During the preparation ahead of the above mentioned test, we determined the pipe materials, which also provided a clue in finding possible failures. The water supply mains are mainly built of steel, zinc galvanized and asbestos cement pipes.

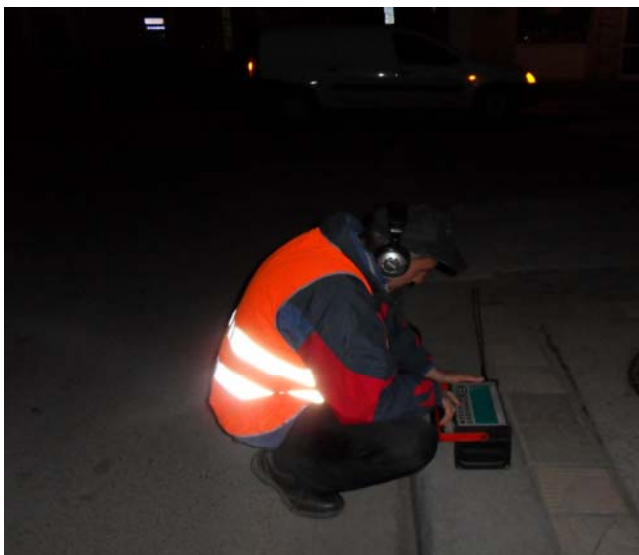
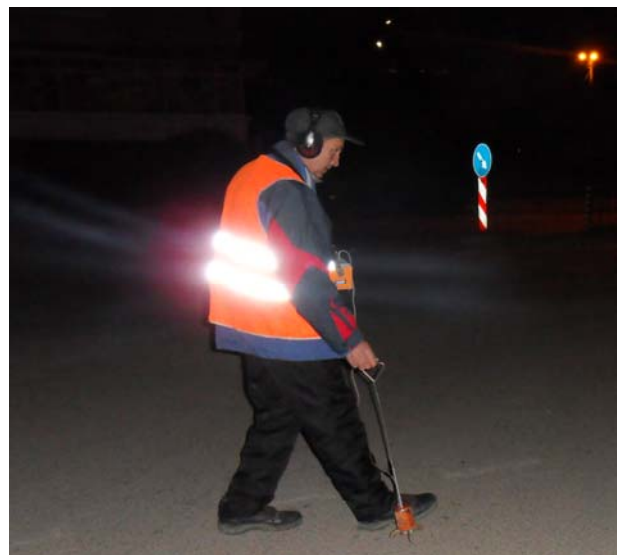
Picture 9. Searching in sub-areas 4 and 5 of Kooperativen Pazar DMA

Picture 10. Searching in sub-areas 4 and 5 of Kooperativen Pazar DMA

- 3) The next step in applying the water loss reduction programme was searching the area for hidden leaks with an electrical acoustic listening stick and a correlator. Together with a team of the Razgrad water company, specially trained and equipped for the purpose, we searched sub-areas 4 and 5, making our way along the water main branches made of steel and their associated service connections (Pictures 9 and 10).

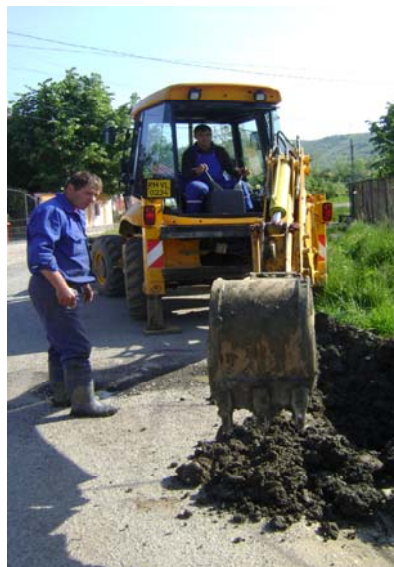
Picture 11. Kooperativen Pazar DMA – Repair of a leak in a sub-area - 3,4 l/s

- 4) Following the interventions in the two areas, we discovered 1 significant leak in sub-area 5. The leak from the steel pipe was due to massive corrosion on the external side. We replaced a 3.0 m long pipe section with a PEHD  $\Phi$  90 PN 10. The effect of the repair of the leak was significant. The minimum night flow fell with 3.40 l/s – down to MNF 1 = 7.20 l/s, which in terms of percentages makes 32 % of MNF (Graph 9).

After the repair of the leak was done (Picture 11), network pressure was expected to rise and therefore we conducted a second pressure measurement in the above mentioned control points (Table 5; Graph 11). It showed a rise in the free pressure in the critical point with 0.20 atm, which meant that pressure management could be applied (PM).
