PREDICTIVE MAINTENANCE REPORT

Customer Name :
 Site :
 Date of Visit : 27th July 2017
 Report No. : PDM/ARC/VA/092/17

Vibration Analysis Report		<div>SKF</div> <div>RELIABILITY SYSTEMS</div>			
27.07.2017					
EQUIPMENT S/NO.	1	EQUIPMENT NAME		HAMMER MILL DC FAN	
MACHINE SKETCH

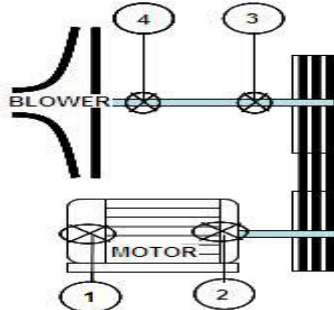
Vibration Limits for this equipment – Velocity in mm/sec (rms)					
POSITION	NORMAL	ALERT		ALARM	
MOTOR / BLOWER	7.1	7.1 to 18.0		Above 18.0	
EQUIPMENT SPECIFICATIONS					
DESCRIPTION	DRIVE	DRIVEN		MOUNTING	Y/N
Rated Speed	1480 RPM	1313 RPM		At Ground	N
Power Rating	75 KW	NA		On Rigid Concrete	N
Bearing No. (DE/NDE)	6317 / 6314	22220 EK / 22220 EK		Above Ground Level	Y
				On Vibro Pad	Y
Pulley Dia	315	335		On Steel Structure	Y
HIGHEST AMPLITUDES & HEALTH CONDITION					
LOCATION	VELOCITY (mm/sec) in rms		HEALTH CONDITION		
	Present (07.06.2017)	Present (27.07.2017)			
MOTOR	3.9	4.2	NORMAL		
BLOWER	3.7	3.6	NORMAL		
OBSERVATIONS:					
This equipment is indicating an "NORMAL" behavior with maximum vibration amplitudes of 4.2 mm/s recorded in the Motor bearings.

ANALYSIS:					
➤ Vibrations increased slightly with minor symptoms of structural looseness at motor end.					
ACTION PLAN:					
1. It is suggested to keep close monitoring over system feedback during routine field observations.

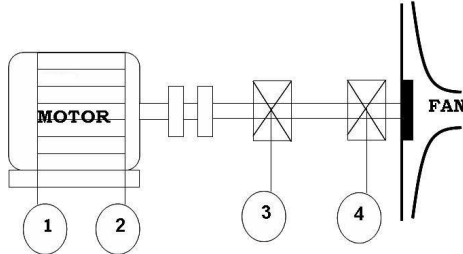
EQUIPMENT S/NO.	5	EQUIPMENT NAME		SELOX MAIN AIR FAN
MACHINE SKETCH

Vibration Limits for this equipment – Velocity in mm/sec (rms)				
POSITION	NORMAL	ALERT		ALARM
MOTOR / BLOWER	4.5	4.5 to 11.2		Above 11.2
EQUIPMENT SPECIFICATIONS				
DESCRIPTION	DRIVE	DRIVEN	MOUNTING	Y/N
Rated Speed	1485 RPM	1485 RPM	At Ground	Y
Power Rating	525 KW	NA	On Rigid Concrete	Y
Bearing No. (DE/NDE)	NU-324	22226 EK	Above Ground Level	N
	6324/C3	22226 EK	On Vibro Pad	N
Pulley Dia	NA	NA	On Steel Structure	N [®]
HIGHEST AMPLITUDES & HEALTH CONDITION				
LOCATION	VELOCITY (mm/sec) in rms		HEALTH CONDITION	
	Present (07.06.2017)	Present (27.07.2017)		
MOTOR	1.3	1.3	NORMAL	
BLOWER	1.5	1.6	NORMAL	
OBSERVATIONS: This equipment is indicating an "NORMAL" behavior with maximum vibration amplitudes of 1.6 recorded in the Blower bearings.				
ANALYSIS: ➤ The health condition of the equipment is NORMAL as per ISO standards, Although vibration trend is stable but excessive lubricant spillage observed at fan bearings.

ACTION PLAN: 1. Ok to run under trend monitoring. It is also suggested to opt proper lubrication practices to ensure adequate amount of lubricant in the system & evade excessive lubrication.

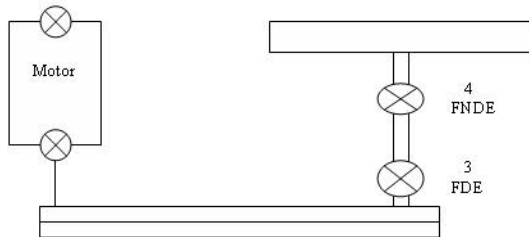
EQUIPMENT S/NO.	14	EQUIPMENT NAME	DE-AGGLOMETER	
MACHINE SKETCH

Vibration Limits for this equipment – Velocity in mm/sec (rms)				
POSITION	NORMAL	ALERT	ALARM	
MOTOR / AGLOMETER	4.5	4.5 to 11.2	Above 11.2	
EQUIPMENT SPECIFICATIONS				
DESCRIPTION	DRIVE	DRIVEN	MOUNTING	Y/N
Rated Speed	1470 RPM	2573 RPM	At Ground	Y
Power Rating	37 KW	NA	On Rigid Concrete	N
Bearing No. (DE/NDE)	6313 6312	NUP2211C3 NU 2212C3	Above Ground Level On Vibro Pad	N Y
Pulley Dia	280	160	On Steel Structure	Y
HIGHEST AMPLITUDES & HEALTH CONDITION				
LOCATION	VELOCITY (mm/sec) In rms		HEALTH CONDITION	
	Present (07.06.2017)	Present (27.07.2017)		
MOTOR	4.9	4.4	NORMAL	
AGLOMETER	2.9	3.7	NORMAL	
OBSERVATIONS: This equipment is indicating an "NORMAL" behavior with maximum vibration amplitudes of 4.4 mm/s recorded in the Motor bearings.				
ANALYSIS: ➤ Although vibrations decreased slightly to NORMAL range as per the previous history but still higher than the baseline trend. Minor symptoms of belt pulley misalignment with motor base structural looseness have been indicated in FFT spectra.

ACTION PLAN: 1. Verify belt pulley alignment and belt tension for any abnormality again. 2. Also check motor base foundation bolts for soft foot & correct the same, if any.

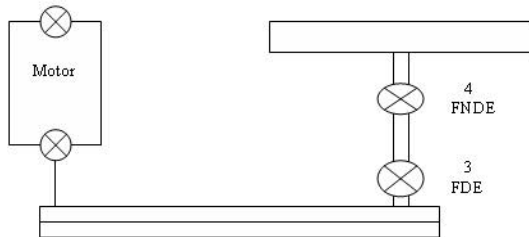
EQUIPMENT S/NO.	15	EQUIPMENT NAME		BLENDER – HOUSING SIDE
MACHINE SKETCH

Vibration Limits for this equipment – Velocity in mm/sec (rms)				
POSITION	NORMAL	ALERT		ALARM
MOTOR / BLENDER	7.1	7.1 to 18.0		Above 18.0
EQUIPMENT SPECIFICATIONS				
DESCRIPTION	DRIVE	DRIVEN	MOUNTING	Y/N
Rated Speed	2920 RPM	2336 RPM	At Ground	N
Power Rating	55 KW	NA	On Rigid Concrete	N
Bearing No. (DE/NDE)	NU 215 EC3 6215 C3	NU-312ECP 6312 ZZC3	Above Ground Level	Y
			On Vibro Pad	Y
Pulley Dia	200	250	On Steel Structure	Y
HIGHEST AMPLITUDES & HEALTH CONDITION				
LOCATION	VELOCITY (mm/sec) In rms		HEALTH CONDITION	
	Present (07.06.2017)	Present (27.07.2017)		
MOTOR	5.1	6.4	NORMAL	
BLENDER	4.2	3.7	NORMAL	
OBSERVATIONS: This equipment is indicating an "NORMAL" behavior with maximum vibration amplitudes of 6.4 mm/s recorded in the Motor bearings.				
ANALYSIS: <ul style="list-style-type: none"> ➤ Vibrations increased slightly to ALERT range as per the previous history. ➤ Minor symptoms of belt pulley misalignment with motor base structural looseness have been indicated in FFT spectra.

ACTION PLAN: <ol style="list-style-type: none"> 1. Verify belt pulley alignment and belt tension for any abnormality. 2. Also check motor base foundation bolts & rubber dampers for proper functioning.
