## PREDICTIVE MAINTENANCE REPORT

Customer Name :  
Site :  
Date of Visit : 23<sup>rd</sup> January 2017  
Report No. : PDM/ARC/VA/013/17

During the visit of our Engineer to your plant on **23.01.2017**, detailed vibration measurement and analysis was carried out on the following machines. The Present health condition of each machines are given below for your ready reference.

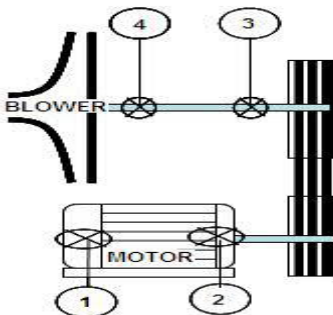
Vibration Analysis Report		<div>SKF</div> <div>RELIABILITY SYSTEMS</div>			
23.01.2017					
EQUIPMENT S/NO.	2	EQUIPMENT NAME		GENERAL DC FAN	
MACHINE SKETCH

Vibration Limits for this equipment – Velocity in mm/sec (rms)					
POSITION	NORMAL	ALERT		ALARM	
MOTOR / BLOWER	7.1	7.1 to 18.0		Above 18.0	
EQUIPMENT SPECIFICATIONS					
DESCRIPTION	DRIVE	DRIVEN	MOUNTING	Y/N	
Rated Speed	1475 RPM	2733 RPM	At Ground	N	
Power Rating	45 KW	NA	On Rigid Concrete	N	
Bearing No. (DE/NDE)	6313 / 6313	6312 / 6312	Above Ground Level	Y	
			On Vibro Pad	Y	
Pulley Dia	315	170	On Steel Structure	Y	
HIGHEST AMPLITUDES & HEALTH CONDITION					
LOCATION	VELOCITY (mm/sec) in rms		HEALTH CONDITION		
	Previous (17.11.2016)	Present (23.01.2017)			
MOTOR	5.1	4.3	NORMAL		
BLOWER	7.5	9.8	ALERT		
OBSERVATIONS:					
This equipment is indicating an "ALERT" behavior with maximum vibration amplitudes of 9.8 mm/s recorded in the Blower bearings.

ANALYSIS:					
➤ Overall health condition of the equipment is slightly above than the ALERT condition but reduced significantly than the previous vibrations data after fan assembly replacement but slight higher at fan end.					
ACTION PLAN:

1. Ok to run under trend monitoring, Improvement in system rigidity may reduce vibrations further.					
2. Check fan bearing housing for any looseness & clean coating accumulated on fan impeller on earliest available opportunity.

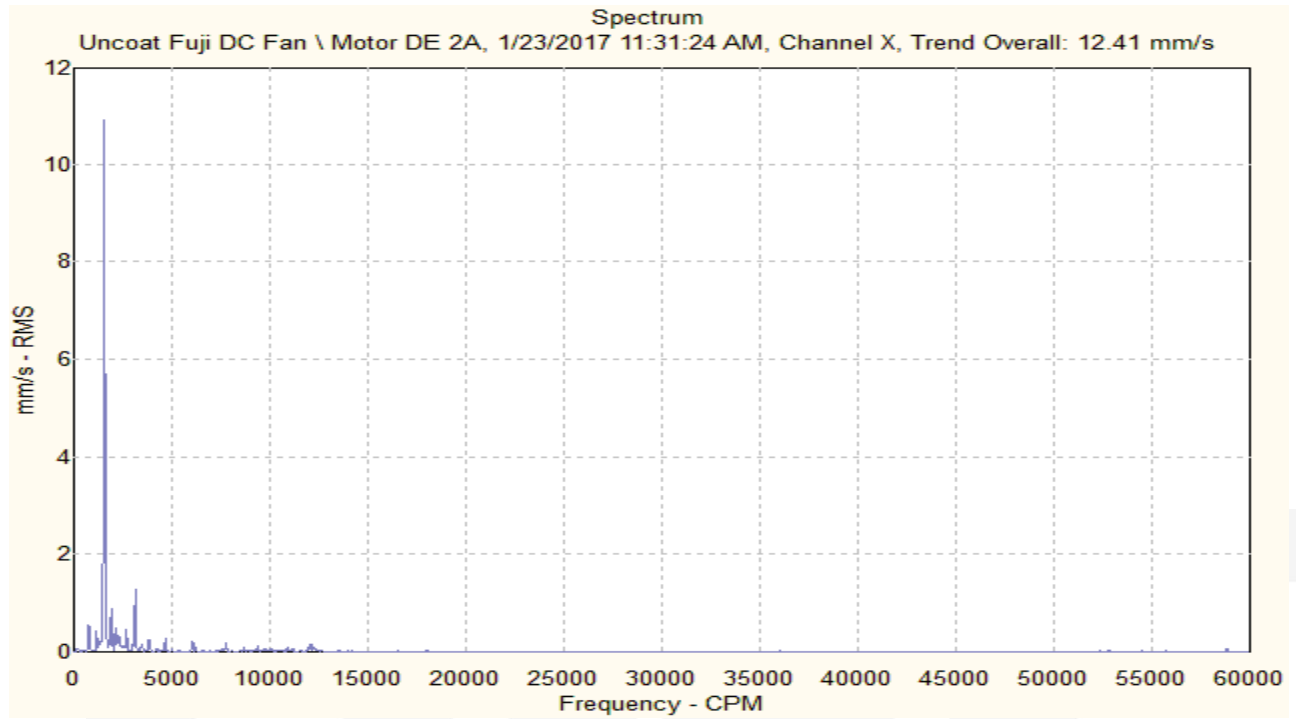
**Uncoat Fuji DC Fan \ Motor DE 2A**

Vibration Limits for this equipment – Velocity in mm/sec (rms)					
POSITION	NORMAL	ALERT		ALARM	
MOTOR / BLOWER	7.1	7.1 to 18.0		Above 18.0	
EQUIPMENT SPECIFICATIONS					
DESCRIPTION	DRIVE	DRIVEN	MOUNTING	Y/N	
Rated Speed	1460 RPM	1460 RPM	At Ground	Y	
Power Rating	18.5 KW	NA	On Rigid Concrete	N	
Bearing No. (DE/NDE)	6310 ZZ	22213 EK	Above Ground Level	N	
	6210 ZZ	22213 EK	On Vibro Pad	Y	
Pulley Dia	250	250	On Steel Structure	Y	
HIGHEST AMPLITUDES & HEALTH CONDITION					
LOCATION	VELOCITY (mm/sec) in rms		HEALTH CONDITION		
	Previous (17.11.2016)	Present (23.01.2017)			
MOTOR	20.1	12.4	ALERT		
BLOWER	22.4	10.1	ALERT		
OBSERVATIONS:					
This equipment is indicating an “ALERT” behavior with maximum vibration amplitudes of 14.5 mm/s recorded in the Blower bearings.					
ANALYSIS:

<ul style="list-style-type: none"><li>➤ Vibrations decreased slightly from the past measurement history.</li><li>➤ Symptoms of structural looseness indicated in FFT spectrum and also considerable unbalance in fan rotor coupled with introductory bearing fault indications observed in fan bearings..</li></ul>					
ACTION PLAN:					
<ol style="list-style-type: none"><li>1. Motor base rigidity is to be improved. Check vibration pads condition for proper function and provide additional rigidity to the system. Check the base foundation frame and bolts for adequate rigidity. Fan bearings are to be inspected for any abnormality and to be replaced if needed. Scheduled coating cleaning to be followed.</li></ol>

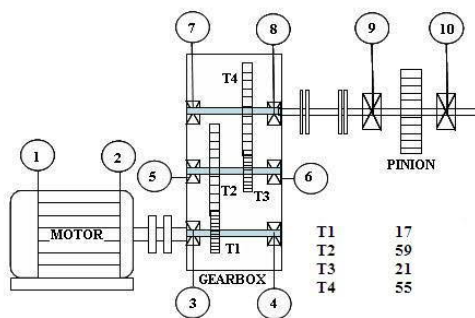
Vibration Analysis Report		<div>SKF</div> <div>RELIABILITY SYSTEMS</div>			
23.01.2017					
EQUIPMENT S/NO.	10	EQUIPMENT NAME		BALL MILL	
MACHINE SKETCH

Vibration Limits for this equipment – Velocity in mm/sec (rms)					
POSITION	NORMAL	ALERT		ALARM	
MOTOR/GEARBOX/PINION	4.5	4.5 to 11.2		Above 11.2	
EQUIPMENT SPECIFICATIONS					
DESCRIPTION	DRIVE	DRIVEN	MOUNTING	Y/N	
Rated Speed	1500 RPM	GB O/P-166.76 BM speed-20	At Ground	Y	
Power Rating	640 KW	NA	On Rigid Concrete	Y	
Bearing No. (DE/NDE)	6322/C3 VL 20171 6324	Pos 9-23140 CC/W33 Pos 10-23140 CC/W33	Above Ground Level	N	
			On Vibro Pad	N	
Pulley Dia	NA	NA	On Steel Structure	N	
HIGHEST AMPLITUDES & HEALTH CONDITION					
LOCATION	VELOCITY (mm/sec) in rms		HEALTH CONDITION		
	Previous (17.11.2016)	Present (23.01.2017)			
MOTOR	2.2	2.1	NORMAL		
GEARBOX	3.8	3.9	NORMAL		
PINION	3.4	3.4	NORMAL		
OBSERVATIONS:					
This equipment is indicating an "NORMAL" behavior with maximum vibration amplitudes of 3.9 mm/s recorded at the Gearbox bearings.

ANALYSIS:					
➤ Symptoms of improper tooth loading symptoms observed at gearbox intermediate gear.					
ACTION PLAN:					
1. Amplitude of GMFs are in trend at gearbox intermediate shaft.

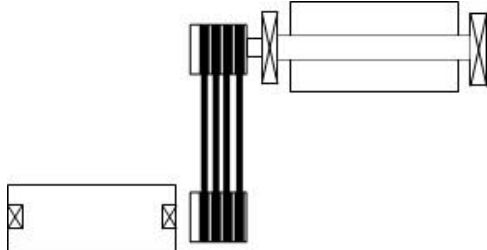
EQUIPMENT S/NO.	11	EQUIPMENT NAME	HAMMER MILL – RIGHT (DRIVE NO.1)	
MACHINE SKETCH

Vibration Limits for this equipment – Velocity in mm/sec (rms)				
POSITION	NORMAL	ALERT	ALARM	
MOTOR / HAMMER SHAFT	7.1	7.2 to 18.0	Above 18.0	
EQUIPMENT SPECIFICATIONS				
DESCRIPTION	DRIVE	DRIVEN	MOUNTING	Y/N
Rated Speed	1480 RPM	1200 RPM	At Ground	N
Power Rating	160 KW	NA	On Rigid Concrete	Y
Bearing No. (DE/NDE)	6319	22320 C3	Above Ground Level	Y
	6319	22320 C3	On Vibro Pad	Y
Pulley Dia	400	500	On Steel Structure	N <sup>®</sup>
HIGHEST AMPLITUDES & HEALTH CONDITION				
LOCATION	VELOCITY (mm/sec) in rms		HEALTH CONDITION	
	Previous (17.11.2016)	Present (23.01.2017)		
MOTOR	10.8	8.1	ALERT	
HAMMER SHAFT	4.8 (23.9 gE)	8.3 (23.5 gE)	ALERT	
OBSERVATIONS: This equipment is indicating an "ALERT" behavior with maximum vibration amplitudes of 8.3 mm/s recorded in the Motor bearings.

ANALYSIS: ➤ Overall health condition of the equipment is in NORMAL condition, though vibrations at motor bearings varying within a long range due to inadequate rigidity to the system, hence can't be kept under NORMAL range.				
ACTION PLAN: 1. High vibrations are due to flexible base rigidity. As the vibrations are now almost stable, OEM to be consult for acceptable vibration range for such flexible structure in order to verify the equipment health condition. Trend monitoring is suggested.

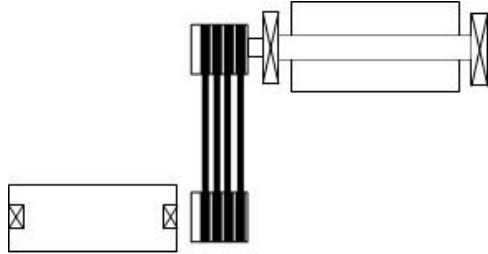
EQUIPMENT S/NO.	12	EQUIPMENT NAME	HAMMER MILL – LEFT (DRIVE NO.2)	
MACHINE SKETCH

Vibration Limits for this equipment – Velocity in mm/sec (rms)				
POSITION	NORMAL	ALERT	ALARM	
MOTOR / HAMMER SHAFT	7.1	7.2 to 18.0	Above 18.0	
EQUIPMENT SPECIFICATIONS				
DESCRIPTION	DRIVE	DRIVEN	MOUNTING	Y/N
Rated Speed	1480 RPM	1200 RPM	At Ground	N
Power Rating	160 KW	NA	On Rigid Concrete	Y
Bearing No. (DE/NDE)	6319	22320 C3	Above Ground Level	Y
	6319	22320 C3	On Vibro Pad	Y
Pulley Dia	400	500	On Steel Structure	N <sup>®</sup>
HIGHEST AMPLITUDES & HEALTH CONDITION				
LOCATION	VELOCITY (mm/sec) in rms		HEALTH CONDITION	
	Previous (17.11.2016)	Present (23.01.2017)		
MOTOR	8.1	7.0	NORMAL	
HAMMER SHAFT	4.4 (17.1 gE)	4.1 (28.6 gE)	NORMAL	
OBSERVATIONS: This equipment is indicating an "NORMAL" behavior with maximum vibration amplitudes of 7.0 mm/s recorded in the Motor bearings.

ANALYSIS: ➤ Overall health condition of the equipment is in NORMAL condition, though vibrations at motor bearings varying within a long range due to inadequate rigidity to the system, hence can't be kept under NORMAL range.				
ACTION PLAN: 1. High vibrations are due to flexible base rigidity. As the vibrations are now almost stable, OEM to be consult for acceptable vibration range for such flexible structure in order to verify the equipment health condition. Trend monitoring is suggested.

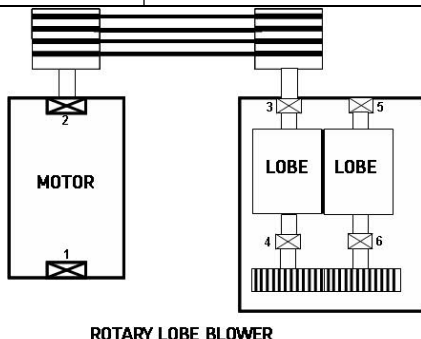
Vibration Analysis Report		<div>SKF</div> <div>RELIABILITY SYSTEMS</div>			
23.01.2017					
EQUIPMENT S/NO.	17	EQUIPMENT NAME	BLENDER AERATION BLOWER		
MACHINE SKETCH

ROTARY LOBE BLOWER			
Vibration Limits for this equipment – Velocity in mm/sec (rms)					
POSITION	NORMAL	ALERT		ALARM	
MOTOR / BLOWER	7.1	7.1 to 18.0		Above 18.0	
EQUIPMENT SPECIFICATIONS					
DESCRIPTION	DRIVE	DRIVEN	MOUNTING	Y/N	
Rated Speed	1450 RPM	725 RPM	At Ground	N	
Power Rating	11 KW	NA	On Rigid Concrete	N	
Bearing No. (DE/NDE)	6309 ZZ	6205 ZZ	Above Ground Level	Y	
	6209ZZ	6205 ZZ	On Vibro Pad	N	
Pulley Dia	125	250	On Steel Structure	Y	
HIGHEST AMPLITUDES & HEALTH CONDITION					
LOCATION	VELOCITY (mm/sec) in rms		HEALTH CONDITION		
	Previous (17.11.2016)	Present (23.01.2017)			
MOTOR	2.1	2.1	NORMAL		
BLOWER	3.9	3.9	NORMAL		
OBSERVATIONS:					
This equipment is indicating an "NORMAL" behavior with maximum vibration amplitudes of 3.9 mm/s recorded in the Blower bearings.

ANALYSIS:					
➤ The health condition of the equipment is NORMAL as per ISO Standards but in increasing trend from past few measurements. Symptoms of improper lobe meshing are being observed.					
ACTION PLAN:

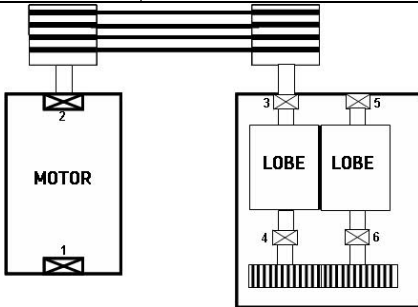
Vibration Analysis Report		<div>SKF</div> <div>RELIABILITY SYSTEMS</div>			
23.01.2017					
EQUIPMENT S/NO.	18	EQUIPMENT NAME	PRODUCT SILO AREATION BLOWER		
MACHINE SKETCH		<div>

</div> <div>ROTARY LOBE BLOWER</div>			
Vibration Limits for this equipment – Velocity in mm/sec (rms)					
POSITION	NORMAL	ALERT		ALARM	
MOTOR / BLOWER	7.1	7.1 to 18.0		Above 18.0	
EQUIPMENT SPECIFICATIONS					
DESCRIPTION	DRIVE	DRIVEN	MOUNTING	Y/N	
Rated Speed	1470 RPM	1317 RPM	At Ground	N	
Power Rating	22 KW	NA	On Rigid Concrete	N	
Bearing No. (DE/NDE)	6310 ZZ	NA	Above Ground Level	Y	
	6310ZZ		On Vibro Pad	N	
Pulley Dia	224	250	On Steel Structure	Y	
HIGHEST AMPLITUDES & HEALTH CONDITION					
LOCATION	VELOCITY (mm/sec) in rms		HEALTH CONDITION		
	Previous (17.11.2016)	Present (23.01.2017)			
MOTOR	7.3	6.9	NORMAL		
BLOWER	6.4	5.7	NORMAL		
OBSERVATIONS:					
This equipment is indicating an “NORMAL” behavior with maximum vibration amplitudes of 6.9 mm/s recorded in the Motor bearings.

ANALYSIS:					
➤ The health condition of the equipment is slightly above ALERT as per ISO standards due to temporary operational changes possibly.					
ACTION PLAN:

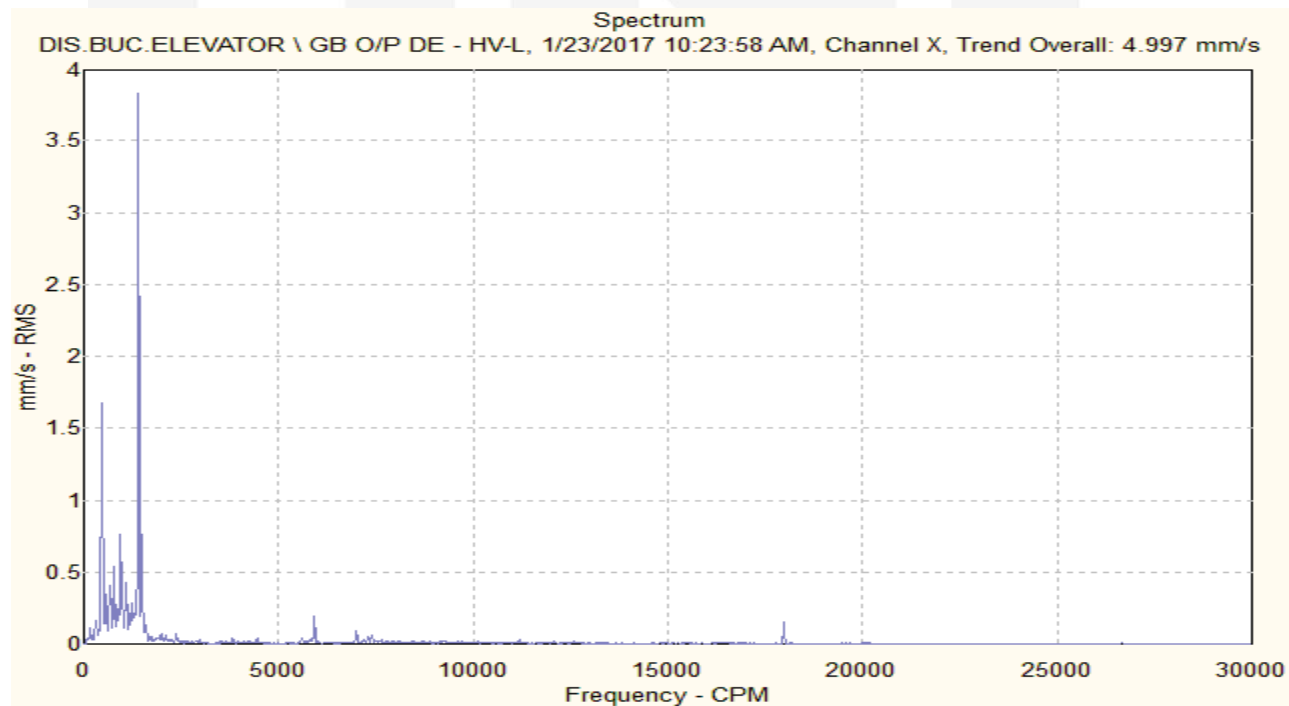
## DIS.BUC.ELEVATOR \ GB O/P DE - HV-L

Vibration Limits for this equipment – Velocity in mm/sec (rms)				
POSITION	NORMAL	ALERT	ALARM	
MOTOR/GEARBOX/ELEVATOR	4.5	4.5 to 11.2	Above 11.2	
EQUIPMENT SPECIFICATIONS				
DESCRIPTION	DRIVE	DRIVEN	MOUNTING	Y/N
Rated Speed	1460	GB I/P-1460 GB O/P-48.6 Pulley shaft-33	At Ground	N
Power Rating	15 KW	NA	On Rigid Concrete	N
Bearing No. (DE/NDE)	6309 ZZ 6209ZZ	Pos 3-32213 Pos 4-32213 Pos 5-32216 Pos 6-32216 Pos 7-22222 EK Pos 8-22222 EK	Above Ground Level	Y
			On Vibro Pad	N
Pulley Dia	GB Sprocket 17 teeth	BE Drum Sprocket 26 teeth	On Steel Structure	Y
HIGHEST AMPLITUDES & HEALTH CONDITION				
LOCATION	VELOCITY (mm/sec) in rms		HEALTH CONDITION	
	Previous (17.11.2016)	Present (23.01.2017)		
MOTOR	3.1	3.8	NORMAL	
GEARBOX	4.3	4.9	ALERT	
ELEVATOR	2.8	2.9	NORMAL	
OBSERVATIONS: This equipment is indicating an "ALERT" behavior with maximum vibration amplitudes of 4.9 mm/s recorded at the Gearbox side.

ANALYSIS: ➤ The health condition of the equipment is ALERT as per ISO standards but slight increment in vibrations observed indicating minor misalignment induced vibrations.				
ACTION PLAN: 1. It is suggested to review machine train alignment within permissible limits and reassess the alignment if required. Also check motor base bolts for slight looseness & rectify the same if needed.

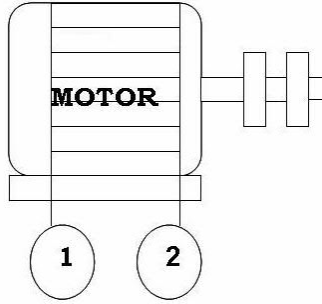
EQUIPMENT S/NO.	21	EQUIPMENT NAME		CLASSIFIER AIR SLIDE FAN	
MACHINE SKETCH

Vibration Limits for this equipment – Velocity in mm/sec (rms)					
POSITION		NORMAL		ALERT	
MOTOR / FAN		4.5		4.5 to 11.2	Above 11.2
EQUIPMENT SPECIFICATIONS					
DESCRIPTION		DRIVE		DRIVEN	
Rated Speed		2915 RPM		2915 RPM	At Ground
Power Rating		5.5 KW		NA	On Rigid Concrete
Bearing No. (DE/NDE)		NA		NA	Above Ground Level
					On Vibro Pad
Pulley Dia		NA		NA	On Steel Structure
HIGHEST AMPLITUDES & HEALTH CONDITION					
LOCATION	VELOCITY (mm/sec) in rms			HEALTH CONDITION	
	Previous (17.11.2016)		Present (23.01.2017)		
MOTOR	10.1		4.8	ALERT	
OBSERVATIONS: This equipment is indicating an "ALERT" behavior with maximum vibration amplitudes of 4.8 mm/s recorded in the Motor bearings.					
ANALYSIS: ➤ Vibrations reduced significantly all time lower range after execution of suggested corrective action at most of the locations but increased in vertical direction & still in ALERT range. Symptoms of inadequate structural rigidity observed in the system.

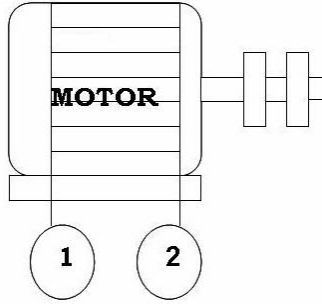
EQUIPMENT S/NO.	22	EQUIPMENT NAME	CLASSIFIER SEAL AIR FAN	
MACHINE SKETCH

Vibration Limits for this equipment – Velocity in mm/sec (rms)				
POSITION	NORMAL	ALERT	ALARM	
MOTOR / FAN	4.5	4.5 to 11.2	Above 11.2	
EQUIPMENT SPECIFICATIONS				
DESCRIPTION	DRIVE	DRIVEN	MOUNTING	Y/N
Rated Speed	2800 RPM	2800 RPM	At Ground	Y
Power Rating	22 KW	NA	On Rigid Concrete	N
Bearing No. (DE/NDE)	6310 2Z C3	NA	Above Ground Level	N
	6210 2Z C3		On Vibro Pad	Y
Pulley Dia	NA	NA	On Steel Structure	Y
HIGHEST AMPLITUDES & HEALTH CONDITION				
LOCATION	VELOCITY (mm/sec) in rms		HEALTH CONDITION	
	Previous (17.11.2016)	Present (23.01.2017)		
MOTOR	6.1	5.5	ALERT	
OBSERVATIONS: This equipment is indicating an "ALERT" behavior with maximum vibration amplitudes of 5.5 mm/s recorded in the Motor bearings.				
ANALYSIS: ➤ The health condition of the equipment is just above ALERT as per ISO standards but vibrations trending higher from past few measurements indicating minor structural looseness induced vibrations.

ACTION PLAN: 1. Check foundation bolts for proper tightening and arrest slight looseness at base bolts, if any. Improvement in base structure rigidity may decrease the vibration level further, Kept under trend monitoring.

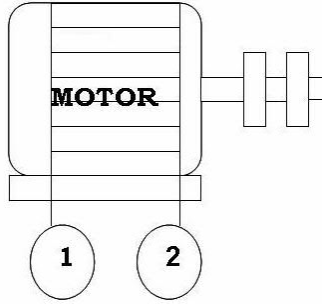
EQUIPMENT S/NO.	24	EQUIPMENT NAME		SILO NO.2 BINVENT FAN	
MACHINE SKETCH

Vibration Limits for this equipment – Velocity in mm/sec (rms)					
POSITION		NORMAL		ALERT	
MOTOR / FAN		7.1		7.1 to 18.0	
EQUIPMENT SPECIFICATIONS					
DESCRIPTION		DRIVE		DRIVEN	
Rated Speed		1400 RPM		NA	
Power Rating		5.5 KW		NA	
Bearing No. (DE/NDE)		6208 ZZ 6207 ZZ		NA	
				Above Ground Level	N
				On Vibro Pad	Y
Pulley Dia		NA		NA	
				On Steel Structure	Y
HIGHEST AMPLITUDES & HEALTH CONDITION					
LOCATION		VELOCITY (mm/sec) in rms		HEALTH CONDITION	
		Previous (17.11.2016)	Present (23.01.2017)		
MOTOR		34.3	24.8	ALARM	
OBSERVATIONS: This equipment is indicating an "ALARM" behavior with maximum vibration amplitudes of 24.8 mm/s recorded in the Motor bearings.					
ANALYSIS: <ul style="list-style-type: none"> <li>➤ Vibrations reduced significantly after partial execution of suggested corrective action at most of the locations but still higher as per the previous history and in ALARM range.</li> <li>➤ Symptoms of considerable unbalance indicated at fan impeller.</li> </ul>

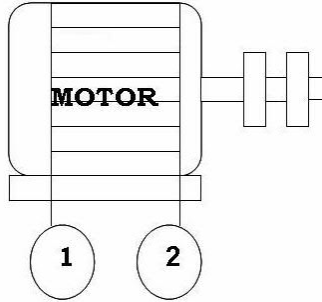
EQUIPMENT S/NO.	25	EQUIPMENT NAME		SILO NO.3 BINVENT FAN
MACHINE SKETCH

Vibration Limits for this equipment – Velocity in mm/sec (rms)				
POSITION	NORMAL	ALERT	ALARM	
MOTOR / FAN	7.1	7.1 to 18.0	Above 18.0	
EQUIPMENT SPECIFICATIONS				
DESCRIPTION	DRIVE	DRIVEN	MOUNTING	Y/N
Rated Speed	1400 RPM	NA	At Ground	Y
Power Rating	5.5 KW	NA	On Rigid Concrete	N
Bearing No. (DE/NDE)	6208 ZZ	NA	Above Ground Level	N
	6207 ZZ		On Vibro Pad	Y
Pulley Dia	NA	NA	On Steel Structure	Y
HIGHEST AMPLITUDES & HEALTH CONDITION				
LOCATION	VELOCITY (mm/sec) in rms		HEALTH CONDITION	
	Previous (17.11.2016)	Present (23.01.2017)		
MOTOR	17.9	8.6	ALERT	
OBSERVATIONS: This equipment is indicating an "ALERT" behavior with maximum vibration amplitudes of 8.6 mm/s recorded in the Motor bearings.				
ANALYSIS: <ul style="list-style-type: none"> <li>➤ Although vibrations reduced significantly as per the previous history but still in ALERT range.</li> <li>➤ Symptoms of considerable unbalance indicated at fan impeller.</li> </ul>
