AGAR WATERCUT FIELD EVALUATION TEST – Otumara and North Bank Flow Stations

Executive Summary:

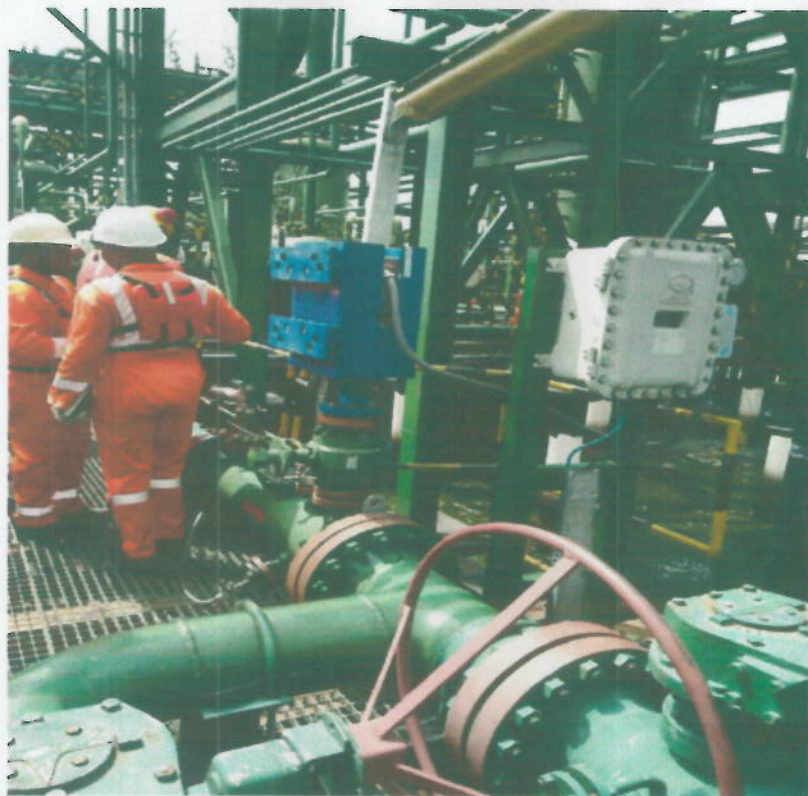
Fig 1.0 Otumara FS Installation

The Agar water cut meter installation at Otumara FS and North Bank FS comprised of inline static mixers upstream the water cut meters. At Otumara, the installation is upstream the metering skid, while that at North bank is downstream the metering skid.

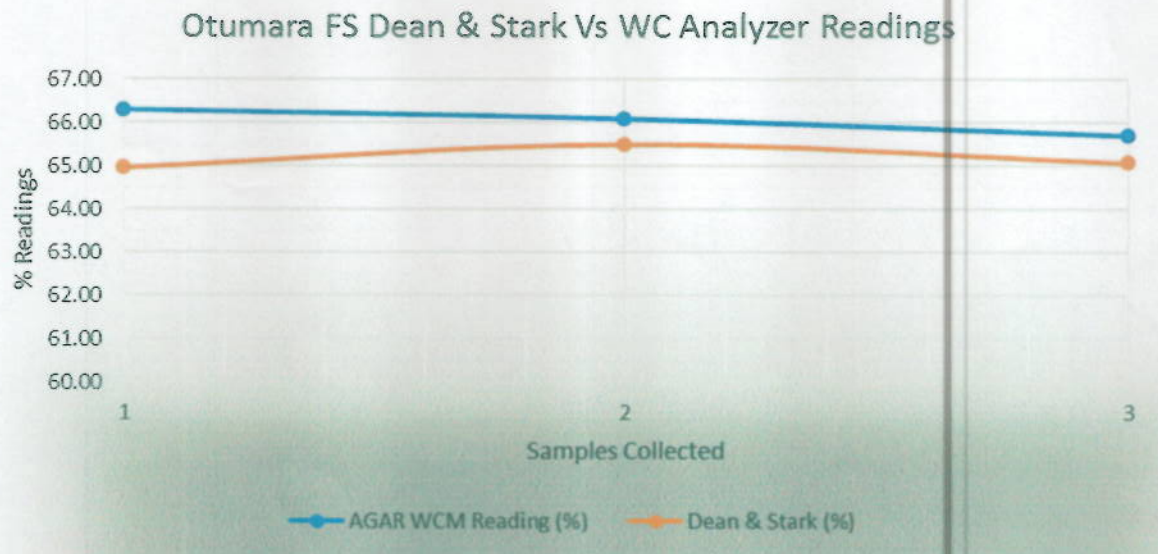
Fig 3.2: Dean & Stark v WC analyser readings for Otumara FS

FACILITY :	Otumara FS		
TEST DATE:	4 th December 2018		
LOCATION OF WATERCUT METER:	Metering Skid area		
METER SERIAL NO/YEAR OF MFG:	130036.18/2013		
METER MANUFACTURE:	AGAR Corporation		
PHYSICAL DESCRIPTION OF STATE OF METER:	Meter was in good condition		
WAS METER POWERED ON: YES/NO	Yes		
DESCRIPTION OF SAMPLE COLLECTION POINT:	Sampling point is on the line		
NUMBER OF SAMPLES COLLECTED:	3		
	SAMPLE 1	SAMPLE 2	SAMPLE 3
START TIME	12:01	12:07	12:11
STOP TIME	12:02	12:08	12:11
AVERAGE WCM READING (OWNwin)	66.30	66.09	65.70
DEAN & STARK(LAB ANALYSIS)	64.96	65.50	65.07

Comparison of data as shown in Fig. 3.2 and 3.4 shows that the deviation between D & S and water cut readings is less than $\pm 2\%$. This is clearly represented in the deviation plot below.

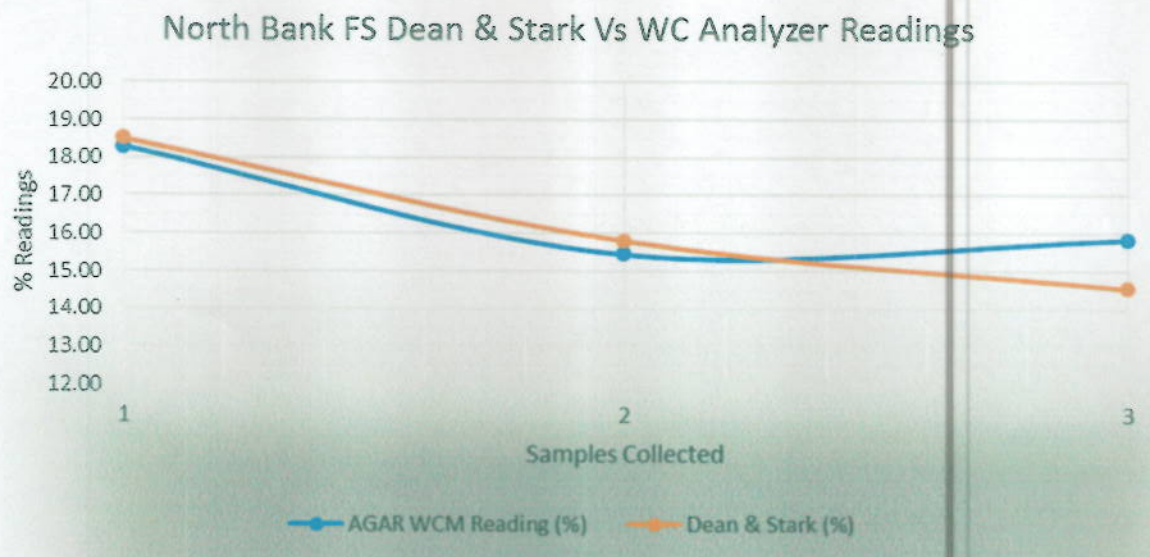
Fig 3.4: Dean & Stark v Water analyser reading for North bank FS

FACILITY:	North Bank FS		
TEST DATE:	5 th December 2018		
LOCATION OF WATERCUT METER:	Metering Skid area		
METER SERIAL NO/YEAR OF MFG:	130036.4/2013		
METER MANUFACTURE:	AGAR Corporation		
PHYSICAL DESCRIPTION OF STATE OF METER:	Meter was in good condition		
WAS METER POWERED ON: YES/NO	Yes		
DESCRIPTION OF SAMPLE COLLECTION POINT:	Sampling point is on the line		
NUMBER OF SAMPLES COLLECTED:	3		
	SAMPLE 1	SAMPLE 2	SAMPLE 3
START TIME	17:43	17:47	17:50
STOP TIME	17:44	17:47	17:50
AVERAGE WCM READING (OWNwin)	18:29	15:44	15:83
DEAN & STACK(LAB ANALYSIS)	18:50	15:80	14:50
