Replace Transfer Belt

CP2025/CM2320MFP/M351/M451/M375MFP/M475MFP/M476MFP

ITB removal

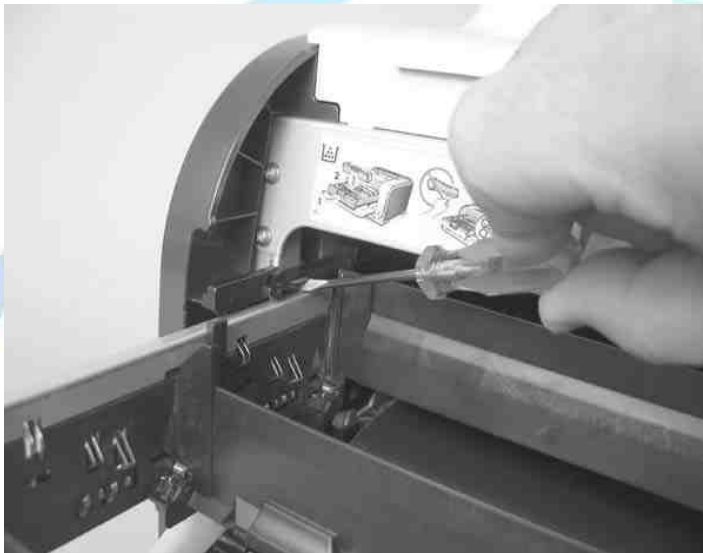
1. Remove the print-cartridge drawer.

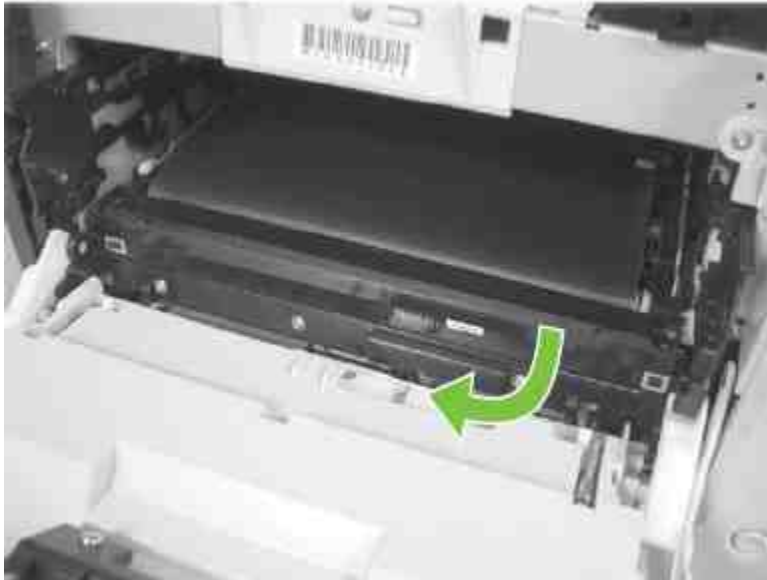
3. Carefully rotate the color mis registration sensor away from the ITB.

CAUTION: The sensor is still attached to the left side of the product and cannot be completely removed.

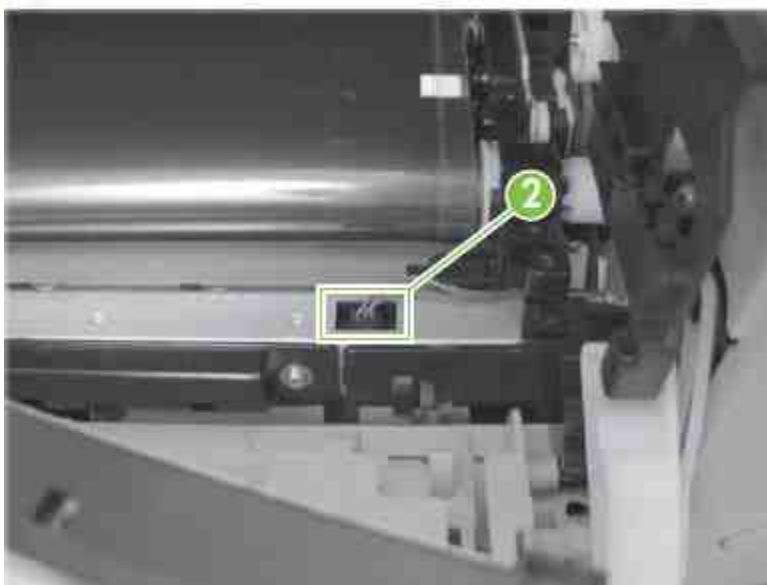
4. Disconnect one connector (callout 2).

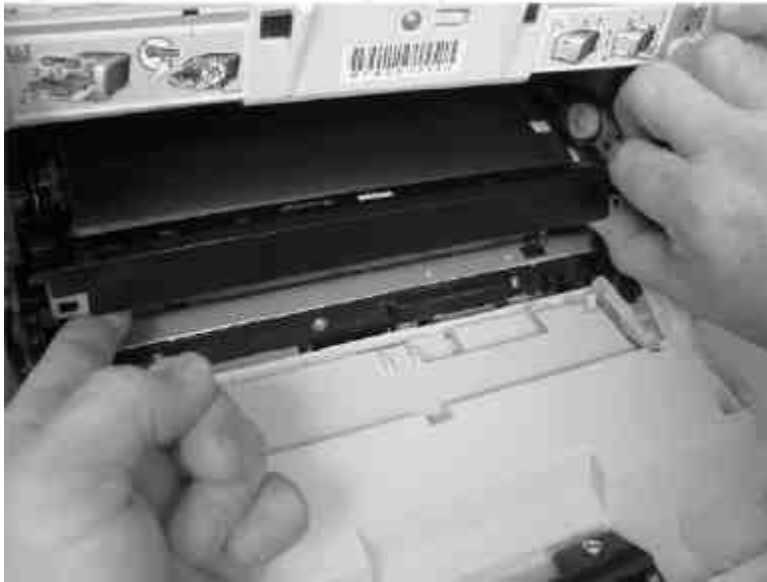
5. Carefully lift up on the front of the ITB to release it.

CAUTION: Avoid touching the black plastic transfer belt. Skin oils on the belt might cause print-quality problems. Lift the ITB as shown below by using the hard-plastic edges of the ITB.
