HP LaserJet P3005/M3027MFP/M3035MFP Grinding

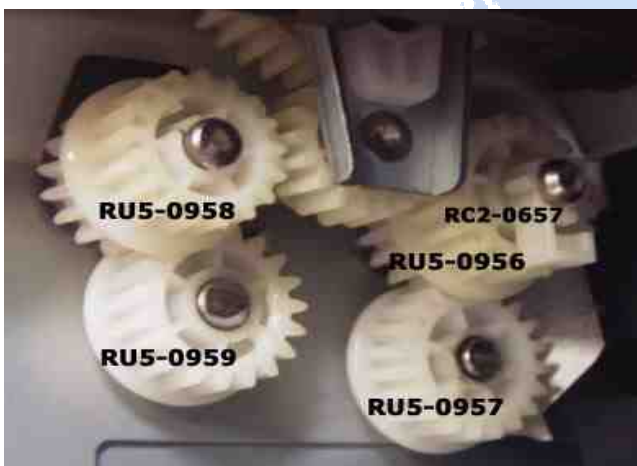
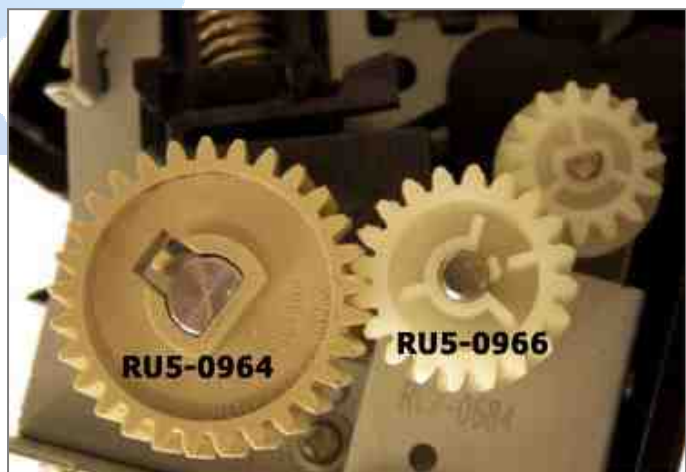
NOTE: when replacing the plastic Thrust Stopper Clip (RC2-0657), be sure to have the longer part pointing down (see image). Failure to do so will cause paper to jam at the fuser or to jam when printing duplex mode.

Cluster of Fuser Driver Gears: RU5-0956, RU5-0957, RU5-0958 & RU5-0959

Fuser Thrust Stopper (Clip) - RC2-0657

Fuser Gear - RU5-0966

Fuser Pressure Roller Gear - RU5-0964

All of these parts (7) can be purchased together from Laser Pros International using part #P3005-GK
