## HP LaserJet CP2025, CM2320, M351, M451, M375, M475, M476

### Paper Jam in Rear Door

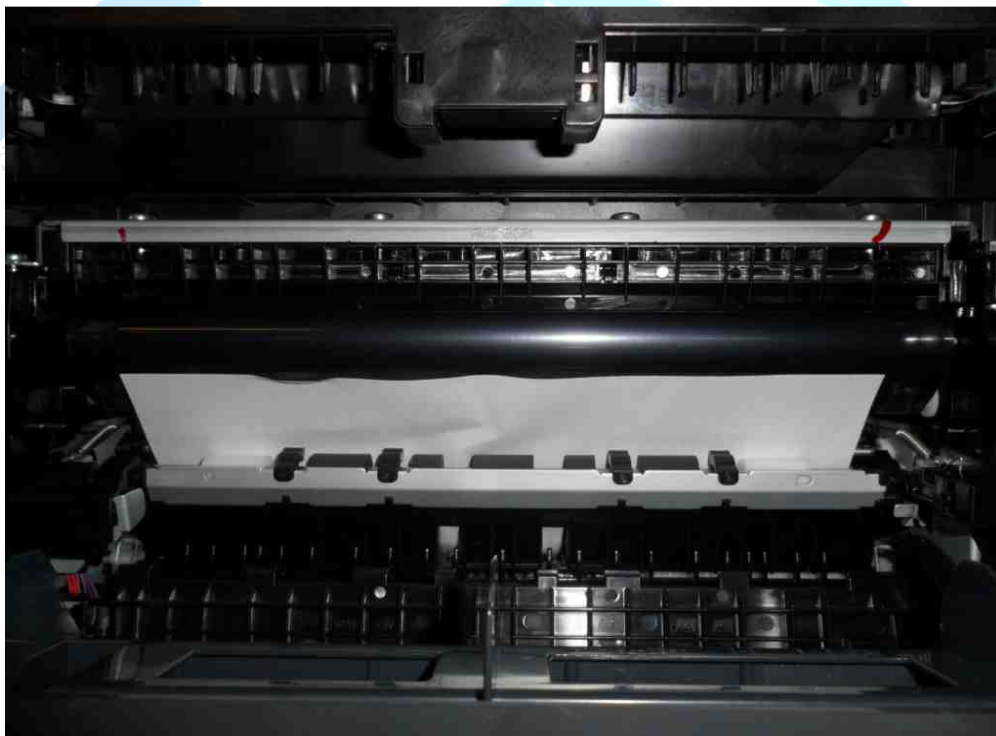
The symptom is that the printer will reach the ready state, start to process the print job, initiate pick up & pull the page about 3 inches into the paper path up to the transfer belt and then display “jam in rear door”.  
(Shown in image below with rear door open)

The cause for this paper jam is that the transfer belt is *not* rotating within the printer.

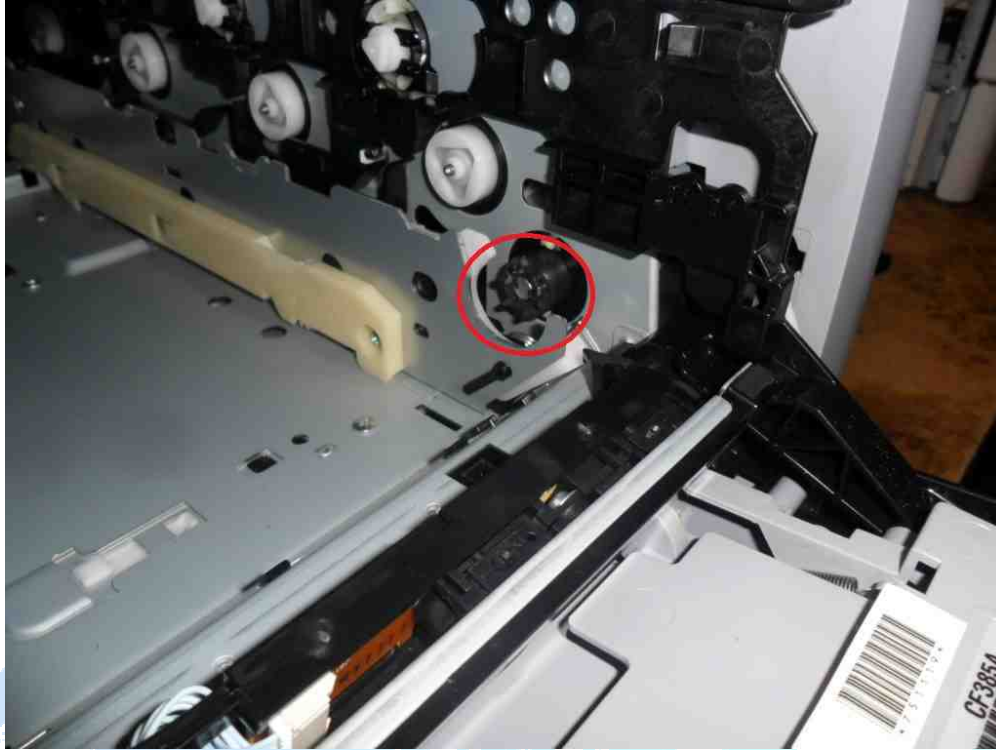
The cause for the belt not rotating is a broken gear on the Main Drive Assembly. The circled gear is supposed to have 6 teeth (shown below with belt removed) that extend out to drive the transfer belt but in these cases the teeth shear off to a smooth surface and at that point require the Main Drive Assembly (MDA) to be replaced.

The service manuals for these models do not list a part # for the MDA as the value of the printer is not worth the 2-3 hour repair time to change it and for most cases the printer is replaced. However it is available through Laser Pros International via part #:

CM2320-GT-R for models CP2025 and CM2320

M475-GT-R for models M351, M451, M375, M475, M476.
