2003 LEXUS RX300

VIN: JTJHF10U630295231

Work Order #: 5424029

DAMAGES - SUGGESTED REPAIRS

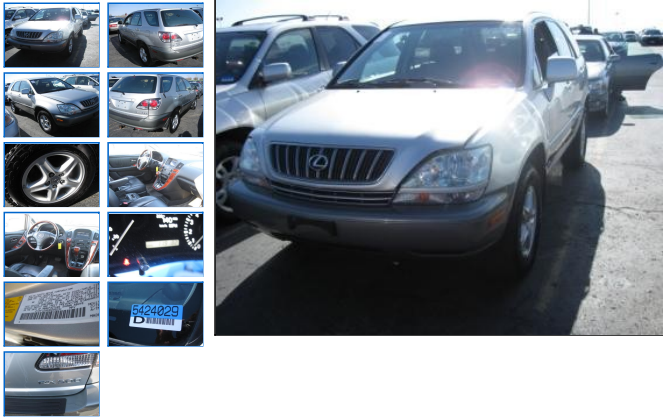
VEHICLE IMAGES

DESCRIPTION	CONDITION	SEVERITY	SUGGESTED REPAIR	TOTAL LABOR HOURS
	LR Door	Dent/No Paint Dmg	PDR/2	PDR	.00
	RR Door	Dent/No Paint Dmg	PDR/3	PDR	.00
	Windshield	Chipped	Vsbl Close Insp	No Action Required	.00
	Front Bumper Co	Chipped	Surface Damage	Brush Touch	.00
 	Hood	Multiple Chips	Surface Damage	Refinish	3.80
	LF Fender	Chipped	Surface Damage	Brush Touch	.00
	LF Door	Scratched	Surface Damage	Wet Sand	.00
	LR Door	Scratched	Surface Damage	Wet Sand	.00
	L Qtr Panel	Chipped	Surface Damage	Brush Touch	.00
 	Rear Bumper Cov	Scratched	Body Damage	Repair	3.60
	RF Fender	Scratched	Surface Damage	Wet Sand	.00
	RF Door	Scratched	Surface Damage	Wet Sand	.00
	RR Door	Scratched	Surface Damage	Wet Sand	.00

R Qtr Panel	Dent/Paint Dmg	Body Damage	Repair	5.30
				TOTALS	12.70
