Site Survey / Brandbook

Bank Sample
123 Main St
Anytown, US
11111

Survey Index

I.	Location Map
II.	Satellite Map
III.	Overview Photographs
IV.	Site Plan
V.	Elevation Page
VI.	Inventory Summary
VII.	Inventory Detail

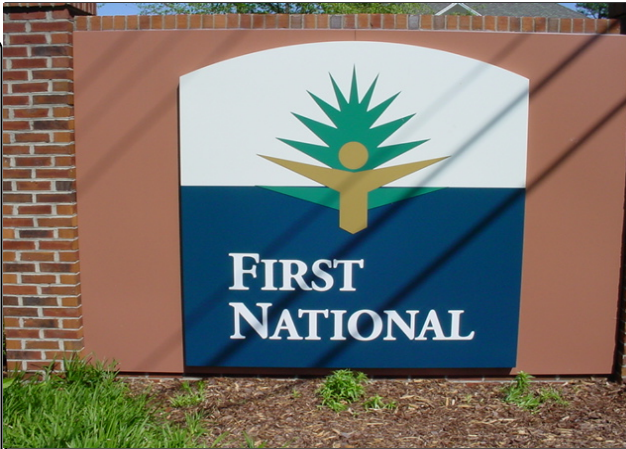
E 01

Notes: E1 Ph# 14 - 19

Quantity 2

Available area represents the metal backplate.

Color code for Metal Backing is between
SW6327 and SW6319

Sign Copy		
First National		
Existing Sign Type		
Monument		
Height	Width	Depth
6' 1"	5' 10 1/2"	2"
Letter Height	OAH above Grade	
8"	6'	
Sign Material	Mount	
Alum	Flush	
Face Type	Face Material	
Flat	Alum	
Retainer Width	Retainer Depth	
N/A	N/A	
V.O. Height	V.O. Width	
Custom	Custom	
Surface Color	Surface Material	
See note	Metal	
Available Height	Available Width	
6' 5 1/4"	9' 7"	
Double Face	Illuminated	
Yes	Yes - External

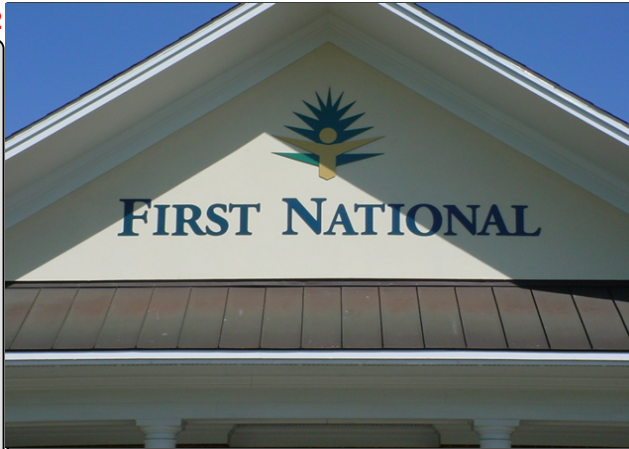
E 02

Notes: E2 Ph# 35 - 37

Estimated due to slanting roof

LOGO is estimated at 4' 1" High

The available height is 9' at the peak

Sign Copy		
First National		
Existing Sign Type		
Letter Set		
Height	Width	Depth
7'	15'	1/4"
Letter Height	OAH above Grade	
1' 6"	26'	
Sign Material	Mount	
Alum	Flush	
Face Type	Face Material	
Flat	Alum	
Retainer Width	Retainer Depth	
N/A	N/A	
V.O. Height	V.O. Width	
N/A	N/A	
Surface Color	Surface Material	
SW6672	Dryvit	
Available Height	Available Width	
9'	18'	
Double Face	Illuminated	
No	No

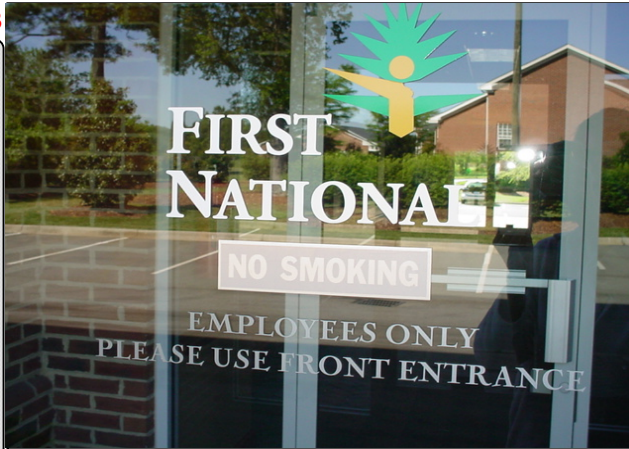
E 03

Notes: E3 Ph# 39 - 41
Quantity 2

Sign Copy		
First National		
Existing Sign Type		
Vinyl		
Height	Width	Depth
11"	1'	N/A
Letter Height	OAH above Grade	
2"	5' 6"	
Sign Material	Mount	
Vinyl	1st Surface	
Face Type	Face Material	
Flat	Glass	
Retainer Width	Retainer Depth	
N/A	N/A	
V.O. Height	V.O. Width	
N/A	N/A	
Surface Color	Surface Material	
Clear	Glass	
Available Height	Available Width	
6'	2' 6"	
Double Face	Illuminated	
No	No

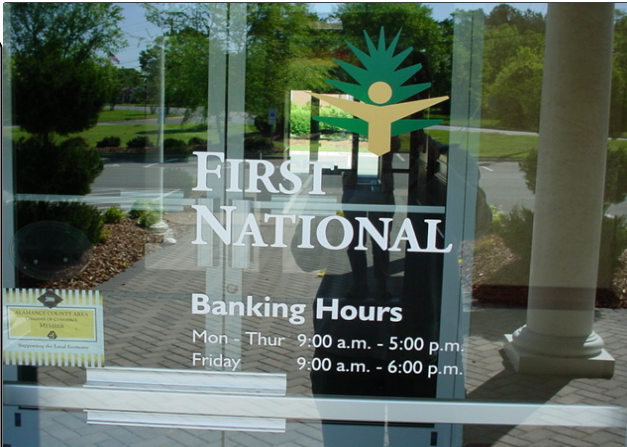
E 04

Notes: E4 Ph# 39

Sign Copy		
Banking Hours		
Existing Sign Type		
Vinyl		
Height	Width	Depth
4"	1'	N/A
Letter Height	OAH above Grade	
1"	4' 6"	
Sign Material	Mount	
Vinyl	1st Surface	
Face Type	Face Material	
Flat	Glass	
Retainer Width	Retainer Depth	
N/A	N/A	
V.O. Height	V.O. Width	
N/A	N/A	
Surface Color	Surface Material	
Clear	Glass	
Available Height	Available Width	
6'	2' 6"	
Double Face	Illuminated	
No	No

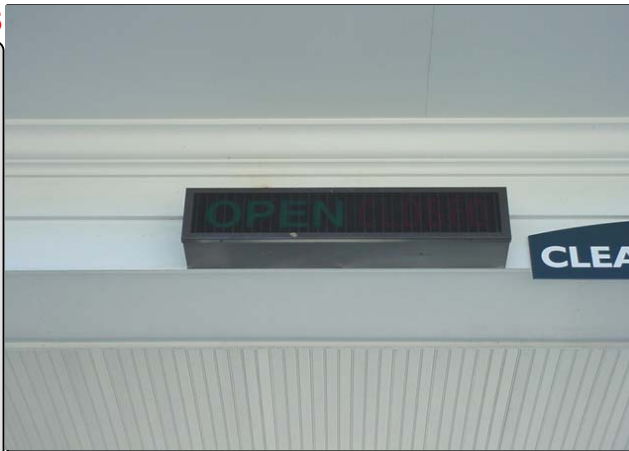
E 05

Notes: E5 Ph# 43 - 45
Quantity 3

Sign Copy		
Open/ Closed		
Existing Sign Type		
Cabinet		
Height	Width	Depth
7"	2' 10"	7"
Letter Height		OAH above Grade
4"		13'
Sign Material		Mount
Alum		Flush
Face Type		Face Material
Flat		Alum
Retainer Width		Retainer Depth
1/2"		N/A
V.O. Height		V.O. Width
6"		2' 9"
Surface Color		Surface Material
SW7005		Wood
Available Height		Available Width
7"		4'
Double Face		Illuminated
No		Yes

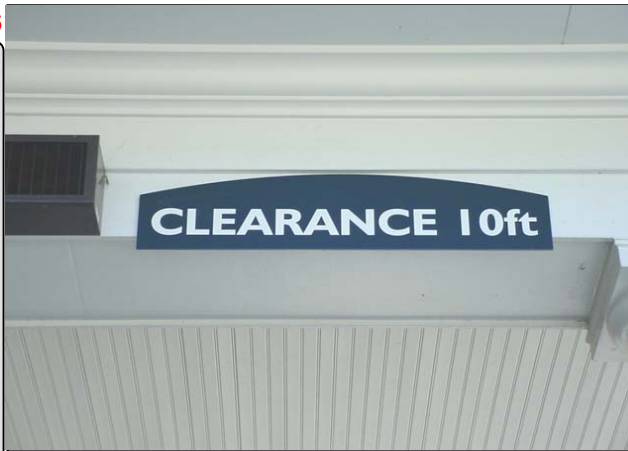
E 06

Notes: E6 Ph# 46 - 48
Quantity 3

Sign Copy		
Clearance 10ft		
Existing Sign Type		
Regulatory		
Height	Width	Depth
8"	2' 10"	7"
Letter Height	OAH above Grade	
3"	13'	
Sign Material	Mount	
Alum	Flush	
Face Type	Face Material	
Flat	Alum	
Retainer Width	Retainer Depth	
N/A	N/A	
V.O. Height	V.O. Width	
Custom	Custom	
Surface Color	Surface Material	
SW7005	Wood	
Available Height	Available Width	
7"	4'	
Double Face	Illuminated	
No	No

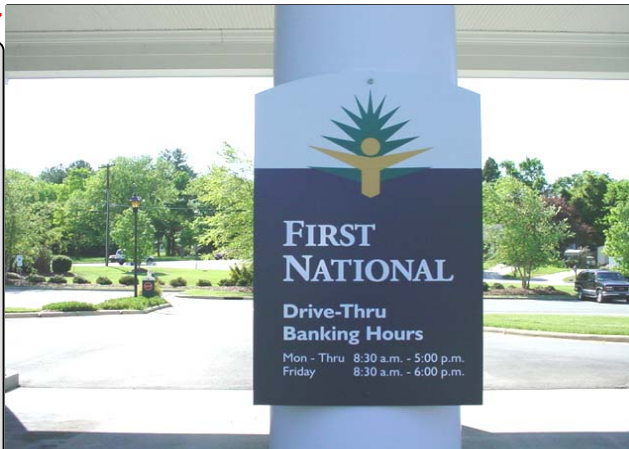
E 07

Notes: E7 Ph# 49 - 51
Quantity 2

Sign Copy		
First National		
Existing Sign Type		
Regulatory		
Height	Width	Depth
2' 1"	1' 4"	1/4"
Letter Height	OAH above Grade	
2"	7'	
Sign Material	Mount	
Alum	Post	
Face Type	Face Material	
Flat	Alum	
Retainer Width	Retainer Depth	
N/A	N/A	
V.O. Height	V.O. Width	
Custom	Custom	
Surface Color	Surface Material	
SW7005	Wood	
Available Height	Available Width	
N/A	N/A	
Double Face	Illuminated	
No	No

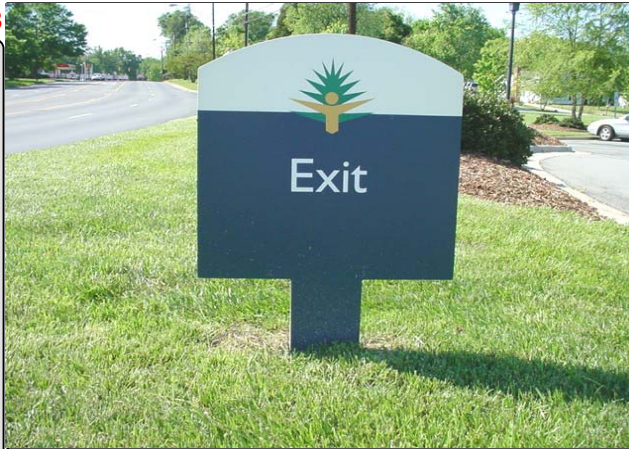
E 08

Notes: E8 Ph# 54, 55, 62, 63
Quantity 2

Post is clad

Sign Copy		
Exit		
Existing Sign Type		
Directional		
Height	Width	Depth
2'	2'	2"
Letter Height	OAH above Grade	
3 1/2"	3'	
Sign Material	Mount	
Alum	Post	
Face Type	Face Material	
Flat	Alum	
Retainer Width	Retainer Depth	
N/A	N/A	
V.O. Height	V.O. Width	
Custom	Custom	
Surface Color	Surface Material	
N/A	N/A	
Available Height	Available Width	
N/A	N/A	
Double Face	Illuminated	
Yes	No

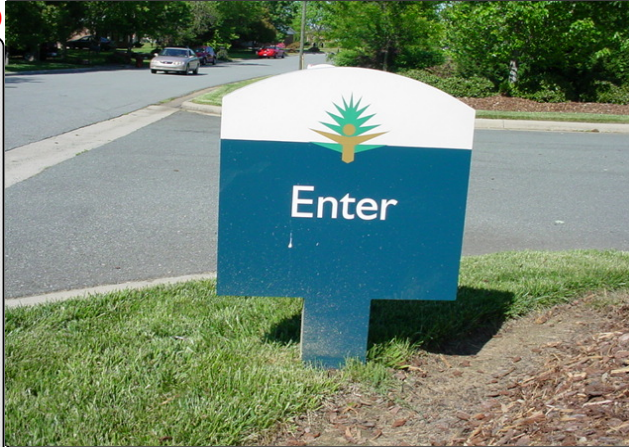
E 09

Notes: E9 Ph# 56, 57, 60, 61
Quantity 2

Post is clad

Sign Copy		
Enter		
Existing Sign Type		
Directional		
Height	Width	Depth
2'	2'	2"
Letter Height		OAH above Grade
3 1/2"		3'
Sign Material		Mount
Alum		Post
Face Type		Face Material
Flat		Alum
Retainer Width		Retainer Depth
N/A		N/A
V.O. Height		V.O. Width
Custom		Custom
Surface Color		Surface Material
N/A		N/A
Available Height		Available Width
N/A		N/A
Double Face		Illuminated
No		No

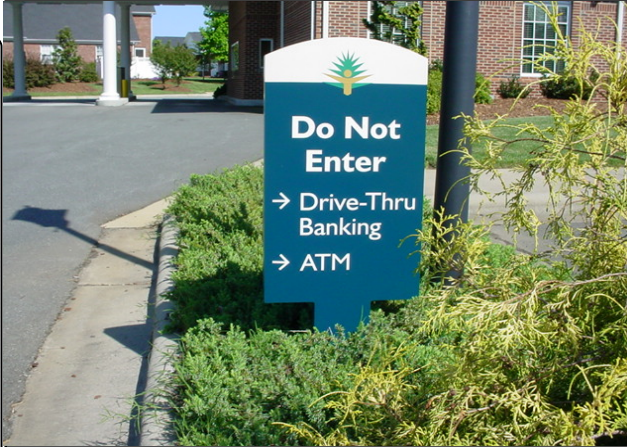
E 10

Notes: E10 Ph# 58, 59

Post is clad

"Stop" is on the reverse side

Sign Copy		
Do Not Enter/ Stop		
Existing Sign Type		
Directional		
Height	Width	Depth
2' 8"	1' 6"	2"
Letter Height		OAH above Grade
2 1/4"		4'
Sign Material		Mount
Alum		Post
Face Type		Face Material
Flat		Alum
Retainer Width		Retainer Depth
N/A		N/A
V.O. Height		V.O. Width
Custom		Custom
Surface Color		Surface Material
N/A		N/A
Available Height		Available Width
N/A		N/A
Double Face		Illuminated
Yes		No

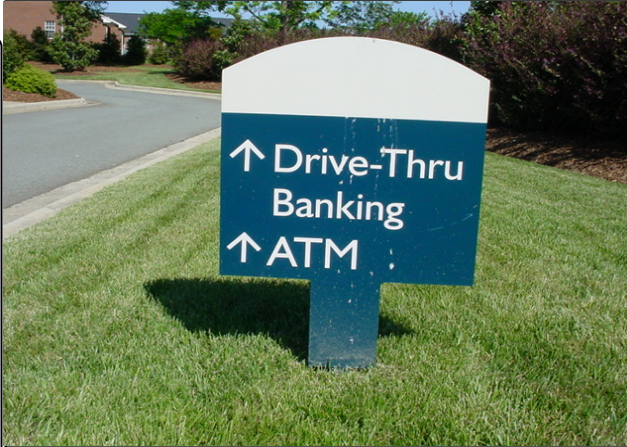
E 11

Notes: E11 Ph# 64, 65

Sign Copy		
Drive Thru ATM		
Existing Sign Type		
Directional		
Height	Width	Depth
2'	2'	2"
Letter Height		OAH above Grade
3"		3'
Sign Material		Mount
Alum		Post
Face Type		Face Material
Flat		Alum
Retainer Width		Retainer Depth
N/A		N/A
V.O. Height		V.O. Width
Custom		Custom
Surface Color		Surface Material
N/A		N/A
Available Height		Available Width
N/A		N/A
Double Face		Illuminated
No		No

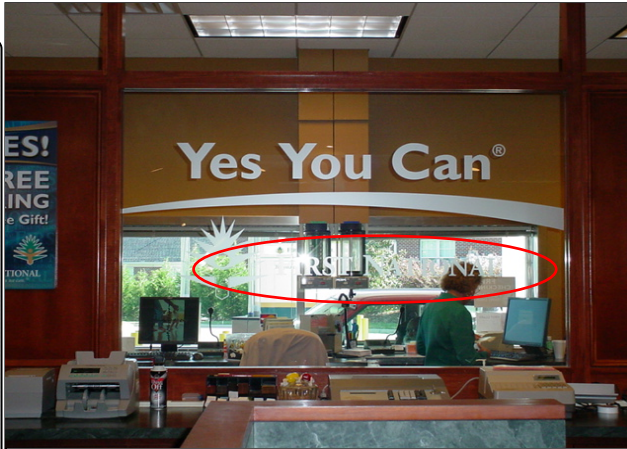
I 01

Notes: I 1 Ph# 4 Interior

The measurement is of the mirror glass

Sign Copy		
First National		
Existing Sign Type		
Vinyl		
Height	Width	Depth
3' 10"	5' 10"	N/A
Letter Height		OAH above Grade
3 1/2"		7' 6"
Sign Material		Mount
Vinyl		Flush
Face Type		Face Material
Flat		Glass
Retainer Width		Retainer Depth
N/A		N/A
V.O. Height		V.O. Width
N/A		N/A
Surface Color		Surface Material
Clear		Glass
Available Height		Available Width
3' 10"		5' 10"
Double Face		Illuminated
No		No
