Maintenance checks report

Checklist name	Year
05_MV - Site proposal - season 6	6

Site	Turbine serial number	Order number
Wikinger. WK40	WK40 - 1121480	60606604
Language	Revision date checklist	Approval date
en-US	2/21/2024	5/8/2024

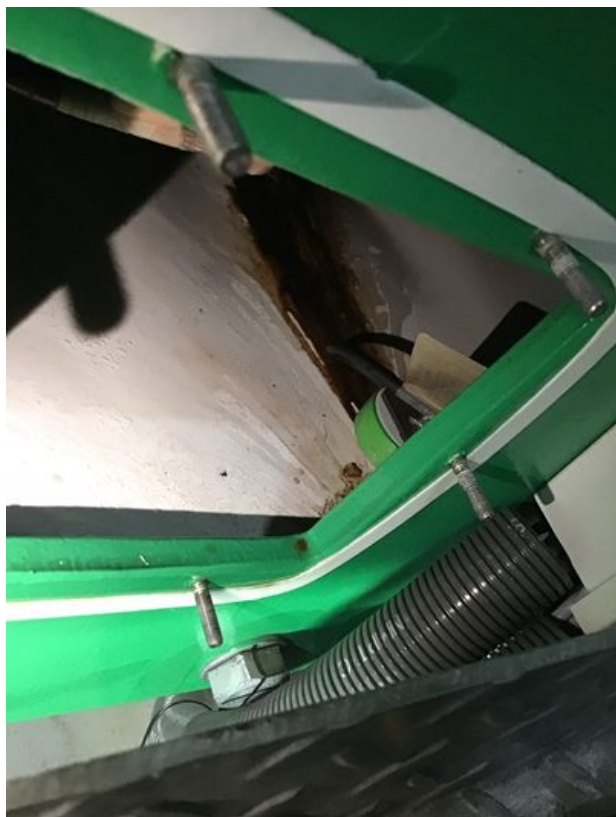
1 Figure from Checklist 'AD 5-135_1_1_5_MV_year_null', Task 15 - Remarks

12	ATD000605.0: Generator - Enclosure of the machine and all holding fixtures - Inspection			✓
13	ATD000605.1: Generator - Stator covers seal & winding connections tightness and external damages - Inspection			✓
14	ATD000605.2: Generator - Terminal box and all the connections - Inspection			✓
15	ATD000605.3: Generator - Rotor - Inspection	<p>Remark 1 Oil found in the generator room, aria's cleaned</p> <p>See annex 'Taken photos': 1</p> <p>Remark 2 Oil found in the generator room, aria's cleaned</p> <p>See annex 'Taken photos': 2</p>		✗

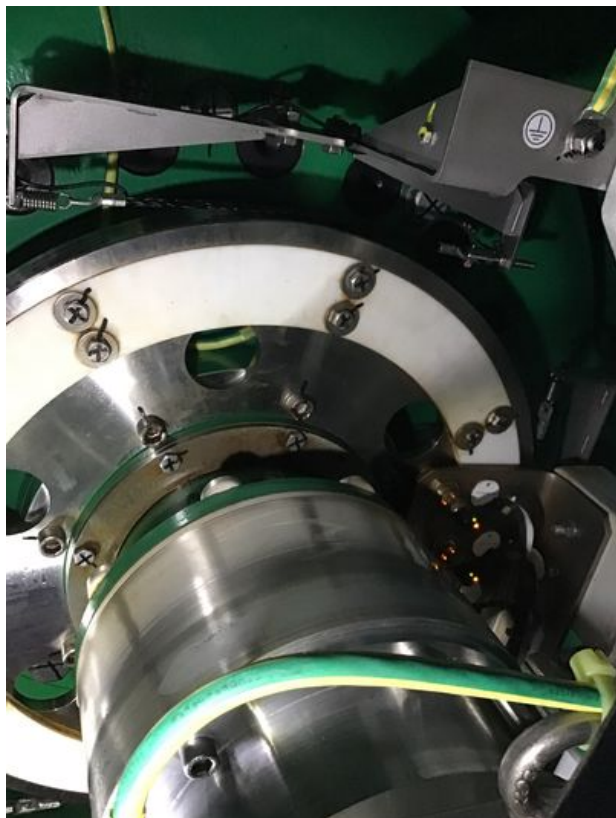
3 Figure from Checklist 'AD 5-135_1_1_5_MV_year_null', Task 15 - Remarks

AD 5-135_1_1_5_MV_year_null				
#	Measuring points	Remarks	Tools	Status
Location: Nacelle inside				
		Remark 3 See annex 'Taken photos': 3 Remark 4 See annex 'Taken photos': 4 Remark 5 Service Order 61269969		
Location: Tower				
16	ADWI017124.10: Main UPS - Cabinet structure - Inspection			✓
17	ADWI017124.11: Main UPS - Battery trays - Inspection and torque			✓
18	ADWI017124.12: Main UPS - Platform fixation - Inspection and torque			✓
19	ADWI017124.1: Main UPS - External cover panels - Inspection and torque			✓
20	ADWI017124.2: Main UPS - Cabinet doors are correctly closed and the handles work properly - Inspection			✓
21	ADWI017124.3: Main UPS - Upper/ lower locking plates - Inspection and torque			✓
22	ADWI017124.4: Main UPS - Fastening claws - Inspection and torque			✓
23	ADWI017124.5: Main UPS - Locking brackets - Inspection and torque			✓
24	ADWI017124.6: Main UPS - Locking rods - Inspection and torque			✓
