THE 2019 E-DEFENSE SHAKE-TABLE TEST OF A LARGE-SCALE 3-STORY DISASTER MANAGEMENT CENTER

Koichi Kusunoki
Earthquake Research Institute, the University of Tokyo

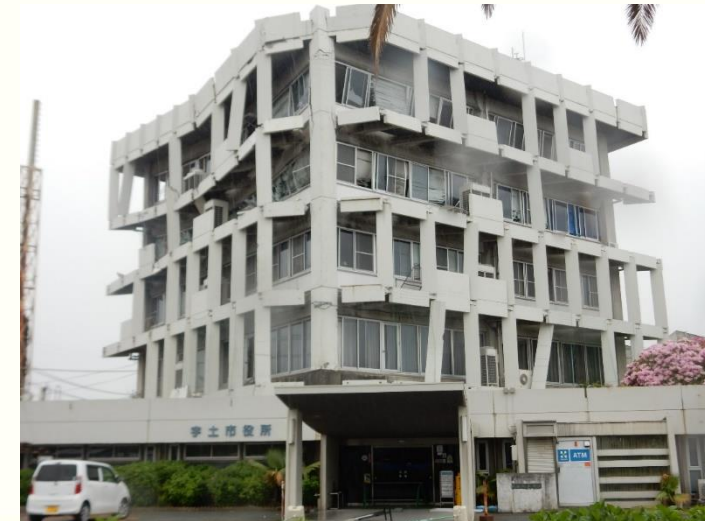
Conventional R/C structure in Japan

- Wing/Hanging/Standing walls contribute.
- High ultimate strength.
- **Low allowable strength.**
- Low ductility.

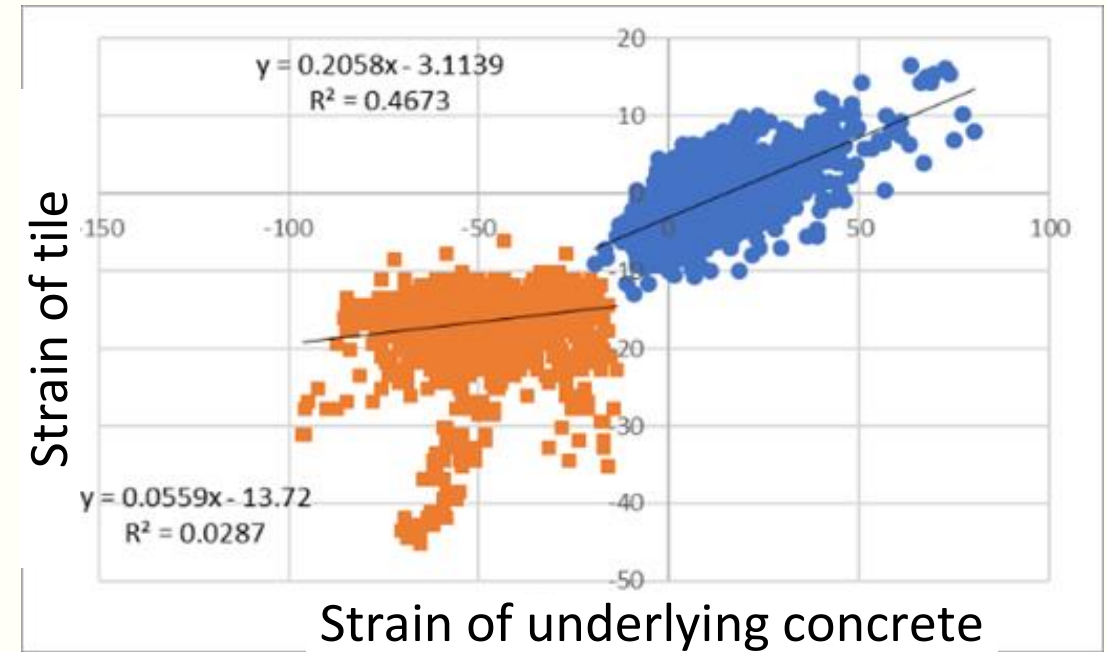
Tiles

- Optical fiber sensor can detect the damage of tiles.

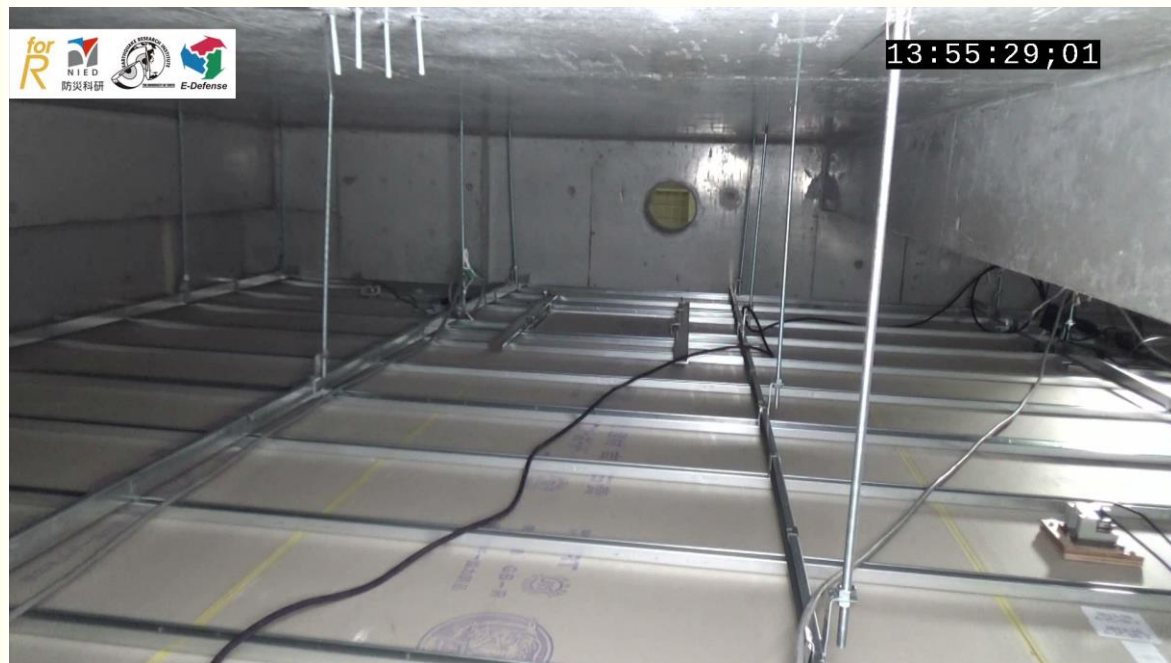
Conventional ceiling

150%-2 Ceiling system
