Experiment 3: Measurement of the Bonding Strength of METLBOND on Carbon Fiber, Aluminum, and PTFE in Shear

ME 411 Engineering Measurement and Instrumentation Systems

Portland State University

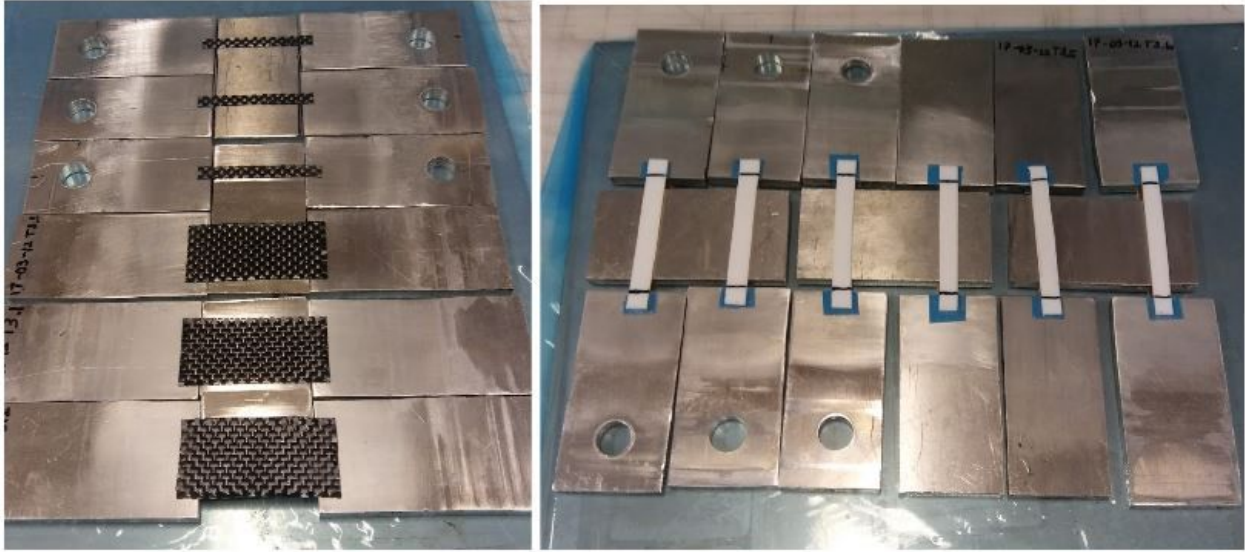
Figure 1: Test Coupons-- Aluminum & CF (Left), Aluminum & PTFE (Right).

The material being bonded to the aluminum was lapped over both pieces, on both sides, as shown in Figure 1, for a total of four bonding zones per coupon¹.

Two sets of test coupons were prepared. A set was made for each material interface and test type combination. Each test coupon was made using two rectangular pieces of aluminum cut from the same piece of 0.25" thick plate. A hole was drilled into each aluminum piece along its vertical axis to allow a hook to pass through.

For each coupon, the four bonding zones were equal in area. This was accomplished by cutting 0.25" x 0.25" squares of METLBOND film for the carbon fiber coupons.. The size of the aluminum PTFE interface was controlled by cutting the PTFE strips 0.25" wide and marking 0.25" from the edge (marking the edge of the bonding surface). The Adhesive film portions were measured out with a ruler, marked with a Sharpie, and cut using a razor blade. (The accuracy of these areas was restricted by half the resolution of the ruler used, 1/32", resulting in an area uncertainty of +/- 0.015 in² per bonding zone, or +/- 0.06 in² per test coupon). Once the coupons were assembled, they were wrapped in a special release film, further wrapped in a breather fabric, vacuum sealed, and cured in an oven (see Figure 2) using a time and temperature regime developed by a previous PSAS airframe capstone team and optimized for maximum adhesion².

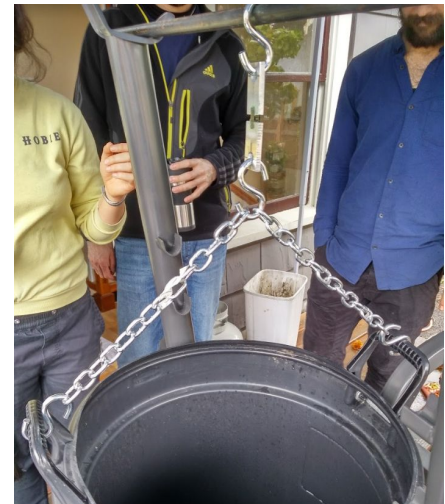
During the experiment, the coupons were hung by one end from a steel support frame using an s-hook. On the other end, a 32-gallon bin was hung using another s-hook attached to two chains, as shown in Figure 3. The chain lengths were altered symmetrically on the hook to ensure that when failure occurred, the testing apparatus would only fall approximately one inch to the ground, eliminating the possibility of water loss or tipping (so that the weight applied to the coupon could later be measured).

Figure 3: Manual Tensile Test Apparatus

mark for each step of the experimental procedure for ease of pouring. Then water was slowly added from a one gallon jug (see Figure 3) until failure of the coupon was apparent (failure was easily visible and audible). Upon failure of the testing coupons, the weight of the loaded testing apparatus (including bin, chains, hooks, and lower-half of test coupon) was measured on an electric scale in order to determine a pound-force subjected to the testing coupon.

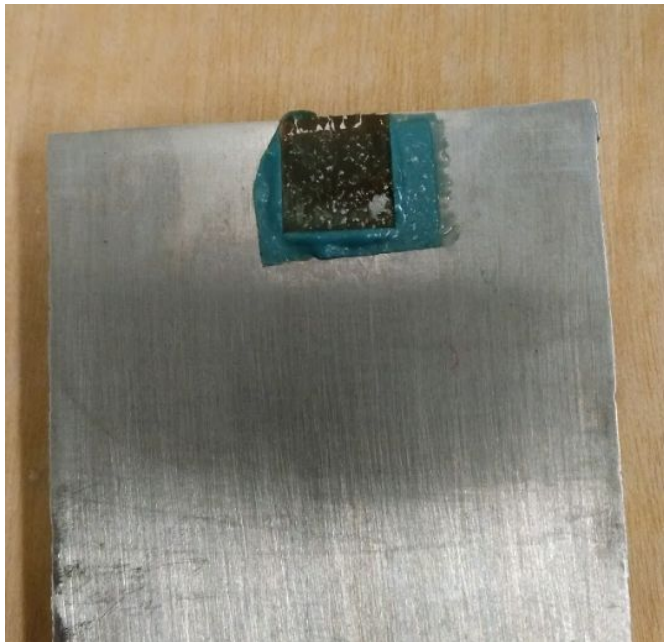
PTFE Etching Failure (Aluminum Side)

PTFE run 1 (T4.1)- failed @ 12 gallons, weighed @ 118 lbs. Twisting/torsion present during filling, failure appears to be the PTFE etching layer coming off of the PTFE itself as opposed to METLBOND failure.

PTFE run 2 (T4.2)- failed at $\sim 10 \frac{1}{3}$ gallons, weighed at 101 lbs. Elongation occurred in PTFE same as 1st run, failure occurred at etching layer on PTFE not METLBOND. @ gallon 10 elongation caused hanging bucket to rest on ground, needed to lift apparatus and shorten chain rung in order to add more water to cause failure.

PTFE run 3 (T4.3) - failed @ $\sim 10 \frac{1}{4}$ gallons, weighed at 100.6 lbs. Same issues as last runs, etching later failure, ripped off of PTFE.
